Nederlandse Aardolie Maatschappij B.V.

# Experimental campaign on RC buildings typical of the Groningen region: dynamic testing of a precast specimen

| LAB AND TESTS RESPONSIBLE | DOCUMENT AUTHOR | REVIEWER |
|---|---|---|
| Issue: 30/10/2017 | Document type:<br><br><b>Technical report</b><br>pages: 364 | File name:<br>EUC_BUILD5-test_campaign_report.pdf |

Brunesi E., Peloso S., Pinho R., Nascimbene R. (2017). *Dynamic testing of a full-scale two-storey RC precast wall-slab-wall structure representative of the Groningen building stock*. Report EUC215/2017U, European Centre for Training and Research in Earthquake Engineering (EUCENTRE), Pavia, Italy.

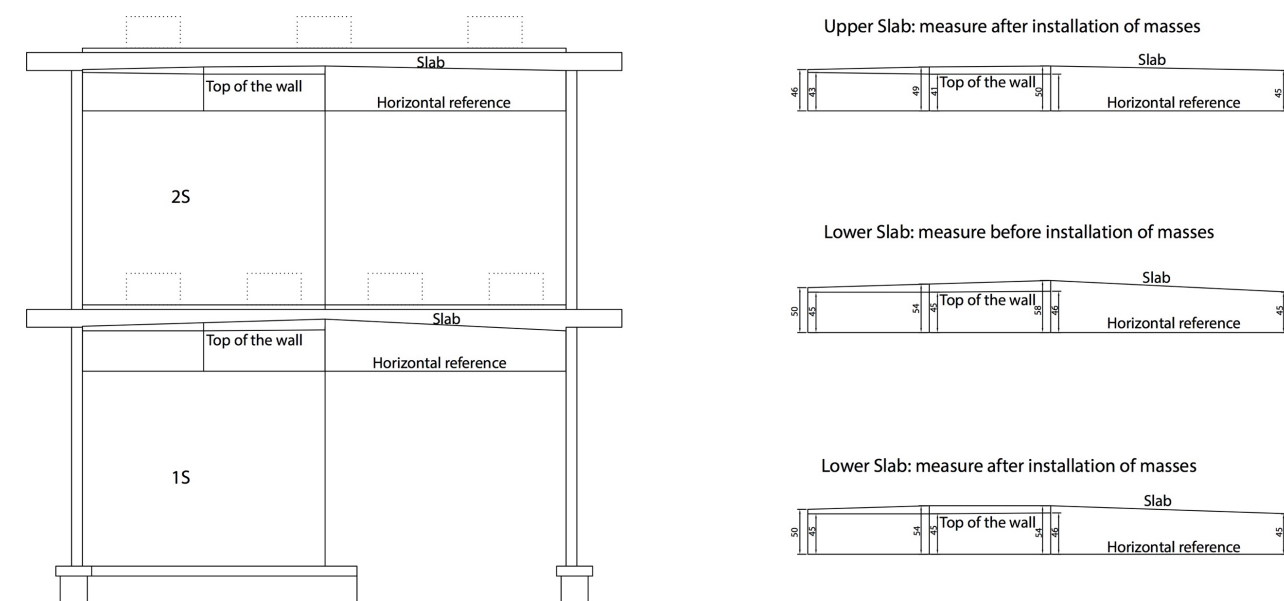
**Figure 158. Measurements of the gap between the stability walls and the slabs – First and second storey.**

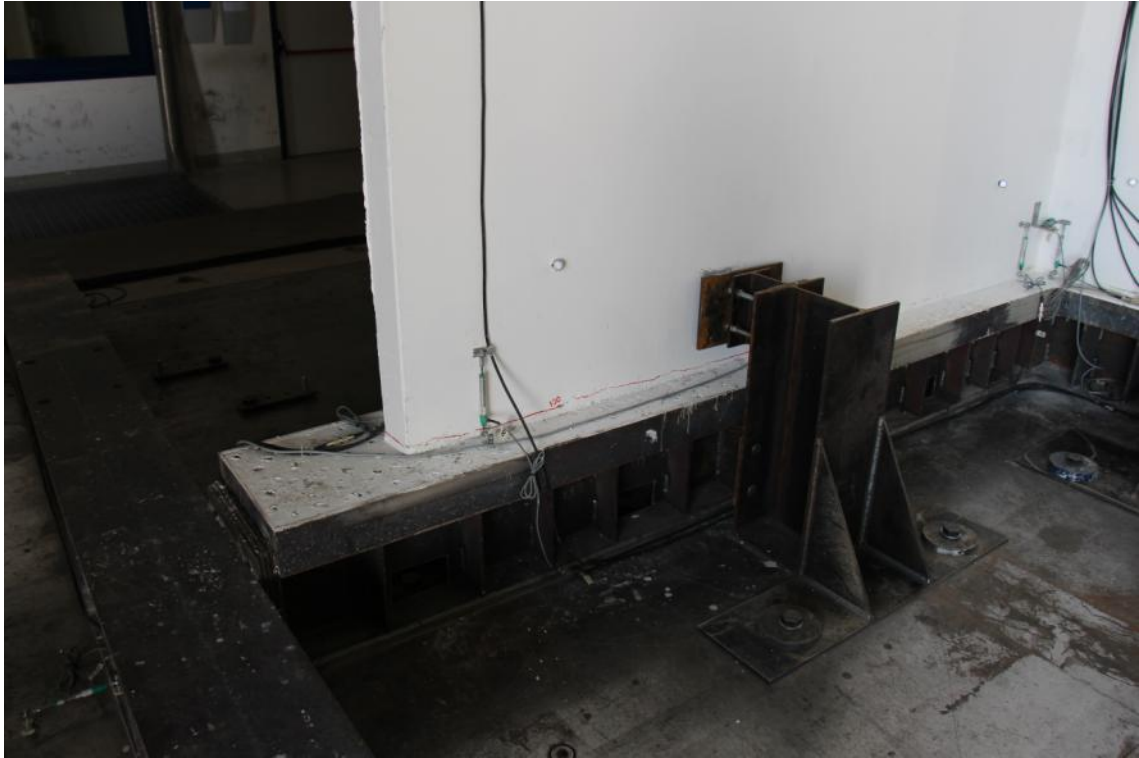
**Figure 256. Development of cracks at the base of the ground-floor stability wall.**

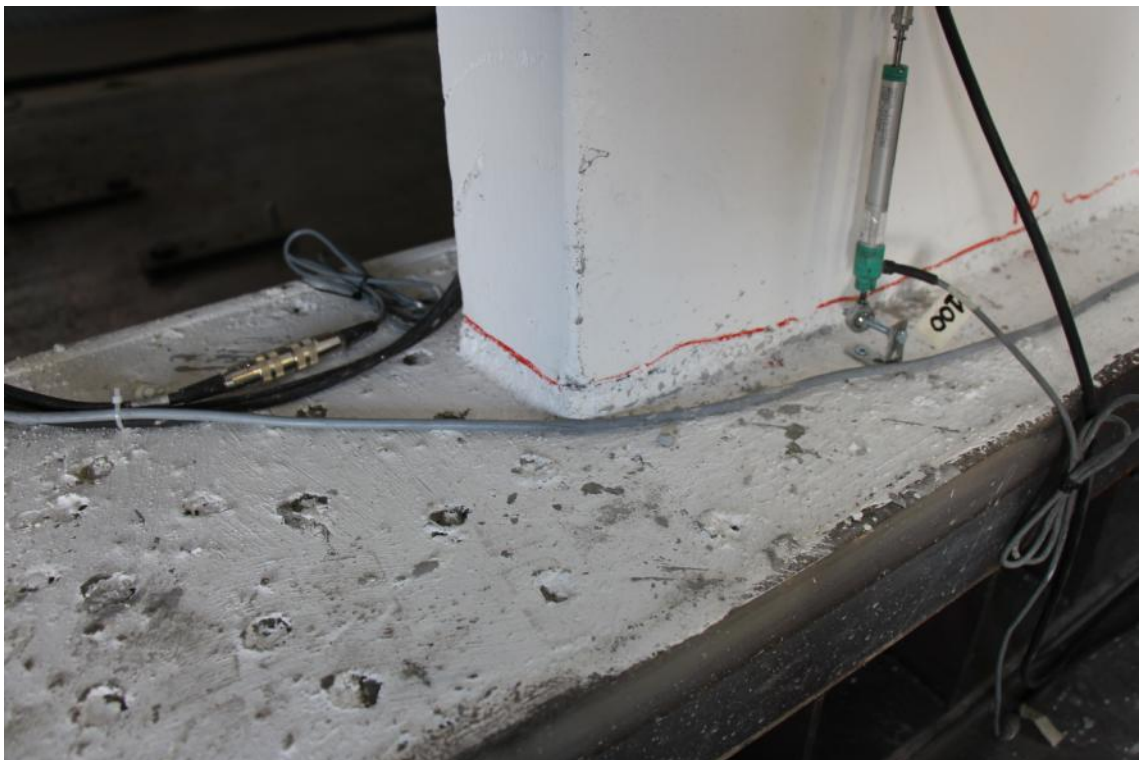
**Figure 257. Crack pattern at the base of the first-floor stability wall – Edge of the wall.**

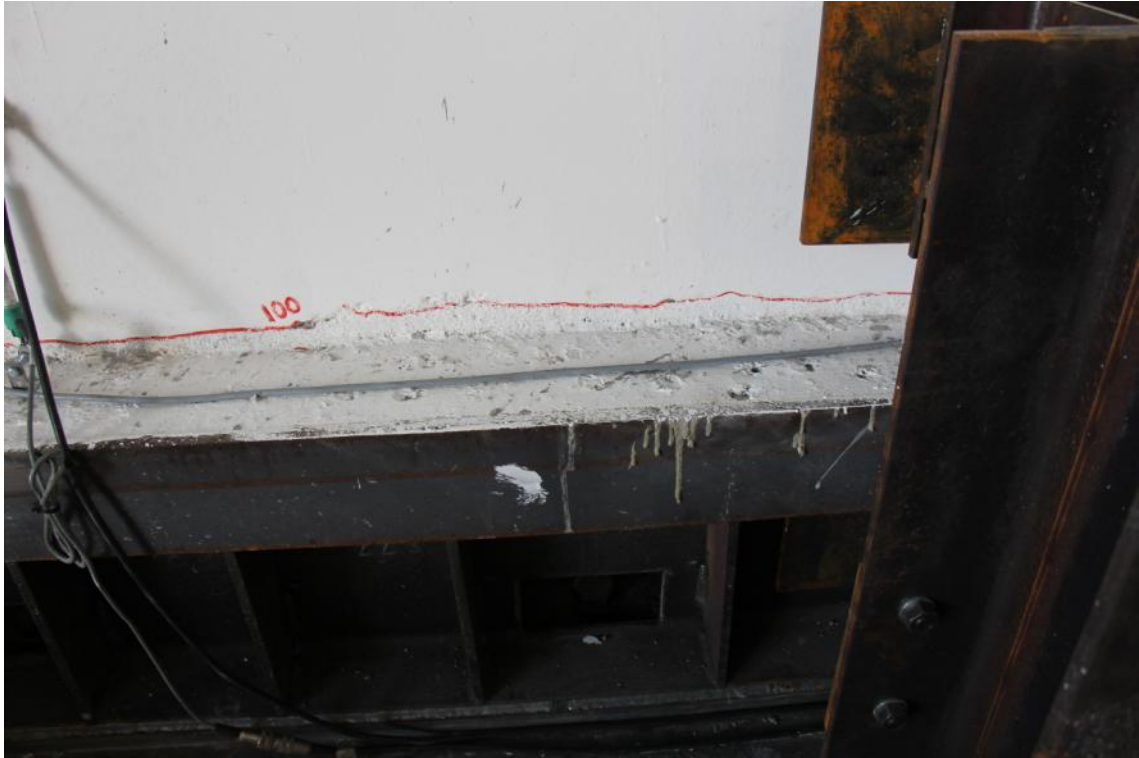
**Figure 258. Detail of crack at the base of the first-storey stability wall – Centre of the wall panel.**

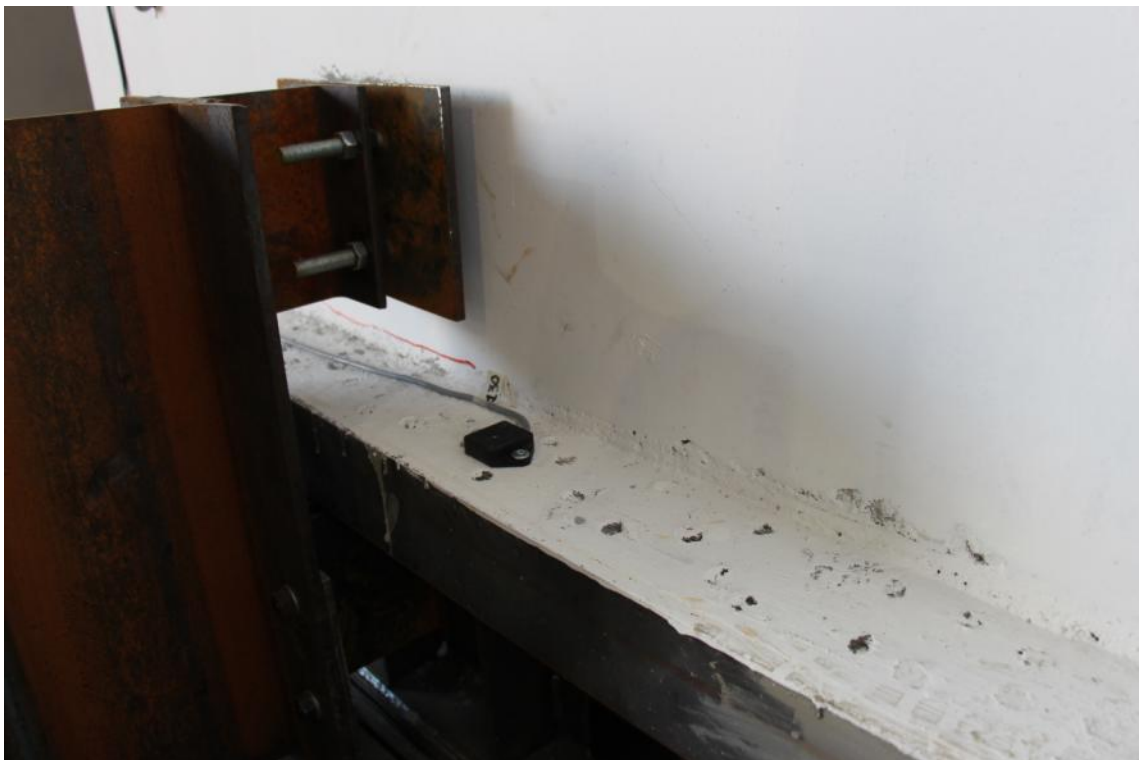
**Figure 259. Crack running from the edge to the centre of the first-storey stability wall – Wall base.**

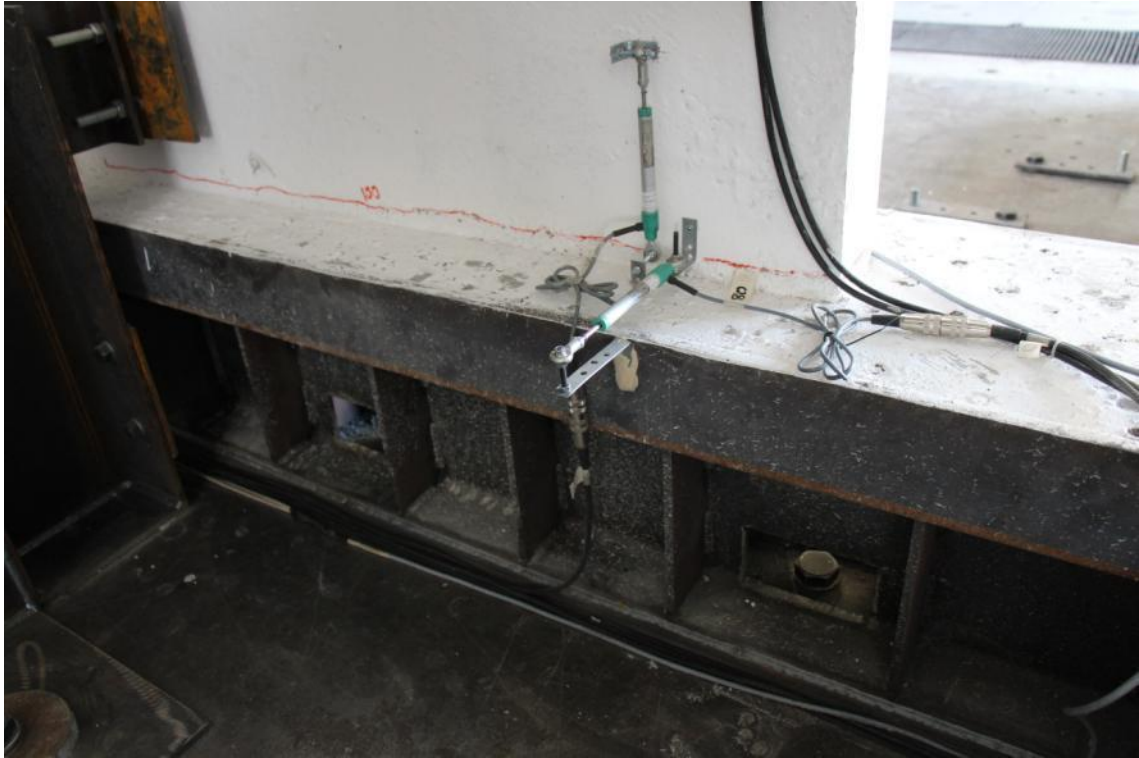
**Figure 260. Crack running from the edge to the centre of the first-storey stability wall – East wall face.**

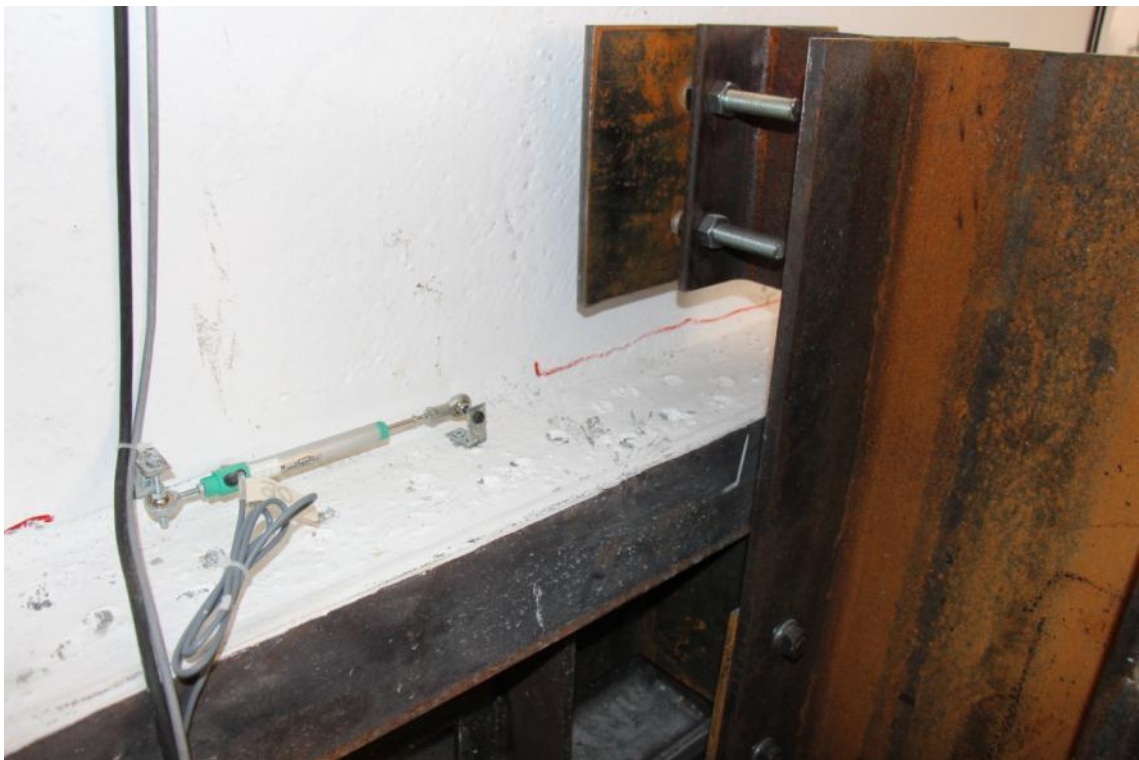
**Figure 261. Detail of the crack at the base of the East face of the first-storey stability wall – South side.**

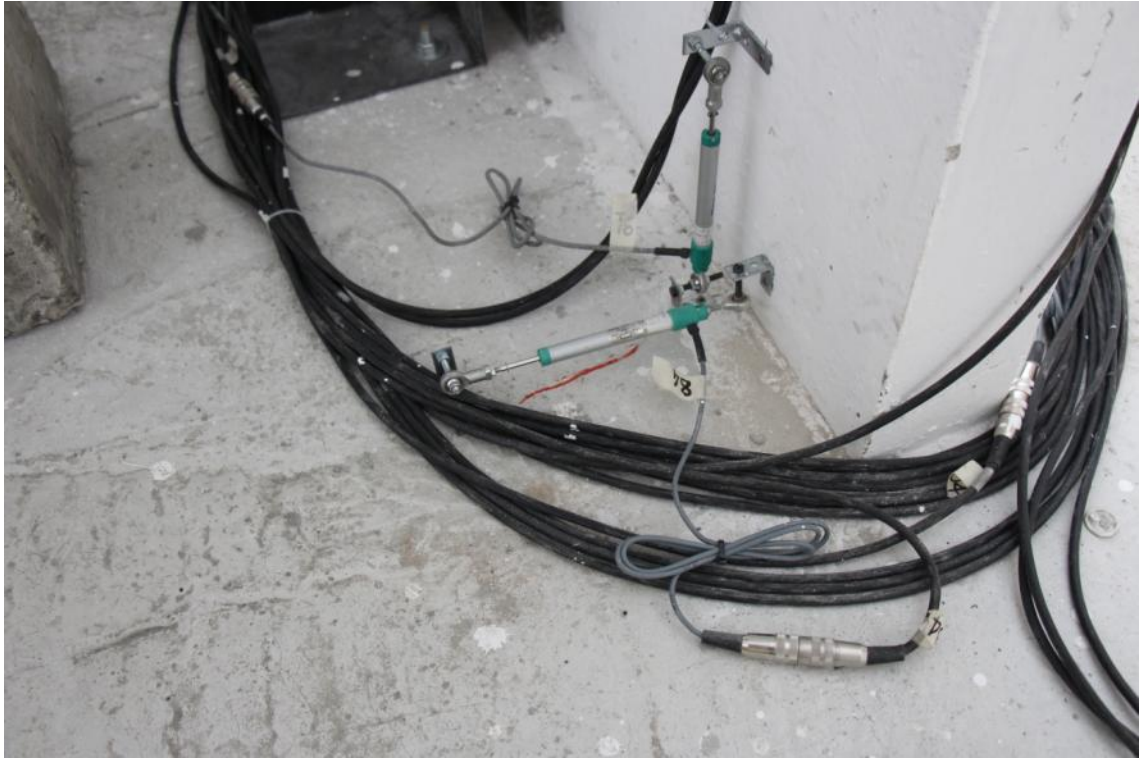
**Figure 262. Minor cracks in the concrete topping close to the North edge of the second-storey stability wall.**

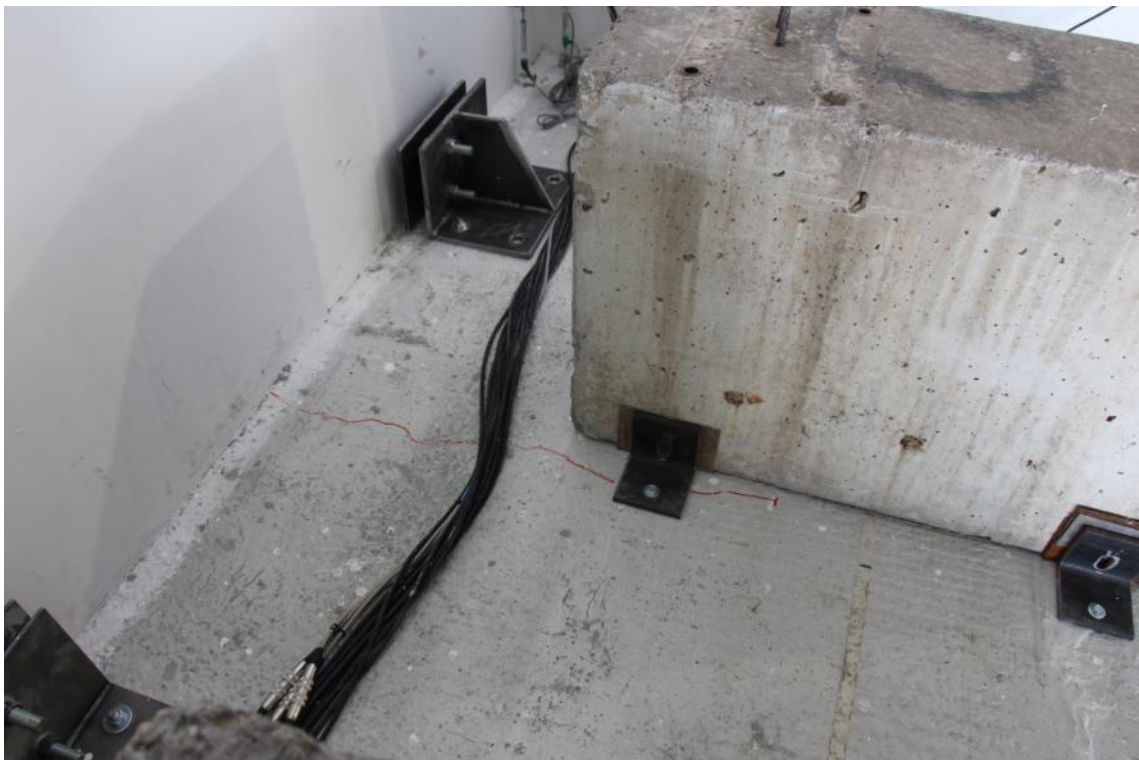
**Figure 263. Crack running from the centre of the second-storey stability wall – West wall face.**

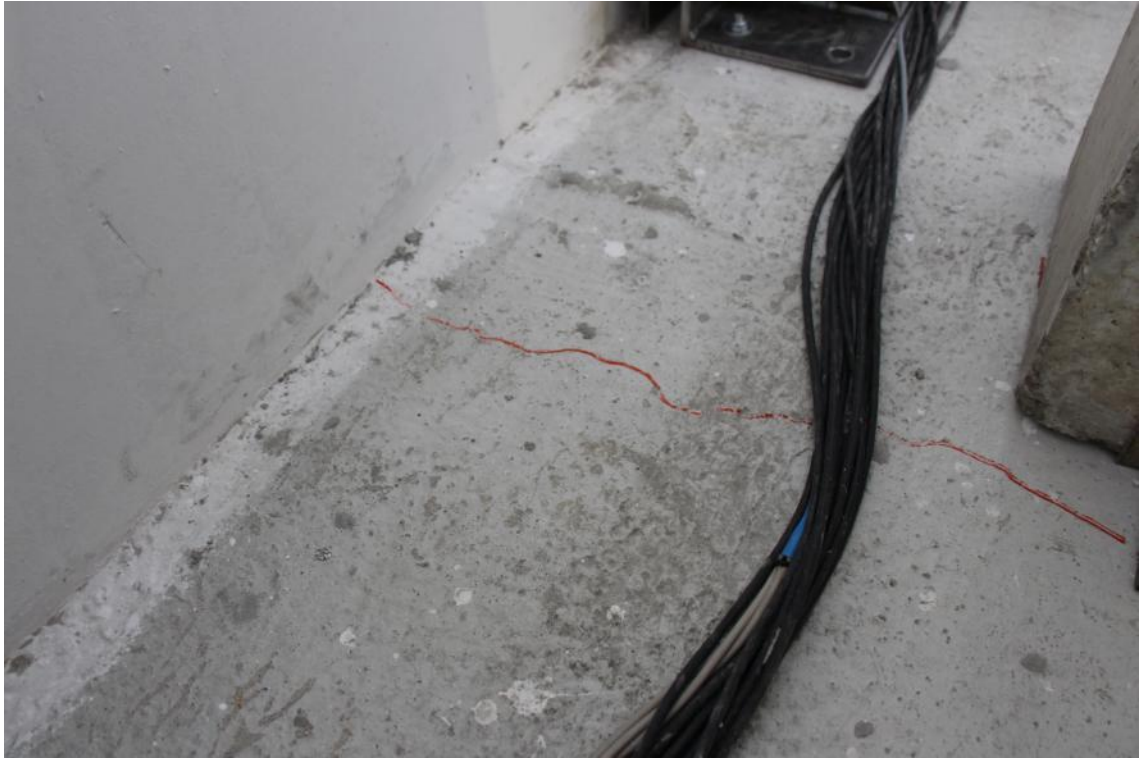
**Figure 264. Crack running from the North edge of the second-storey stability wall – West wall face.**

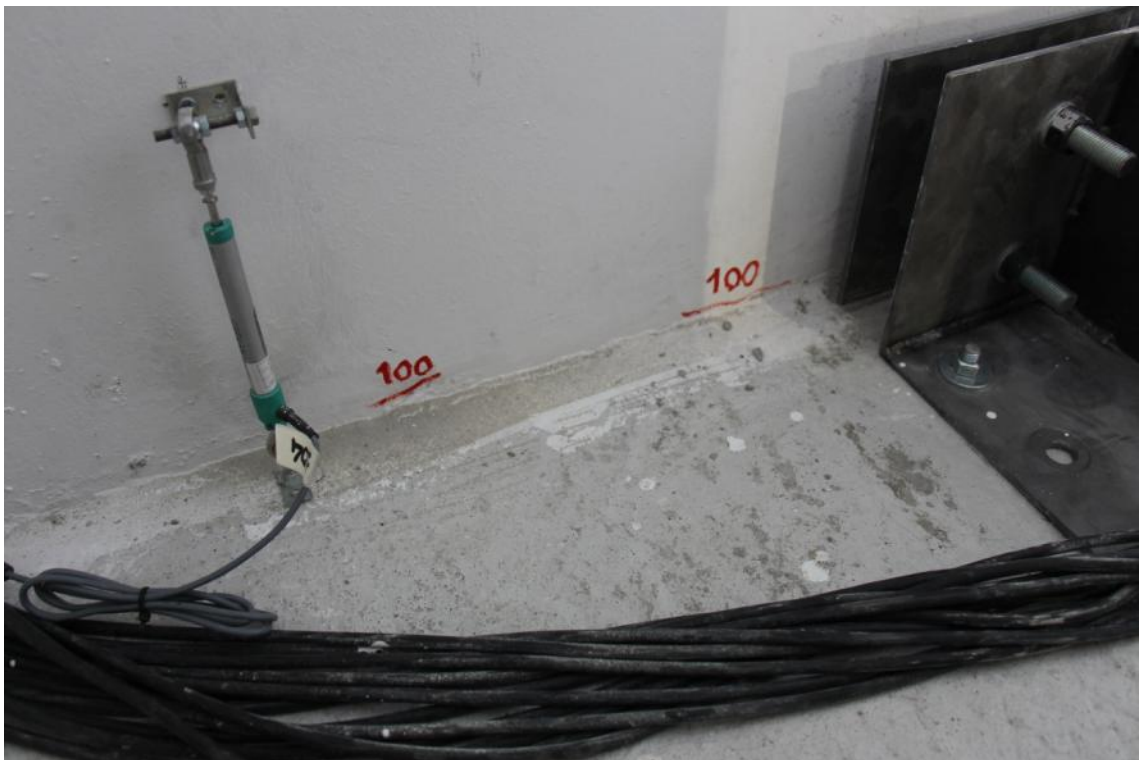
**Figure 265. Cracks developed at the base of the second-storey stability wall – West wall face, North edge.**

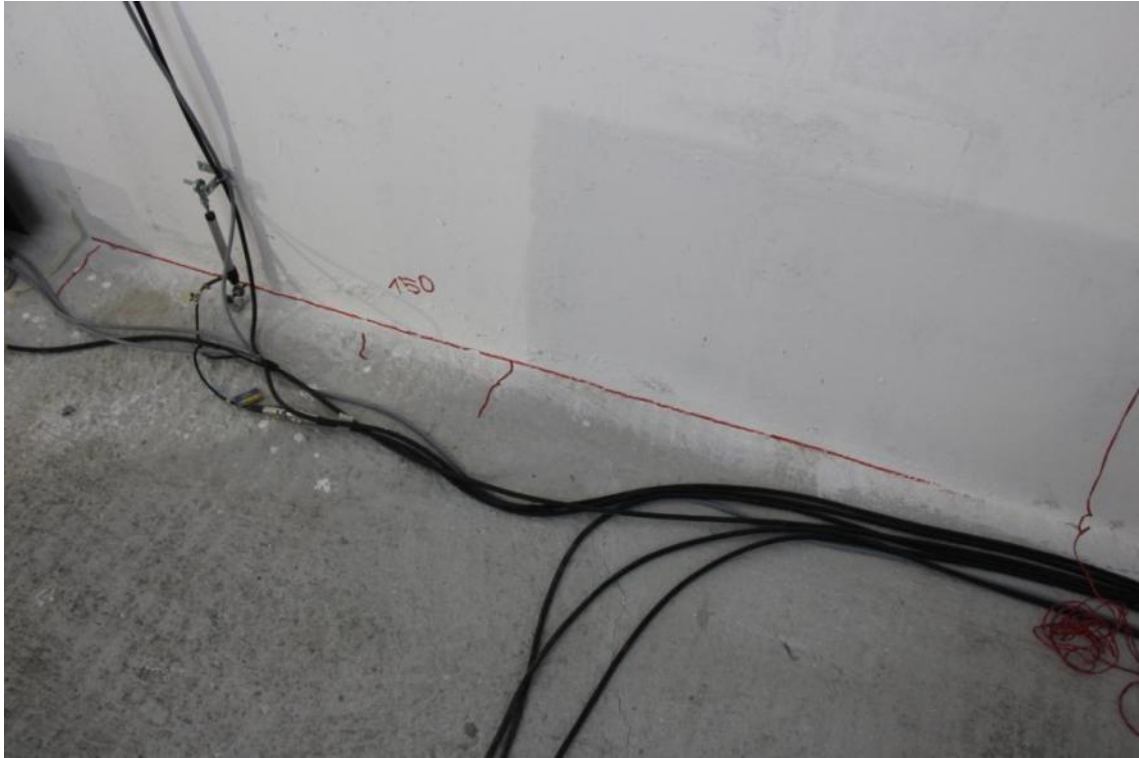
**Figure 266. Development of flexural cracks at the base of the North-sided second-storey transversal walls.**

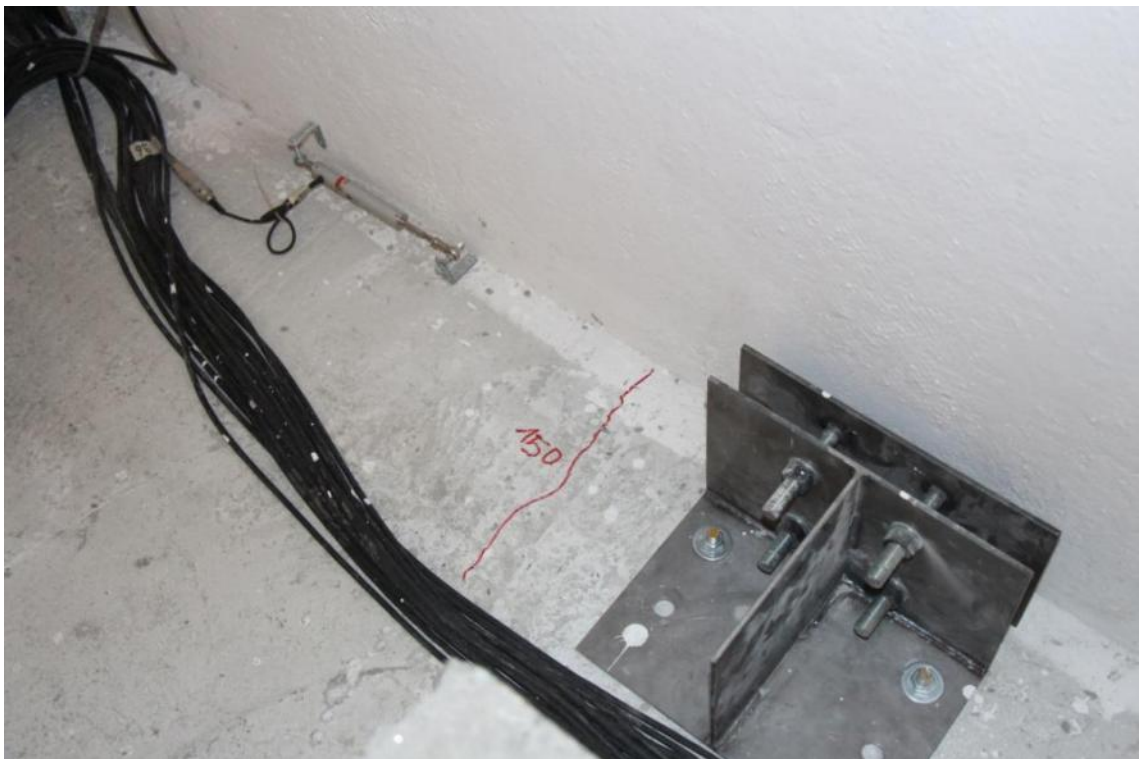
**Figure 267. Crack running from the centre of the second-storey stability wall – East wall face.**

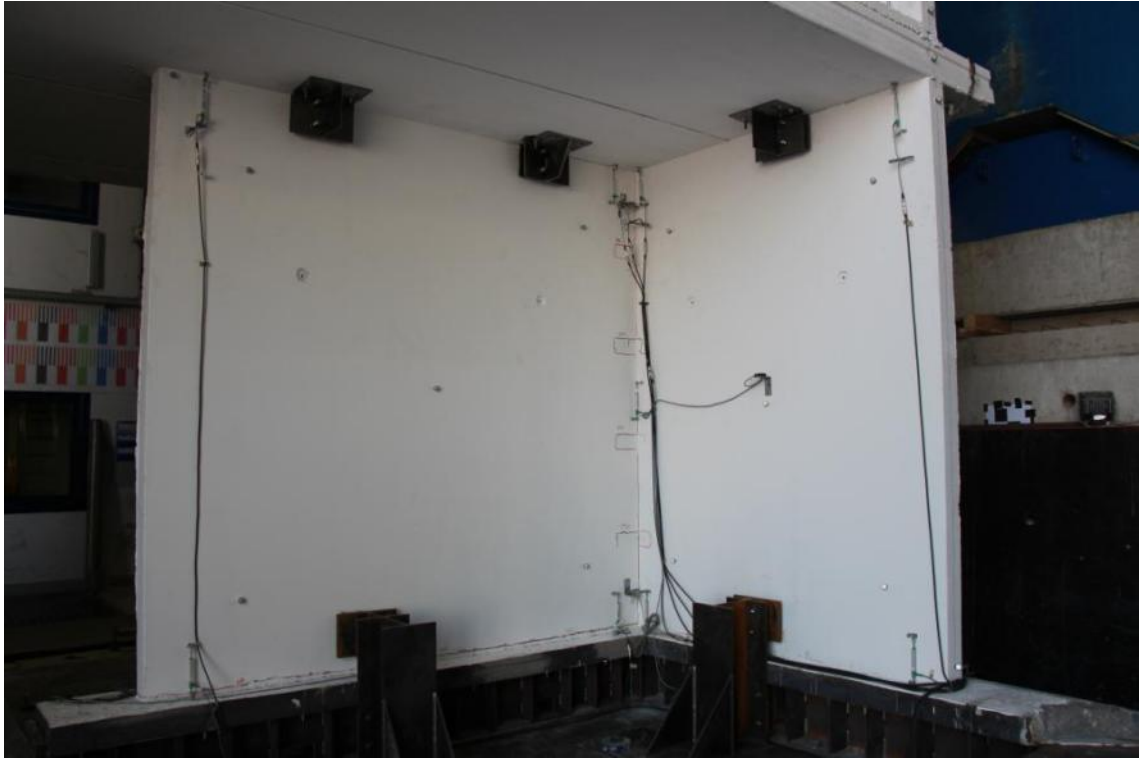
**Figure 268. Crack pattern of the ground-floor stability wall – Wall base and connectors sockets.**

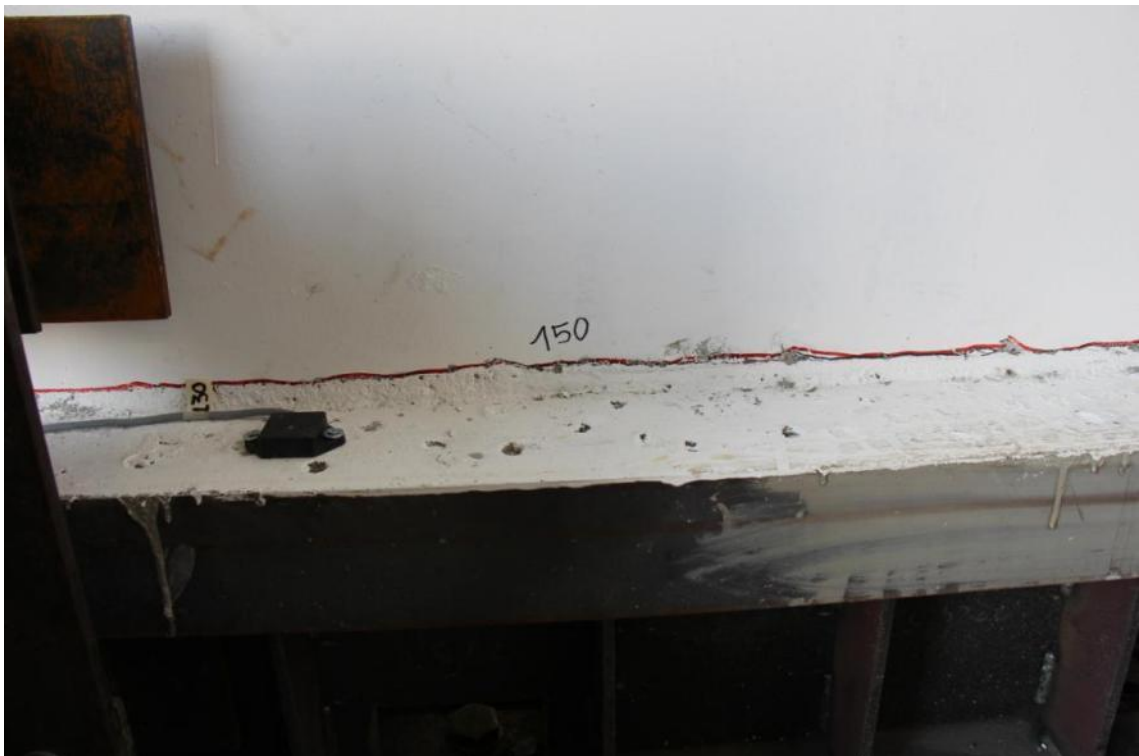
**Figure 269. Propagation of horizontal crack along the depth of the ground-floor stability wall – Wall base.**

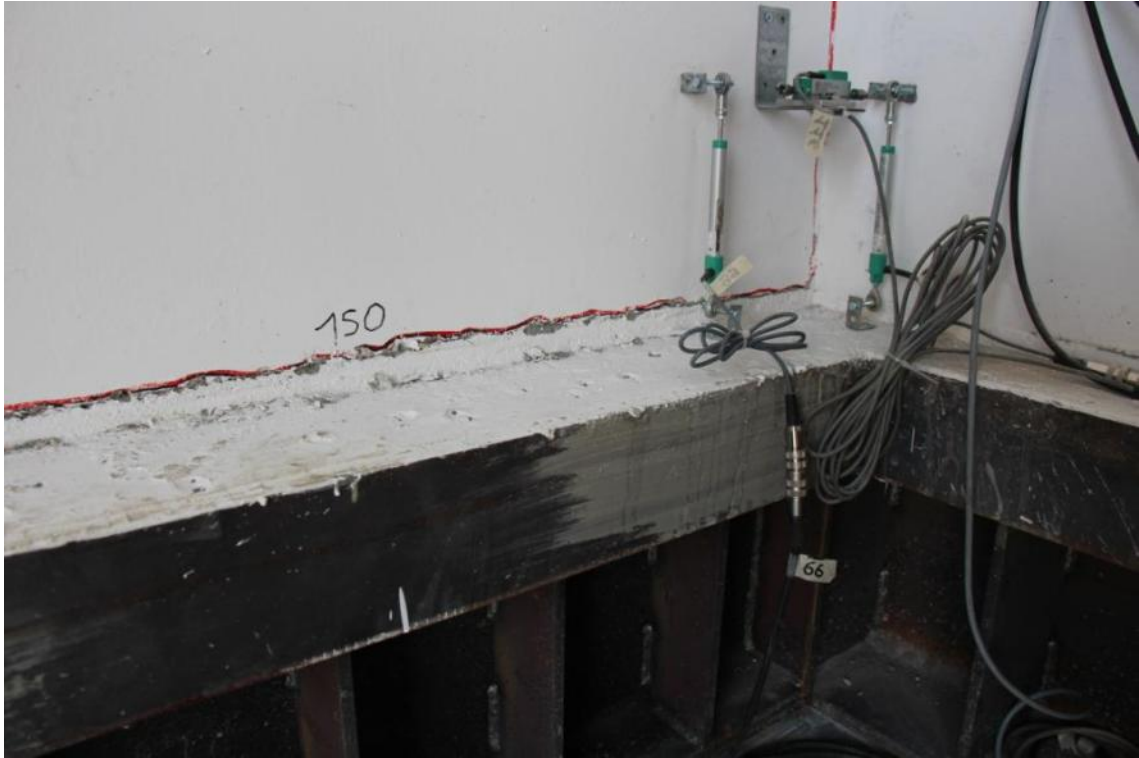
**Figure 270. Crack running along the entire depth of the ground-floor stability wall – Wall base.**

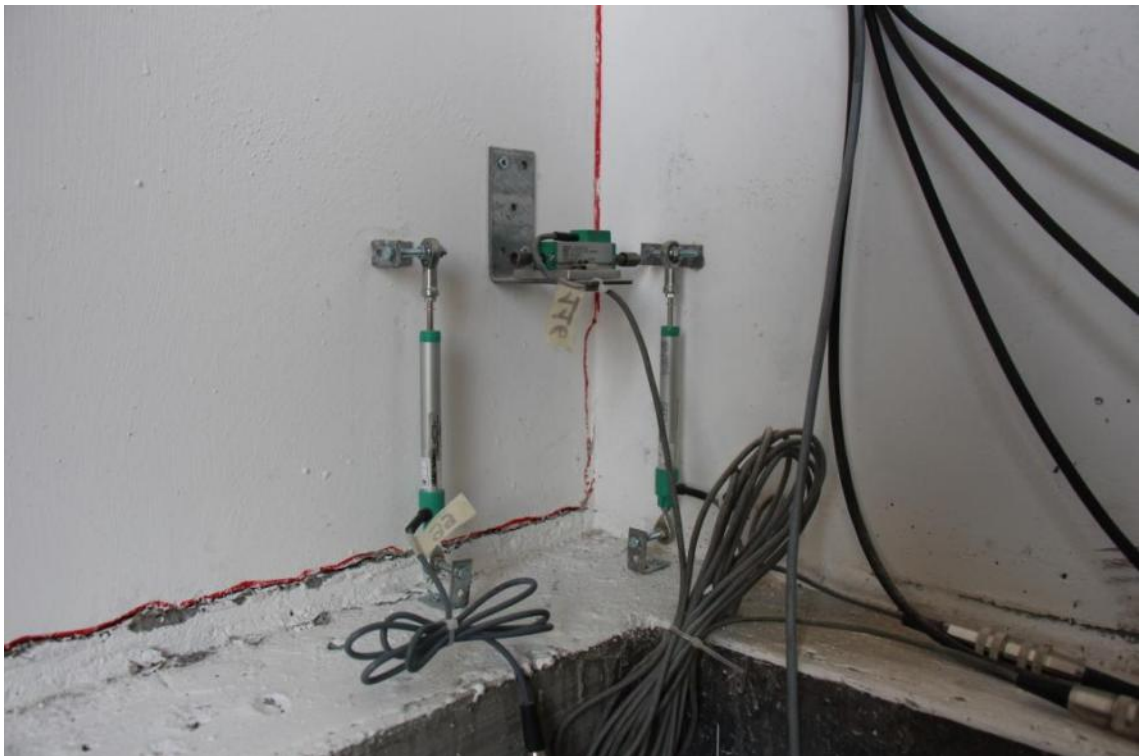
**Figure 271. Vertical crack along the height of the first-storey stability wall – South edge.**

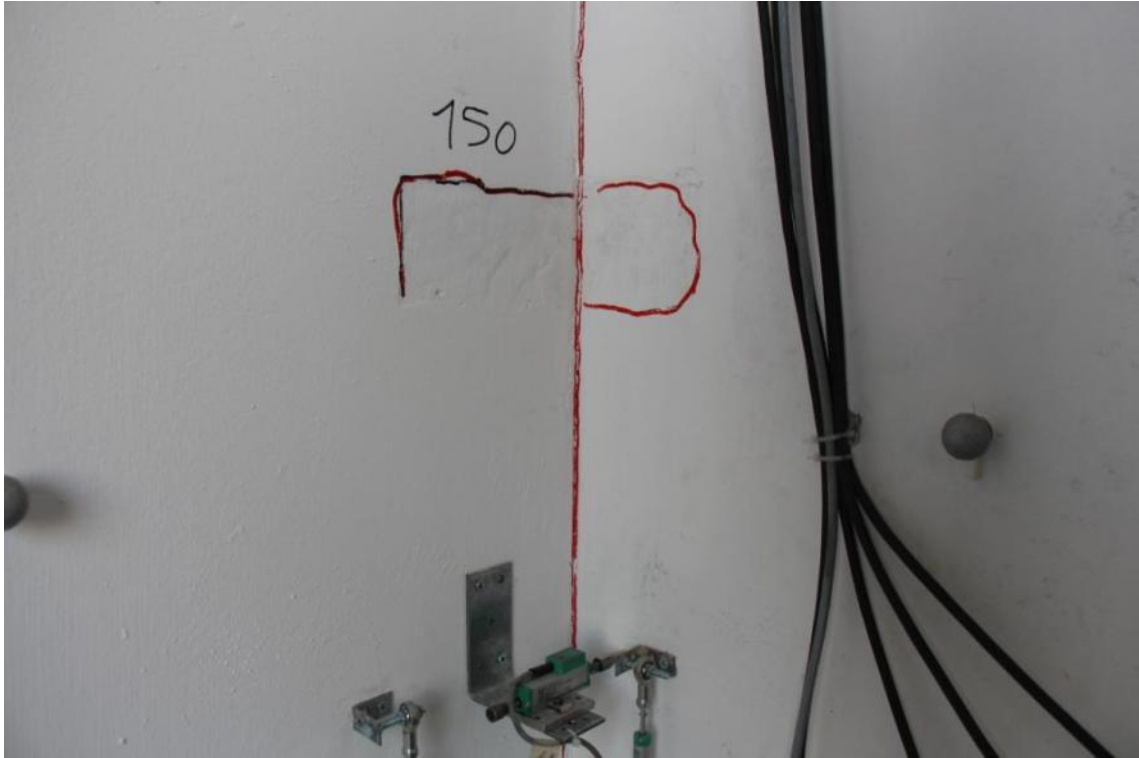
**Figure 272. Cracks along the boundaries of the connectors sockets – Detail of the bottom three-way joint.**

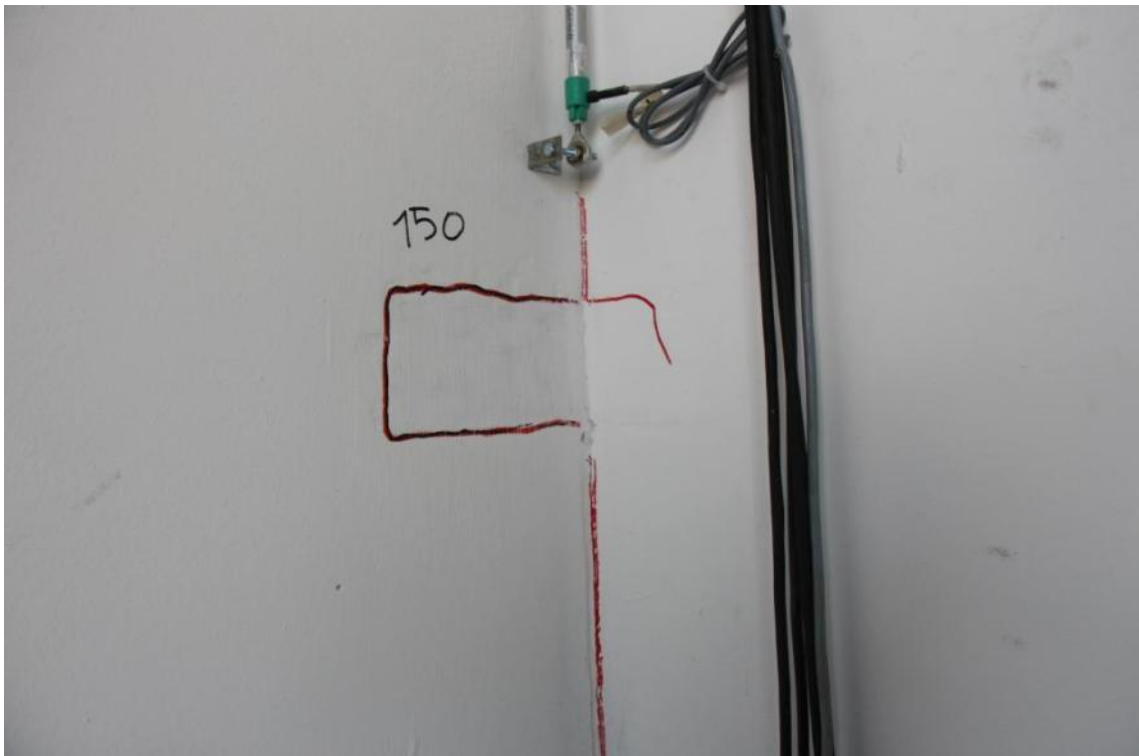
**Figure 273. Development of cracks along the boundaries of the connectors sockets.**

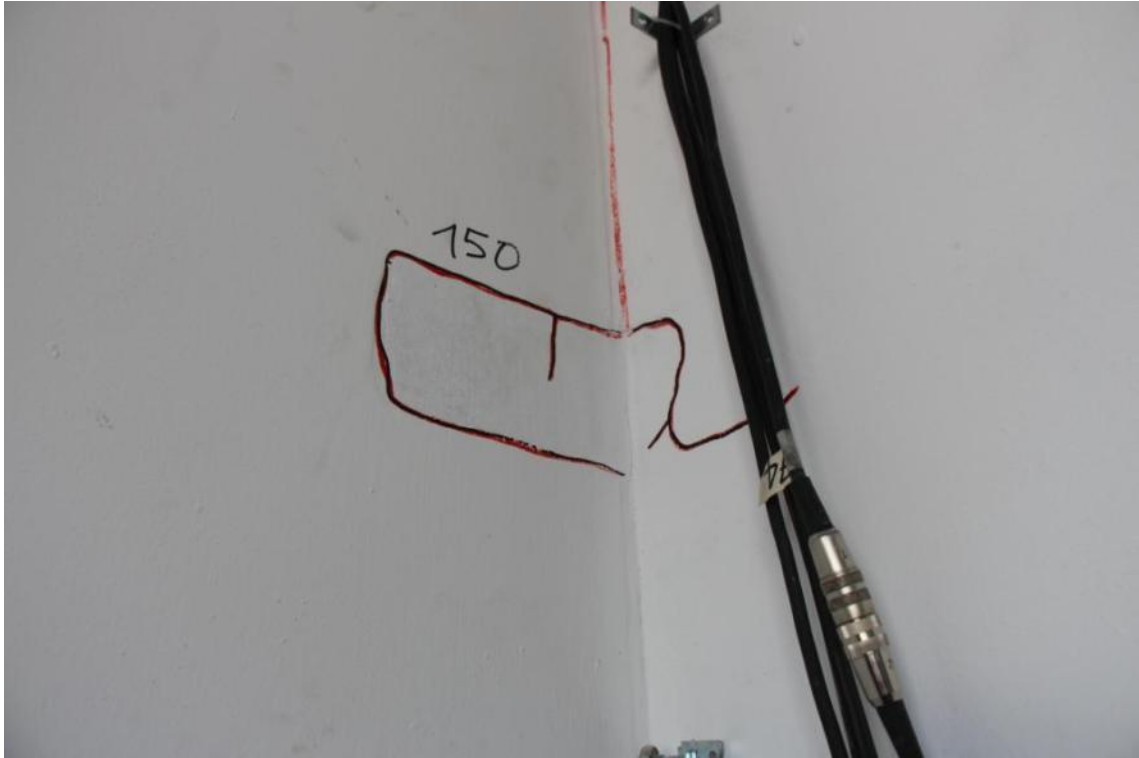
**Figure 274. Cracks along the boundaries of the connectors sockets – Stability wall, West face, first storey.**

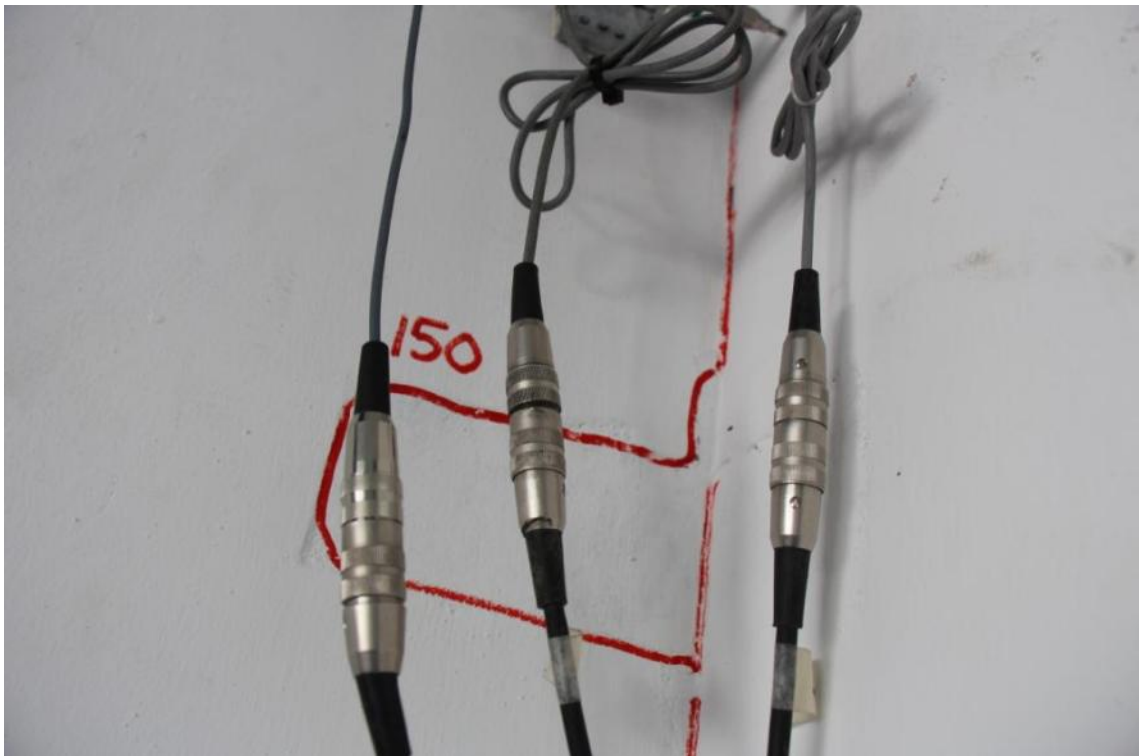
**Figure 275. Cracks along the boundaries of the connectors sockets – Detail of the top three-way joint.**

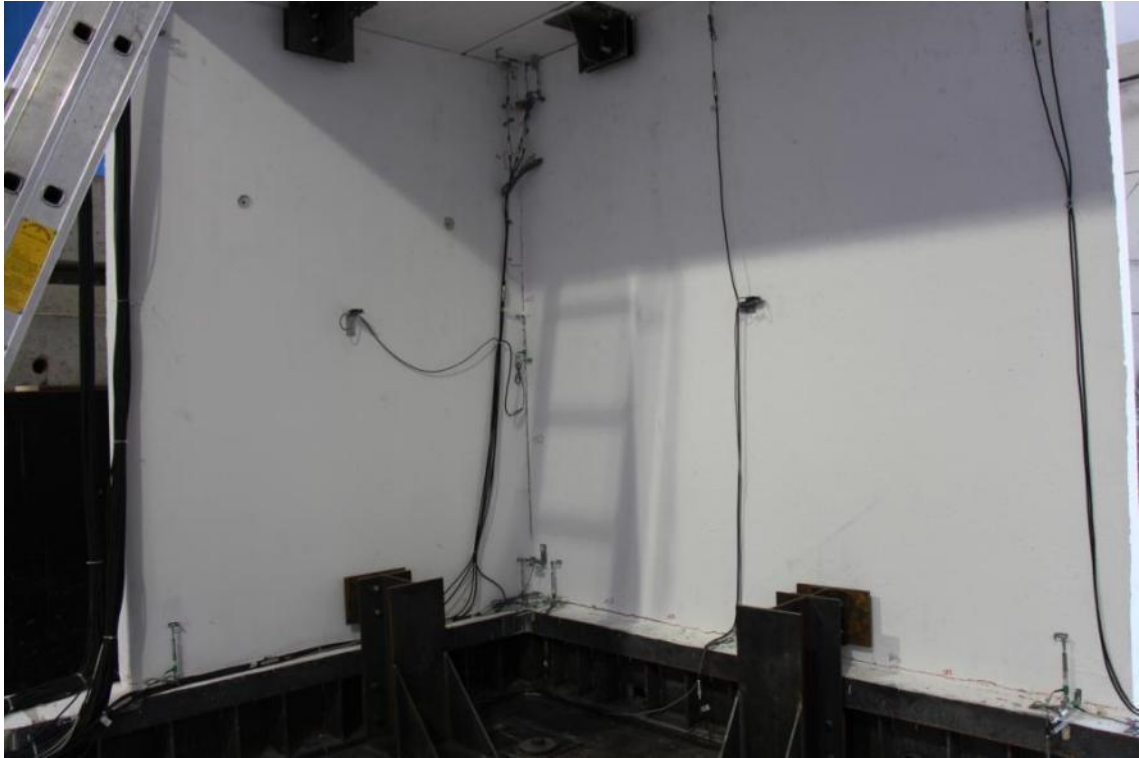
**Figure 276. Crack pattern of the ground-floor stability wall – East wall face, base and connectors sockets.**

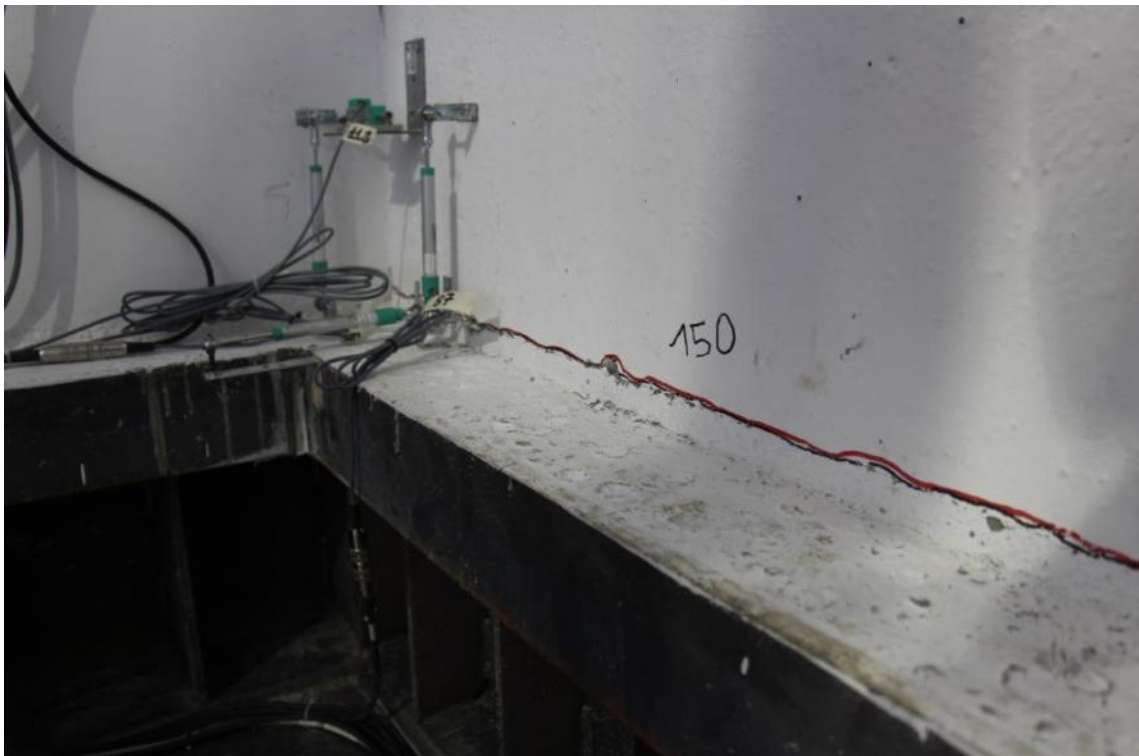
**Figure 277. Crack running along the entire depth of the ground-floor stability wall – East wall face, base.**

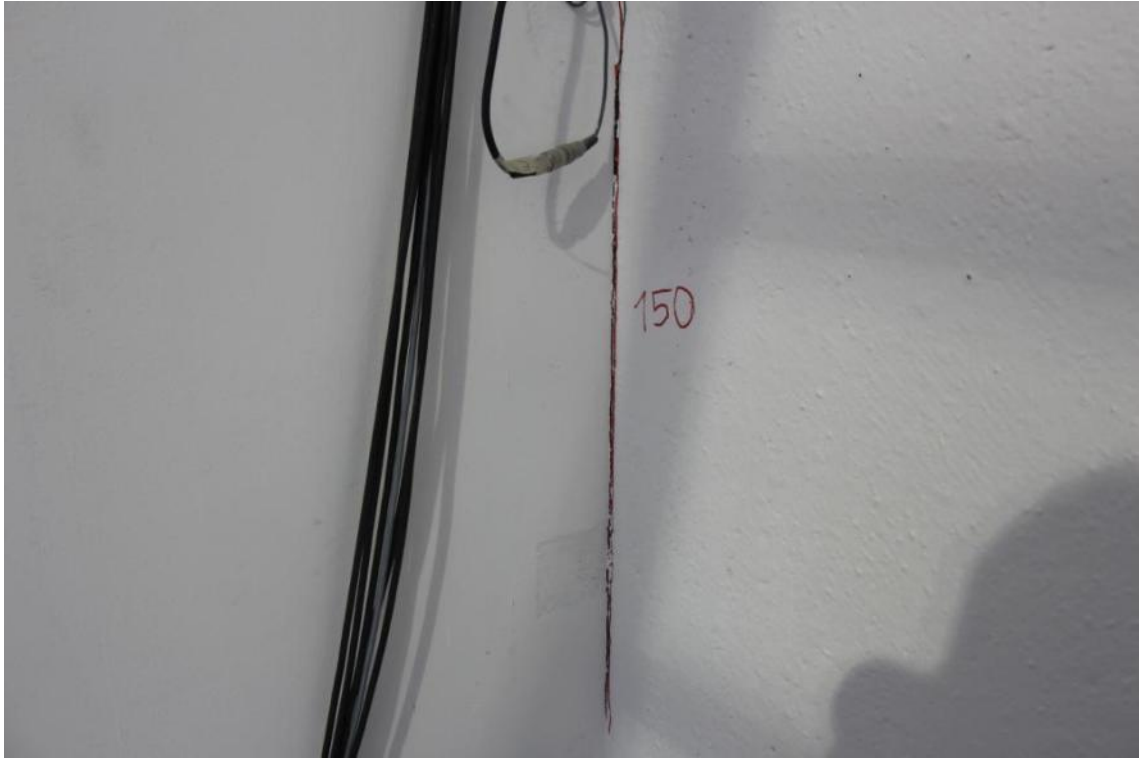
**Figure 278. Vertical crack and detachment between stability and transversal walls – East wall face.**

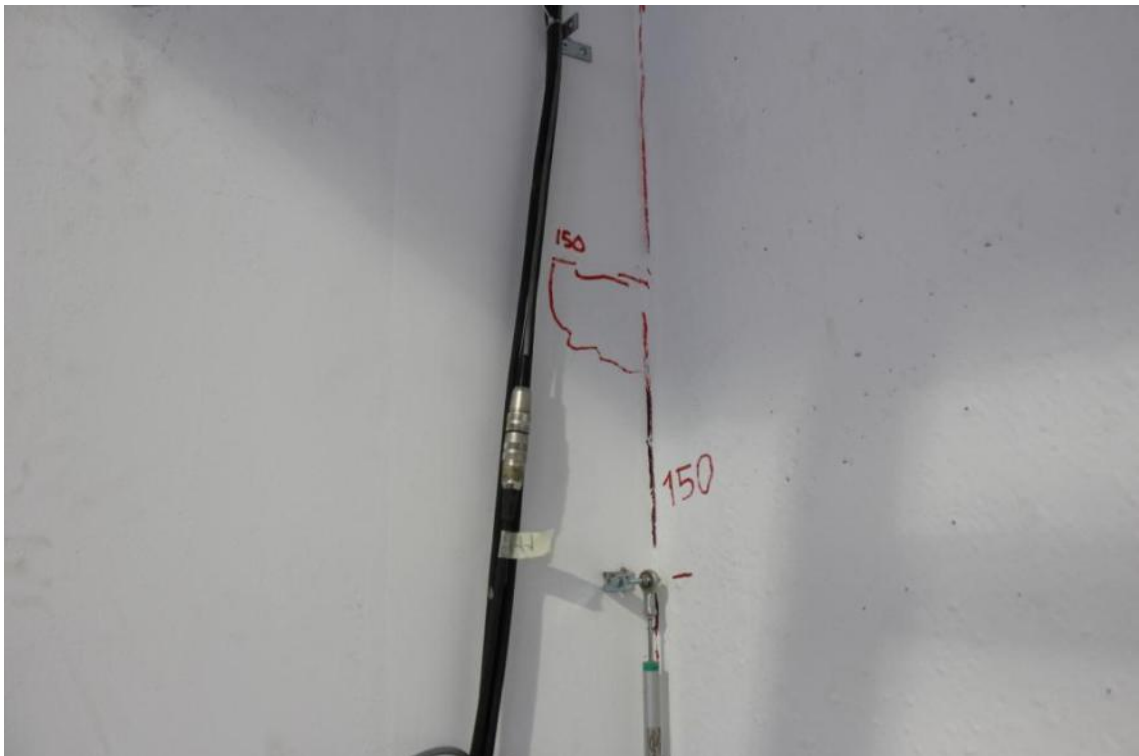
**Figure 279. Propagation of a wide crack along the height of the first-storey stability wall – East wall face.**

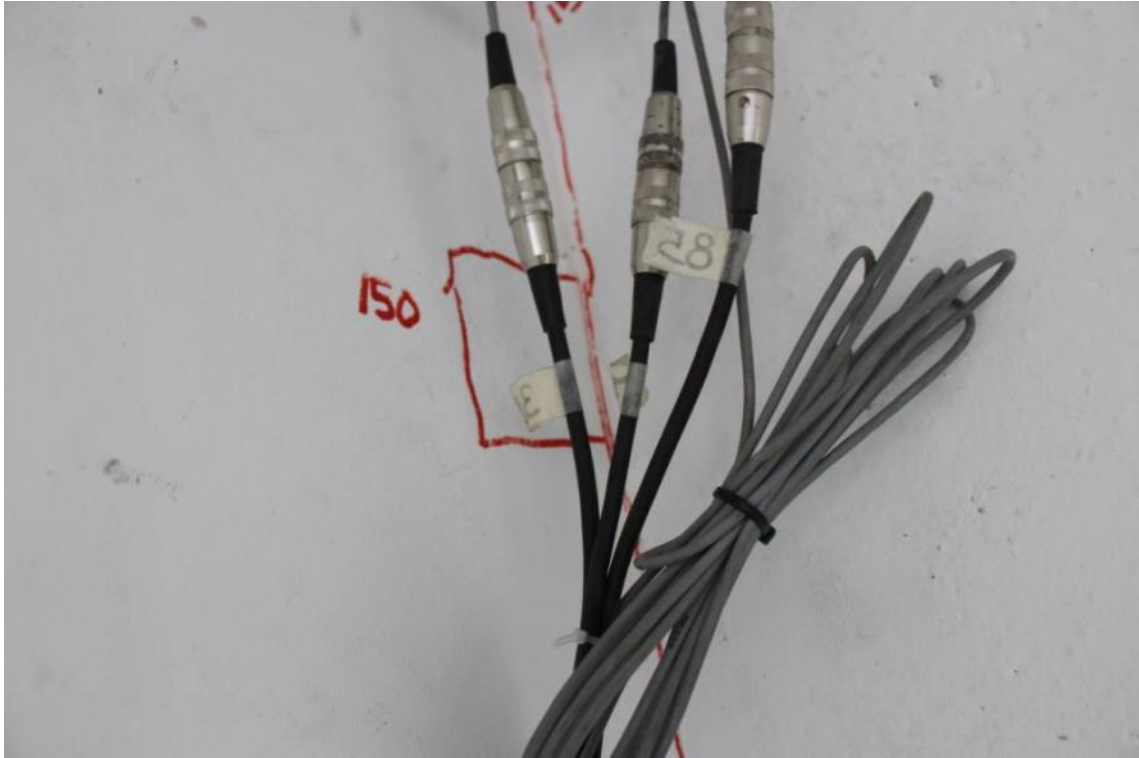
**Figure 280. Cracks along the boundaries of the connectors sockets – Top three-way joint, panel.**
