Nederlandse Aardolie Maatschappij B.V.

# Experimental campaign on RC buildings typical of the Groningen region: dynamic testing of a precast specimen

| LAB AND TESTS RESPONSIBLE | DOCUMENT AUTHOR | REVIEWER |
|---|---|---|
| Issue: 30/10/2017 | Document type:<br><br><b>Technical report</b><br>pages: 364 | File name:<br>EUC_BUILD5-test_campaign_report.pdf |

Brunesi E., Peloso S., Pinho R., Nascimbene R. (2017). *Dynamic testing of a full-scale two-storey RC precast wall-slab-wall structure representative of the Groningen building stock*. Report EUC215/2017U, European Centre for Training and Research in Earthquake Engineering (EUCENTRE), Pavia, Italy.

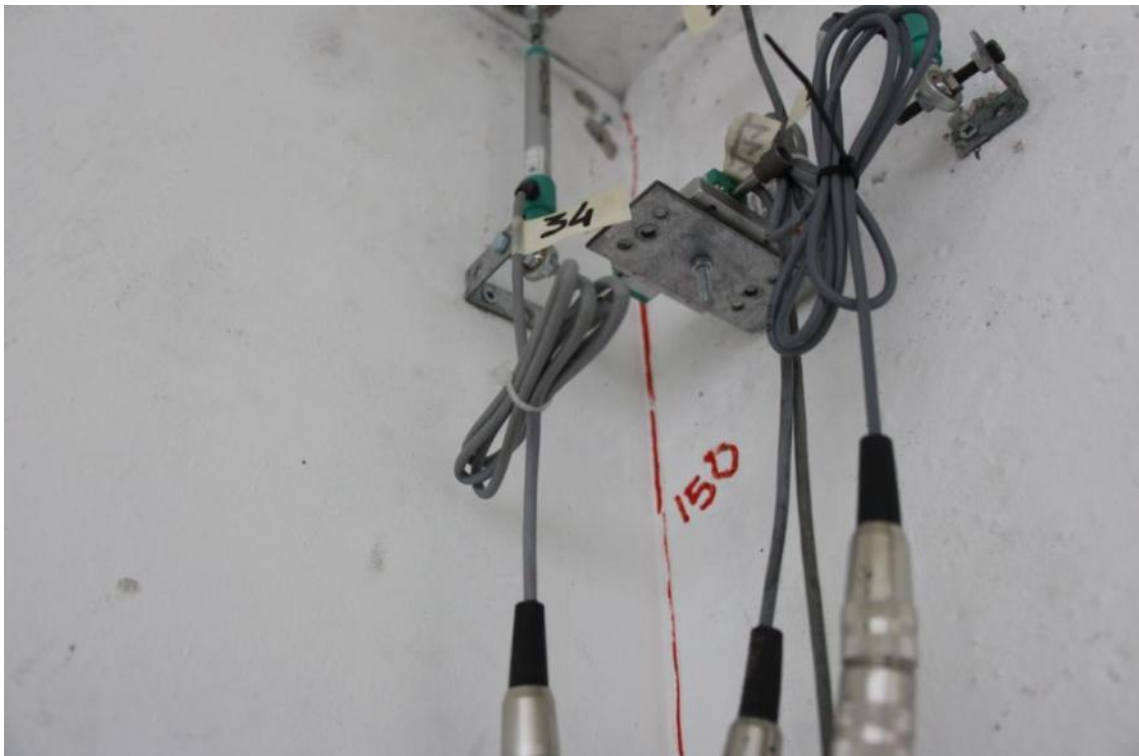
**Figure 281. Vertical crack along the entire height of the ground-floor stability wall – East wall face.**

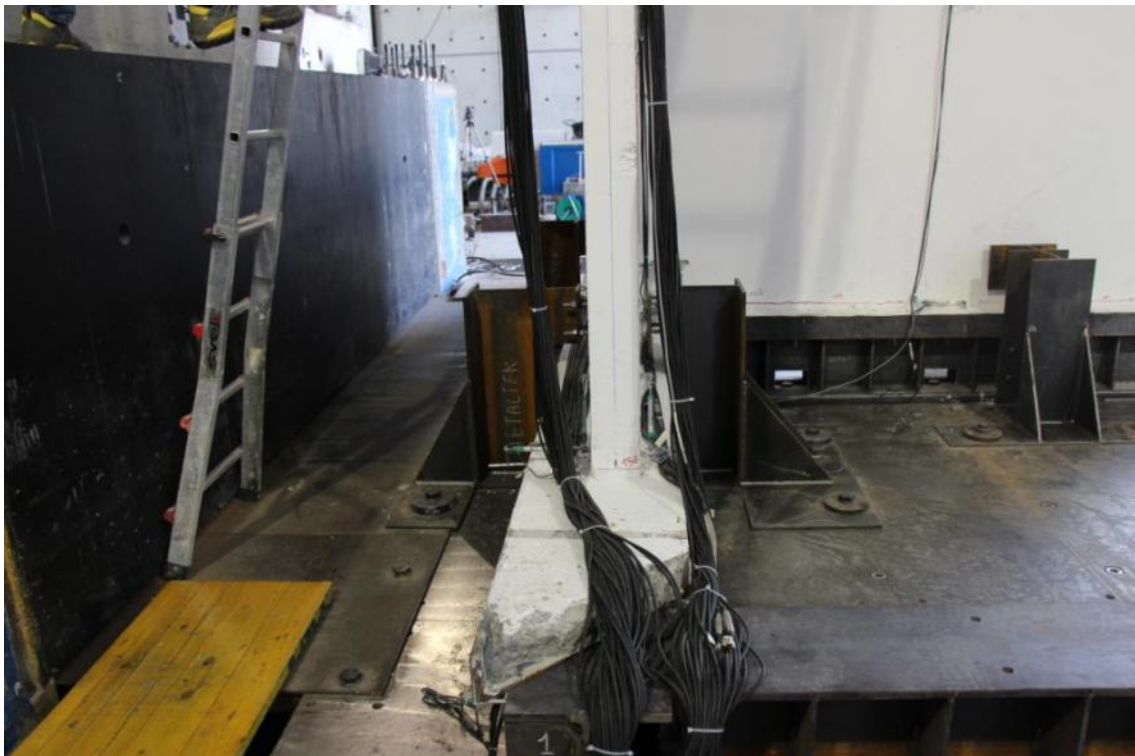
**Figure 283. Formation of a new crack at the base of transversal walls – Panel 1L1, South-East side.**

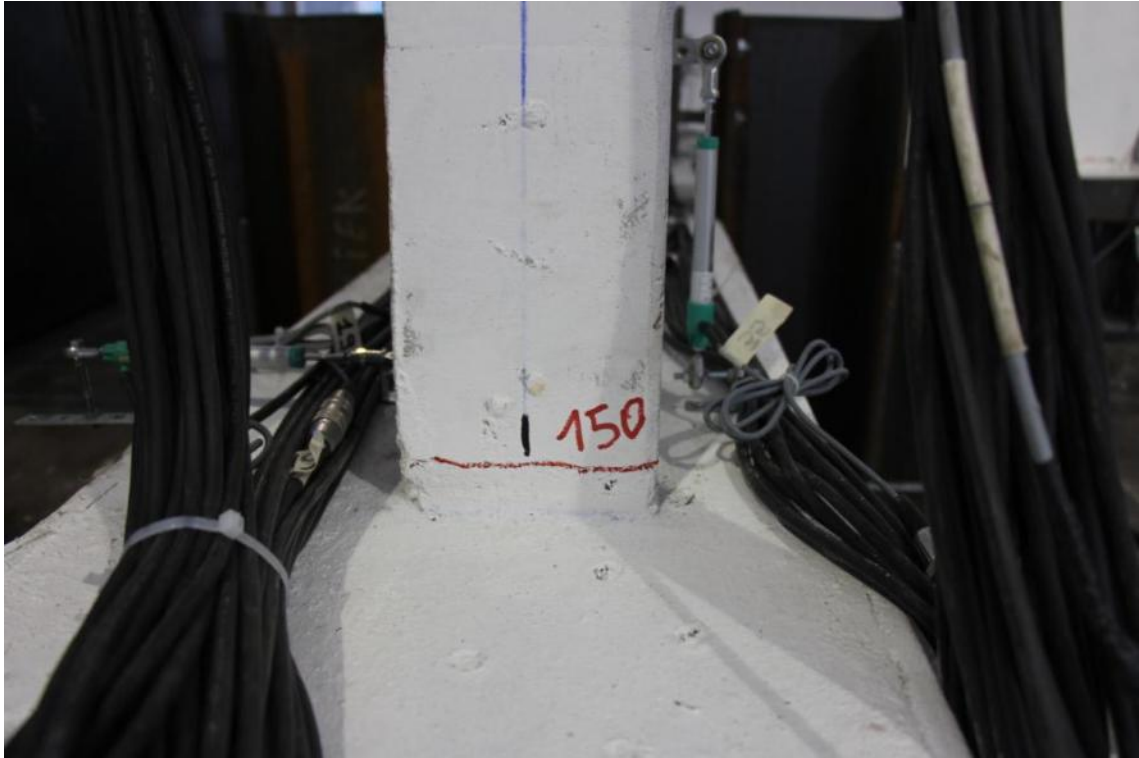
**Figure 284. Detail of horizontal crack running through the entire width of transversal wall 1L1.**

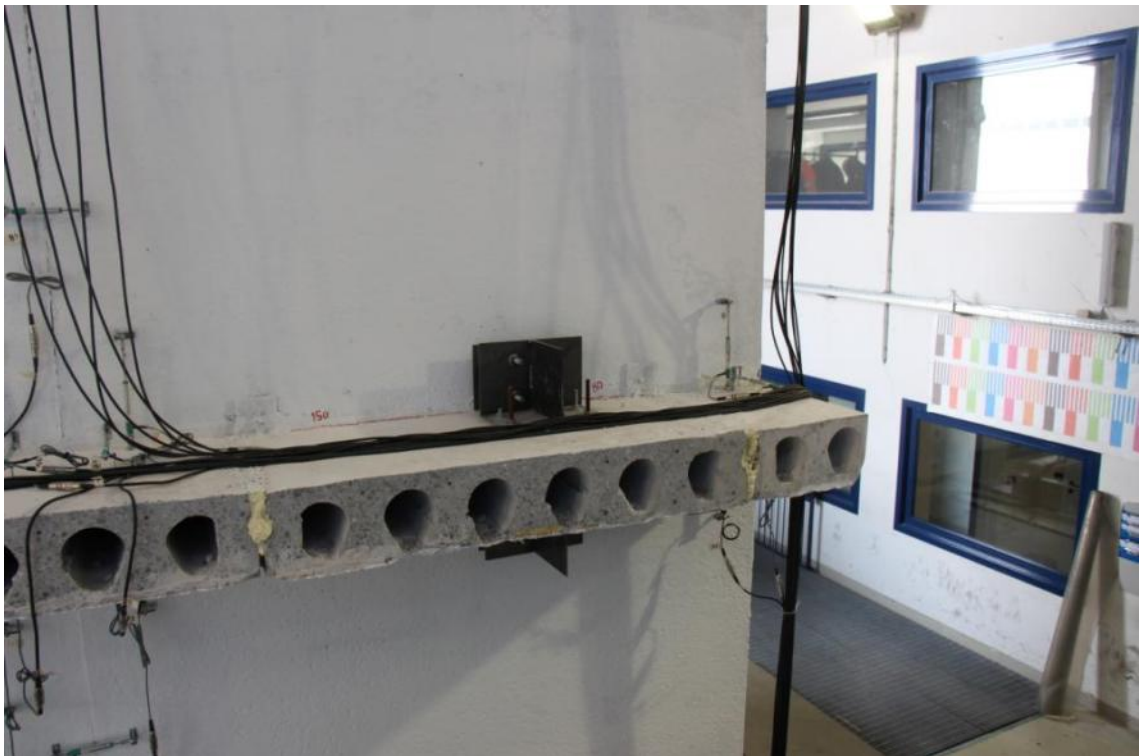
**Figure 285. Development of horizontal flexural cracks at the base of panel 2L1 – Second-storey lateral wall.**

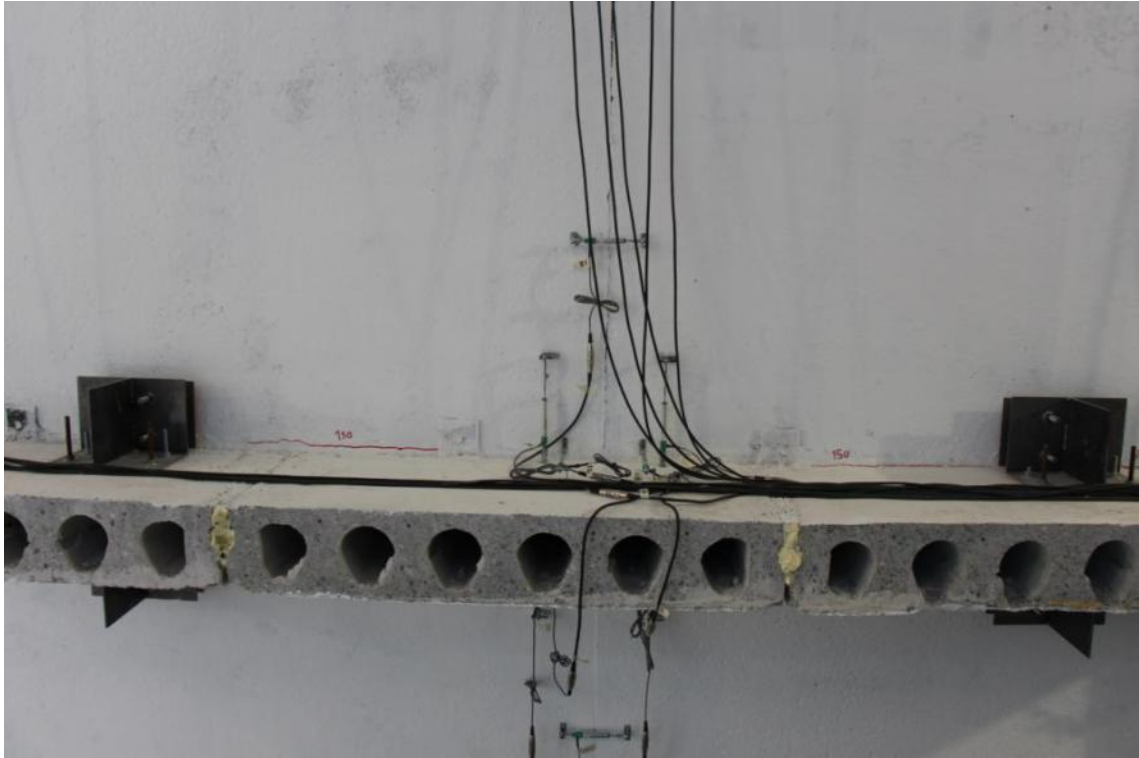
**Figure 286. Horizontal flexural cracks at the base of the South-sided second-storey transversal walls.**

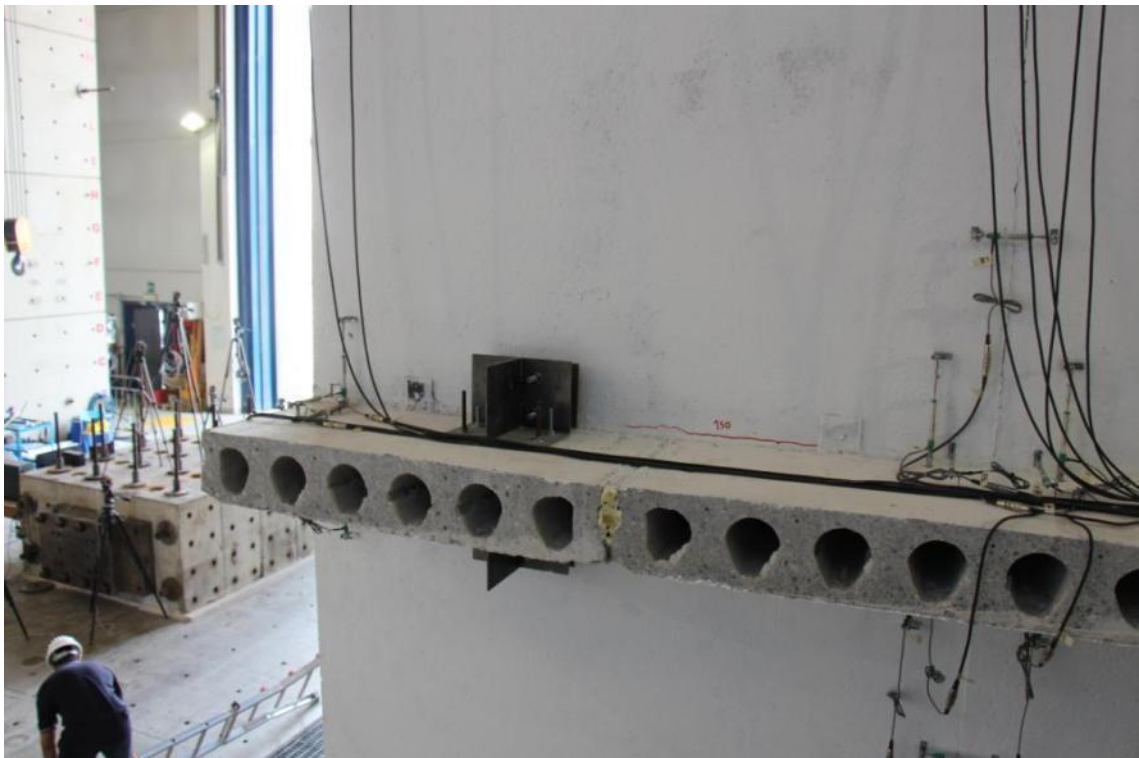
**Figure 287. Development of horizontal flexural cracks at the base of panel 2L2 – Second-storey lateral wall.**

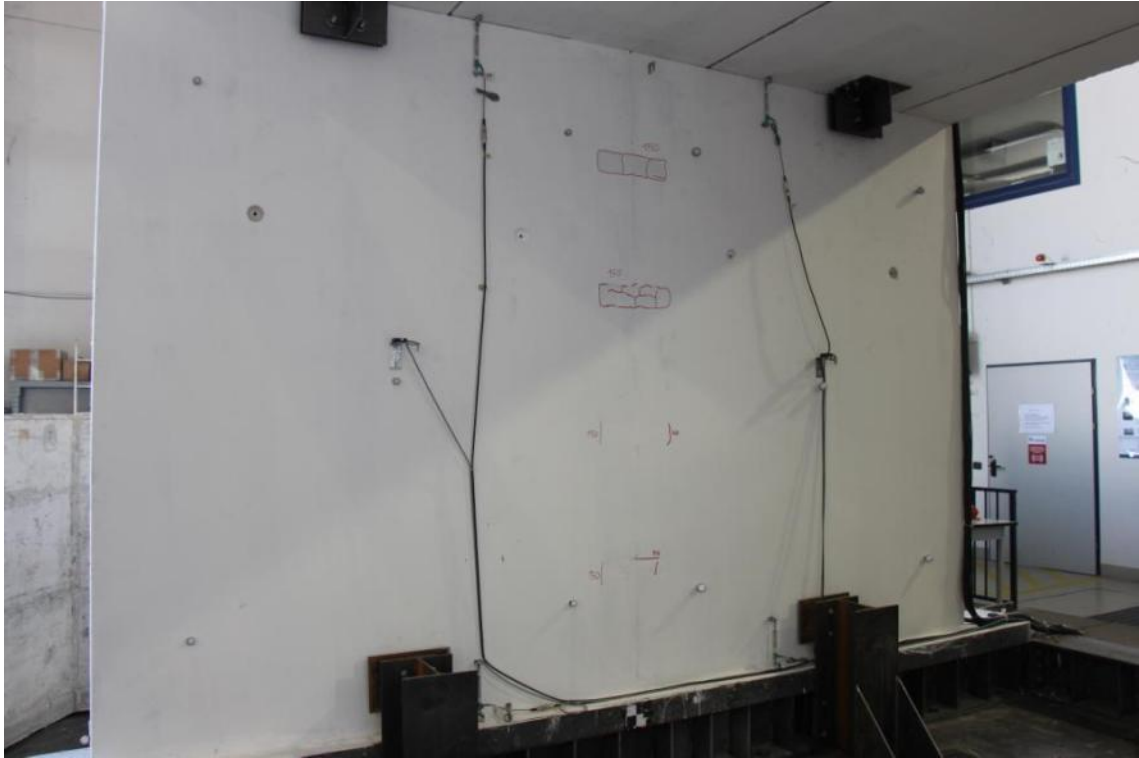
**Figure 288. Cracks along the boundaries of the connectors sockets – North-sided ground-floor lateral walls.**

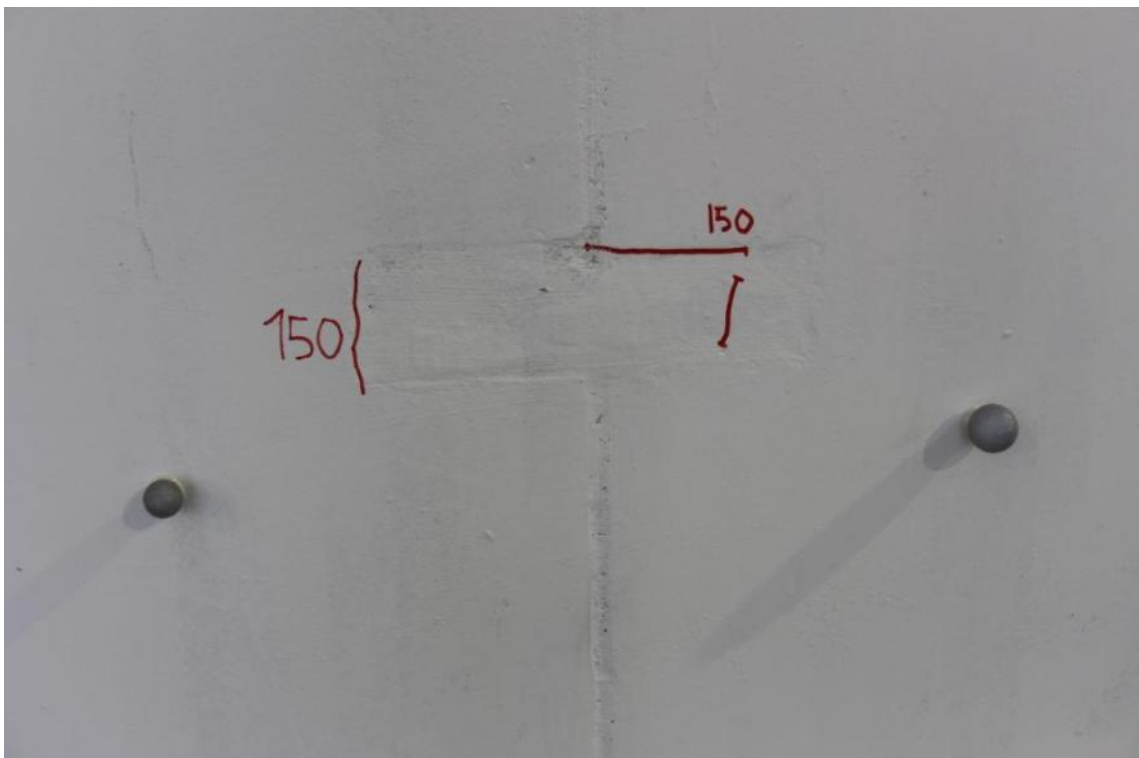
**Figure 289. Cracks along the boundaries of the connectors sockets – Bottom two-way connection.**

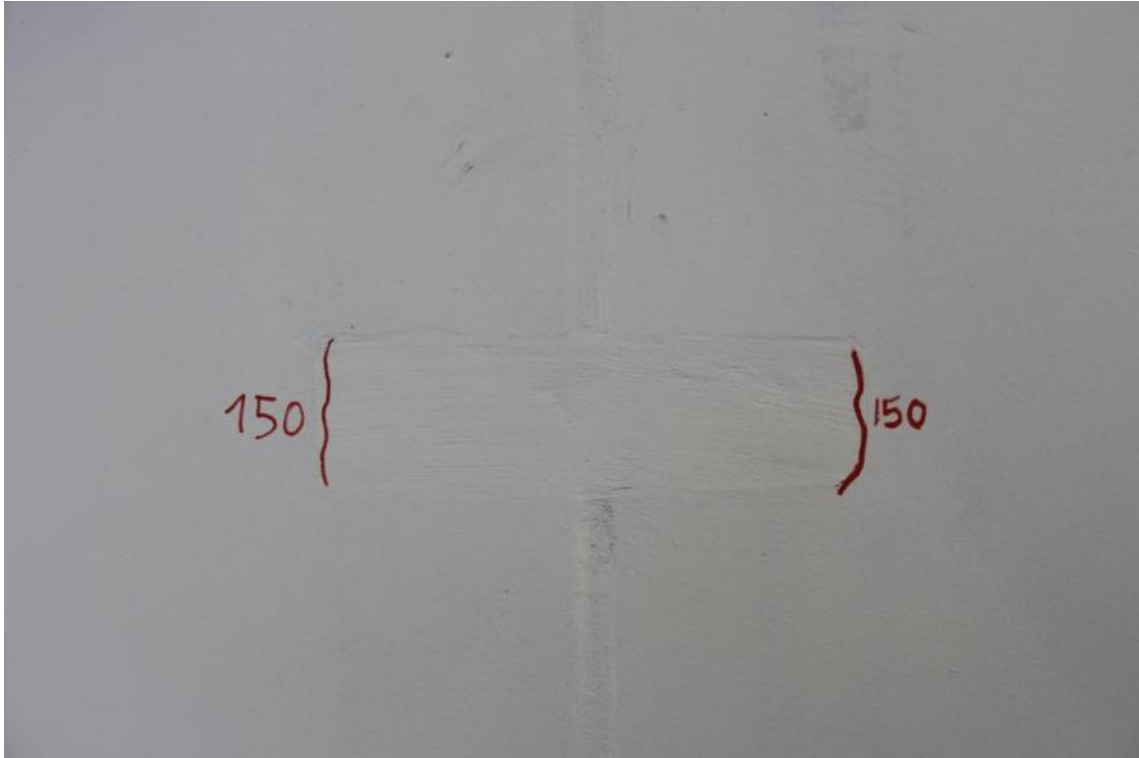
**Figure 290.** Cracks along the boundaries of the two-way connection – Second joint from the base.

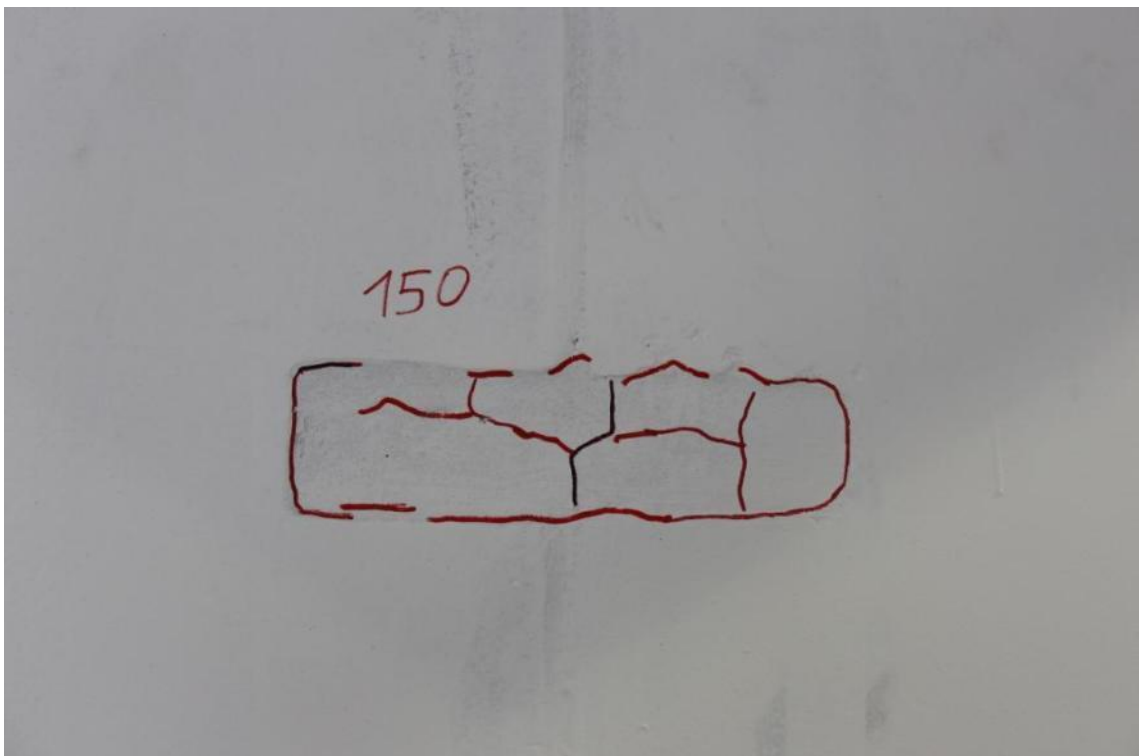
**Figure 291.** Cracks along the boundaries of the two-way connection – Third joint from the base.

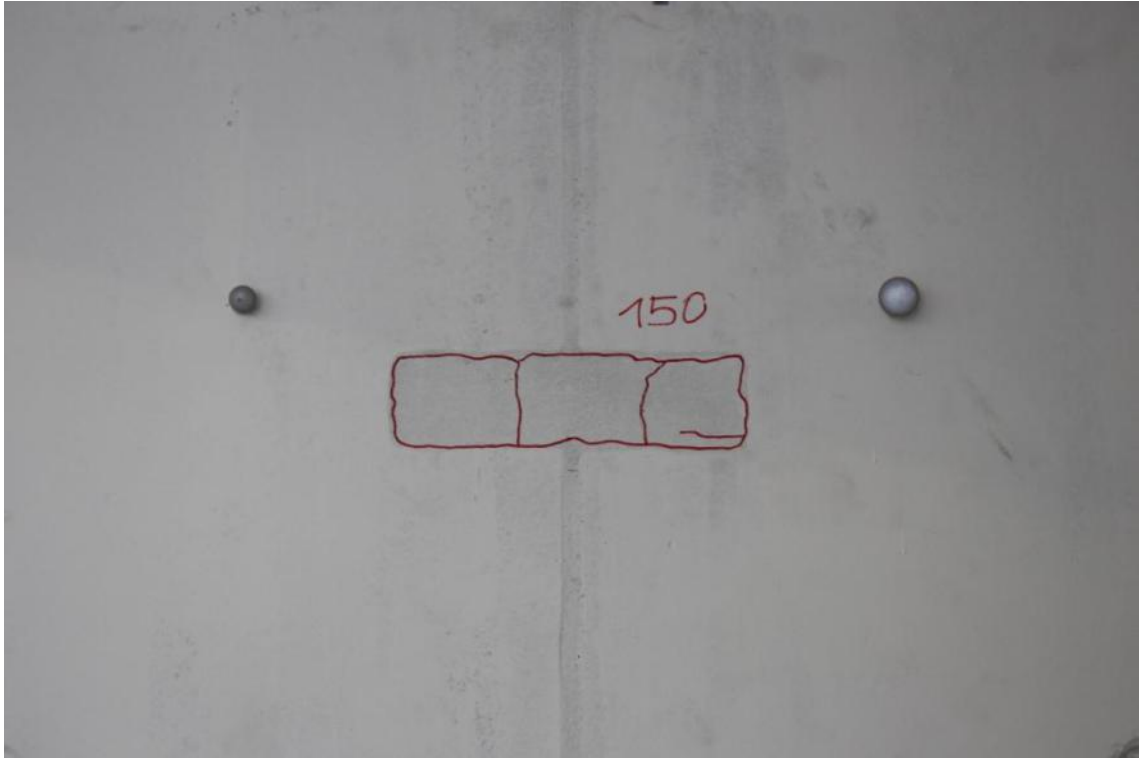
**Figure 292. Detail of cracks along the boundaries of the connectors sockets – Top two-way connection.**

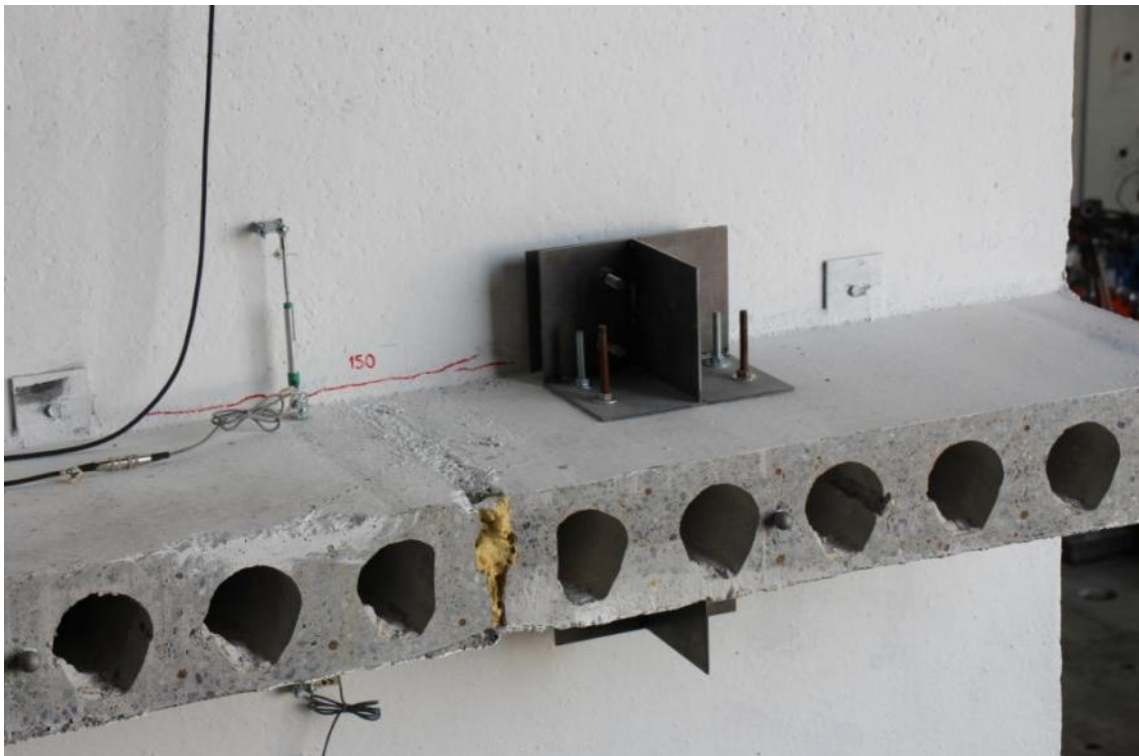
**Figure 293. Horizontal flexural cracks at the base of the North-sided second-storey transversal walls.**

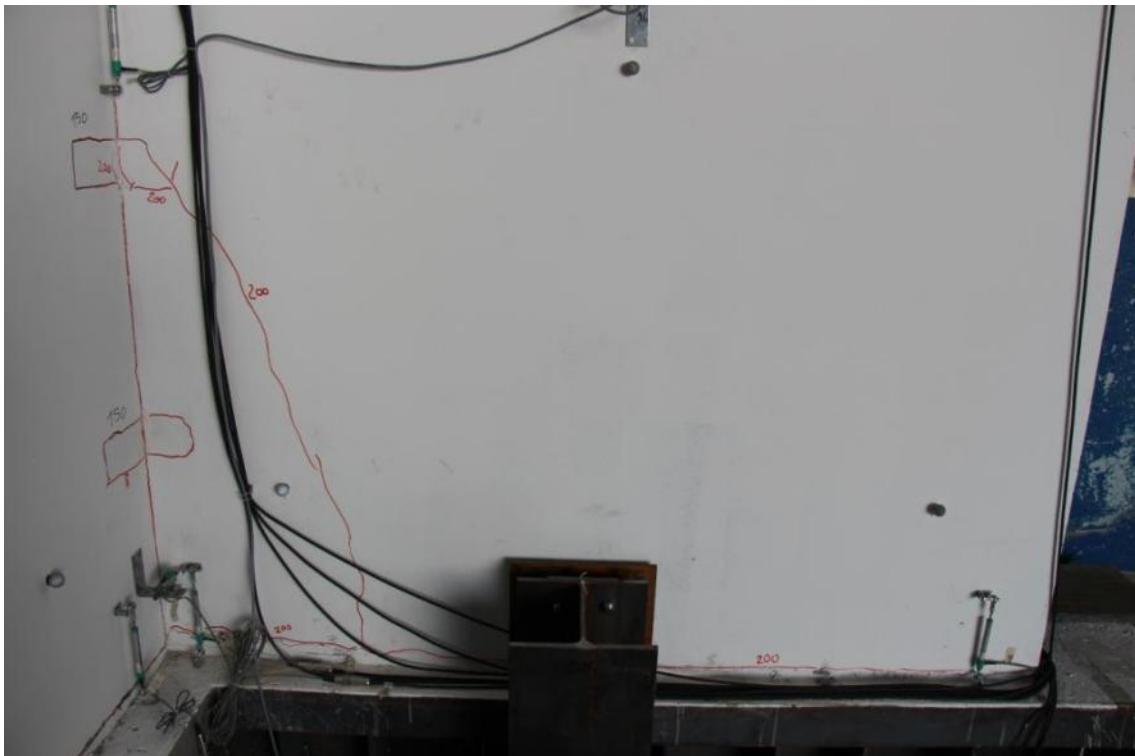
**Figure 295. Inclined and full-depth/full-width/base horizontal crack in the lateral wall 1L2.**

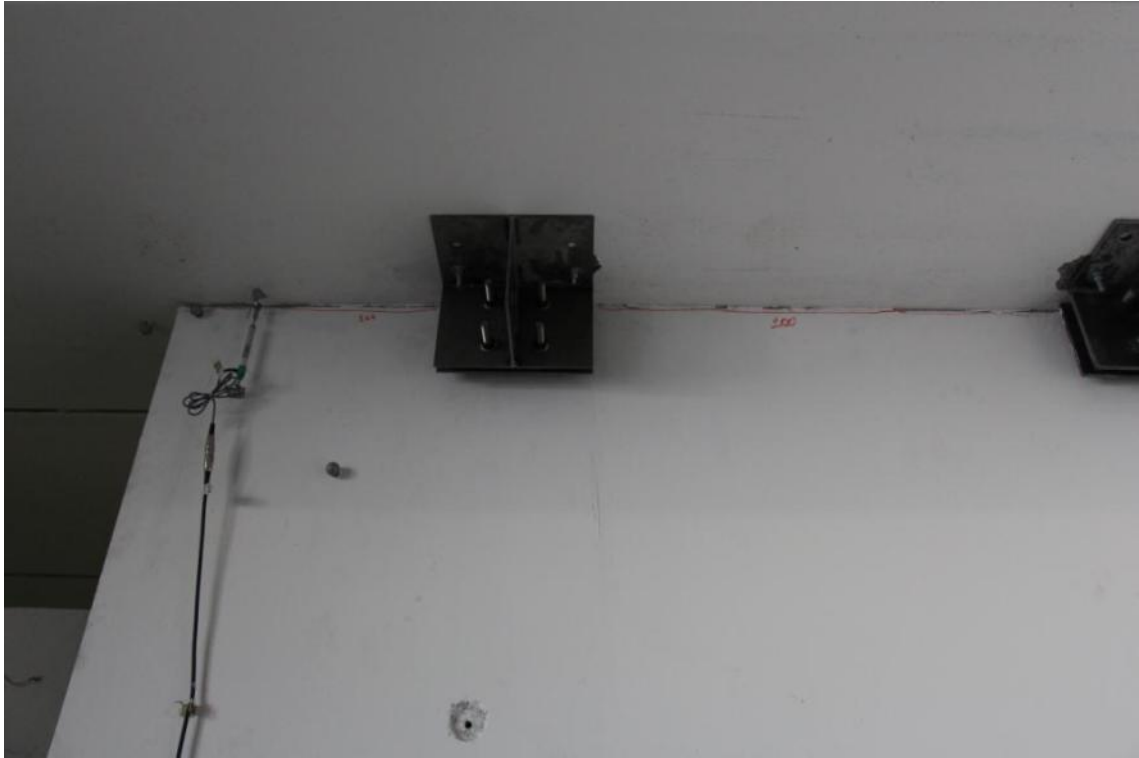
**Figure 296. Damage pattern of the mortar joint between the ground-floor stability wall and the slab panel.**

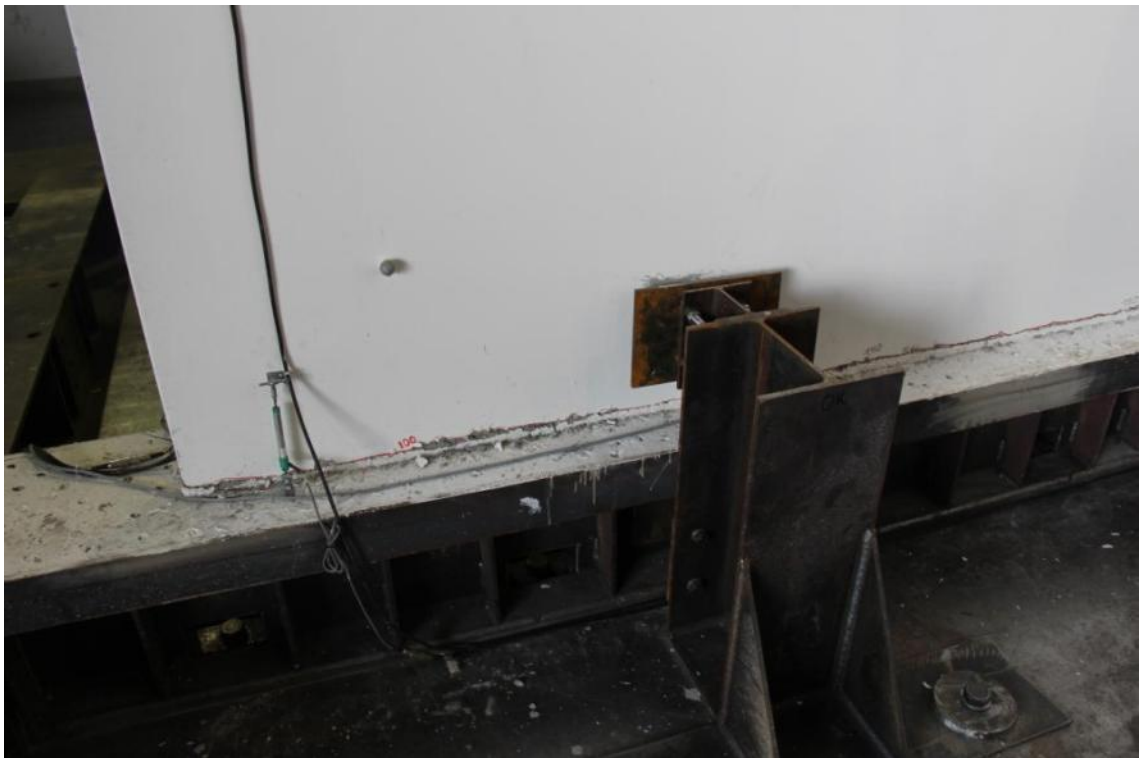
**Figure 297. Full-depth/full-width horizontal crack at the base of the first-storey stability wall.**

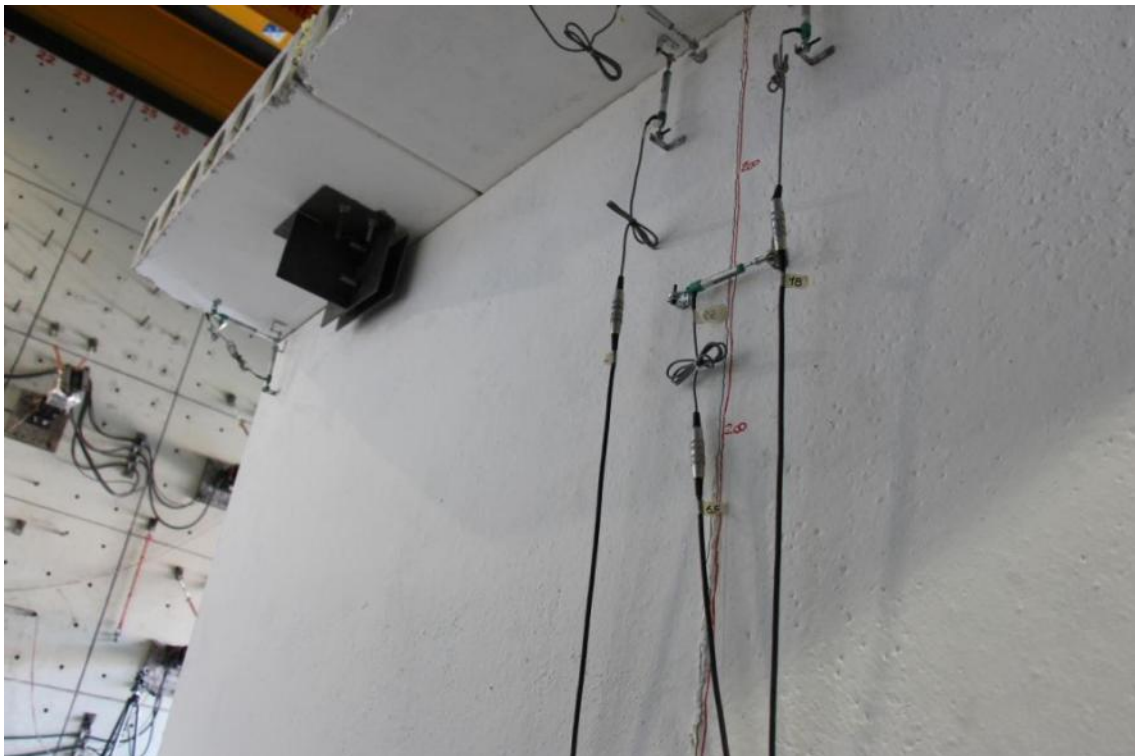
**Figure 299. Development of a full-height vertical crack between adjacent lateral walls – South side, South face.**

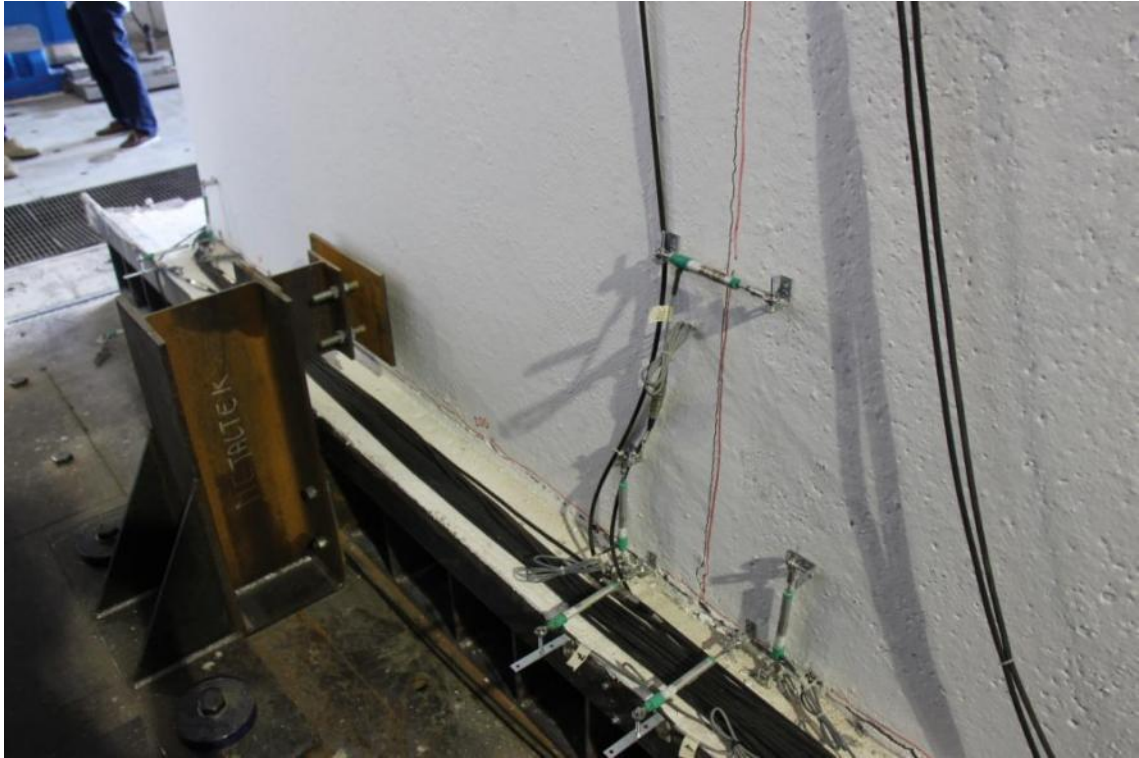
**Figure 300. Damage pattern at the base of the South-sided ground-floor lateral walls.**

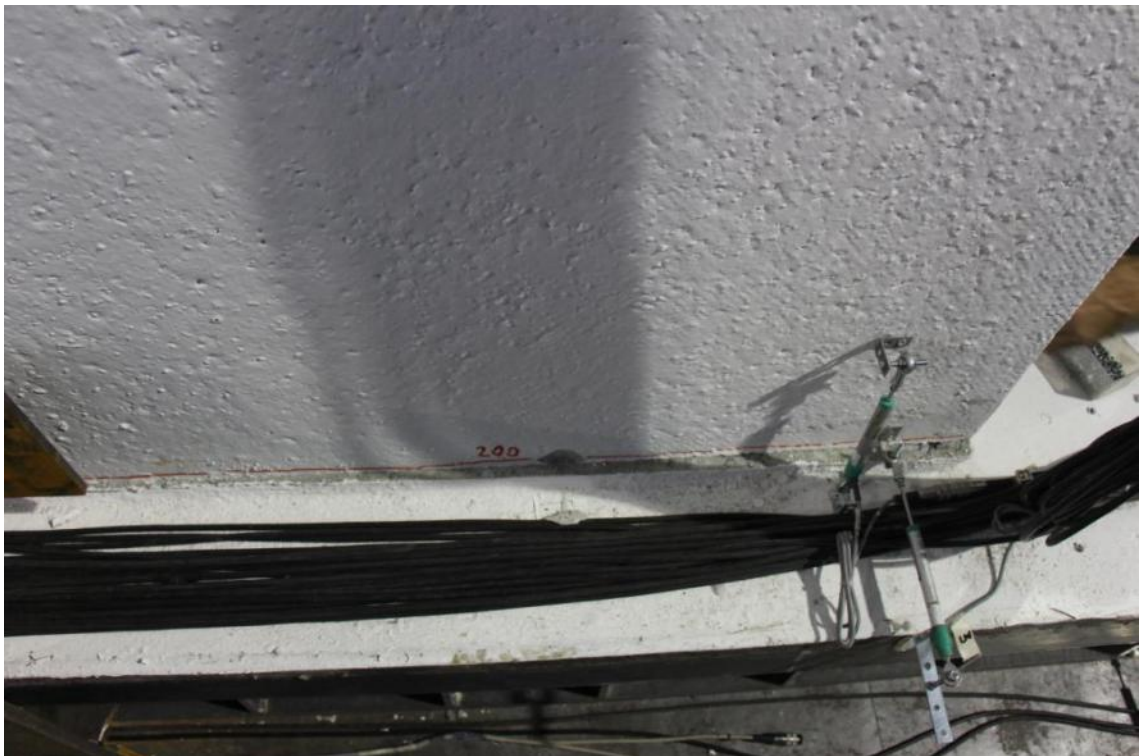
**Figure 301. Full-depth/full-width horizontal crack at the base of the first-storey lateral wall 1L1.**

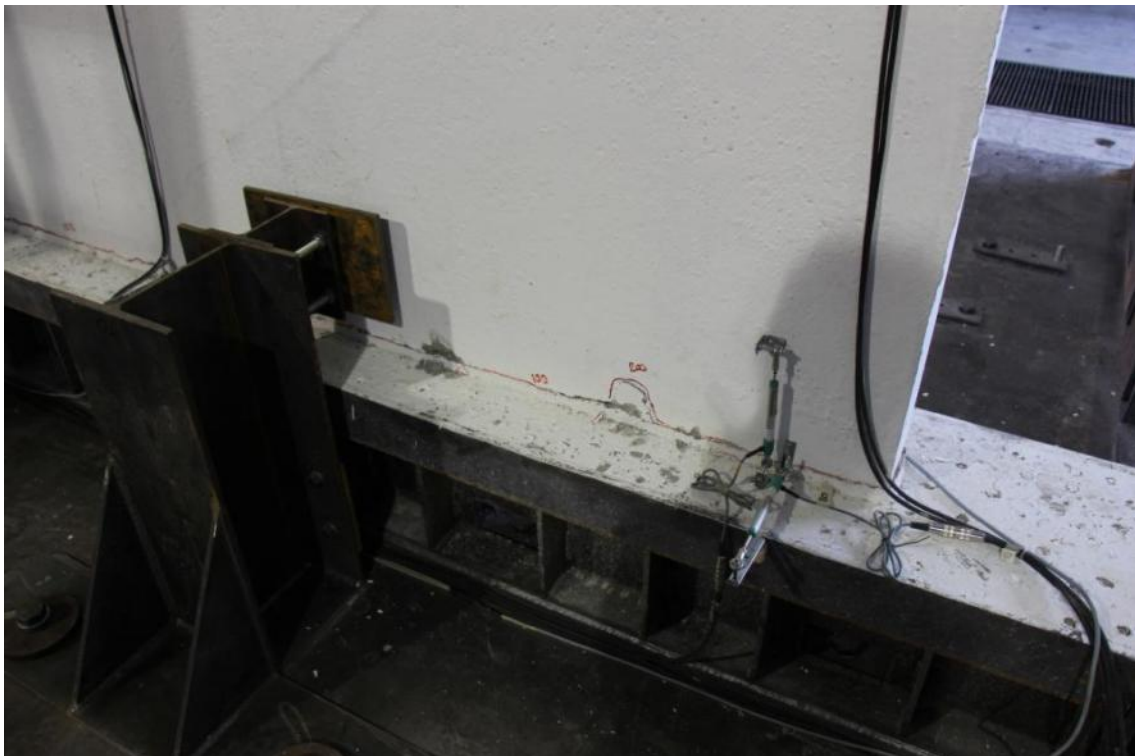
**Figure 303. Full-depth/full-width crack at the base of the first-storey stability wall – East wall face.**

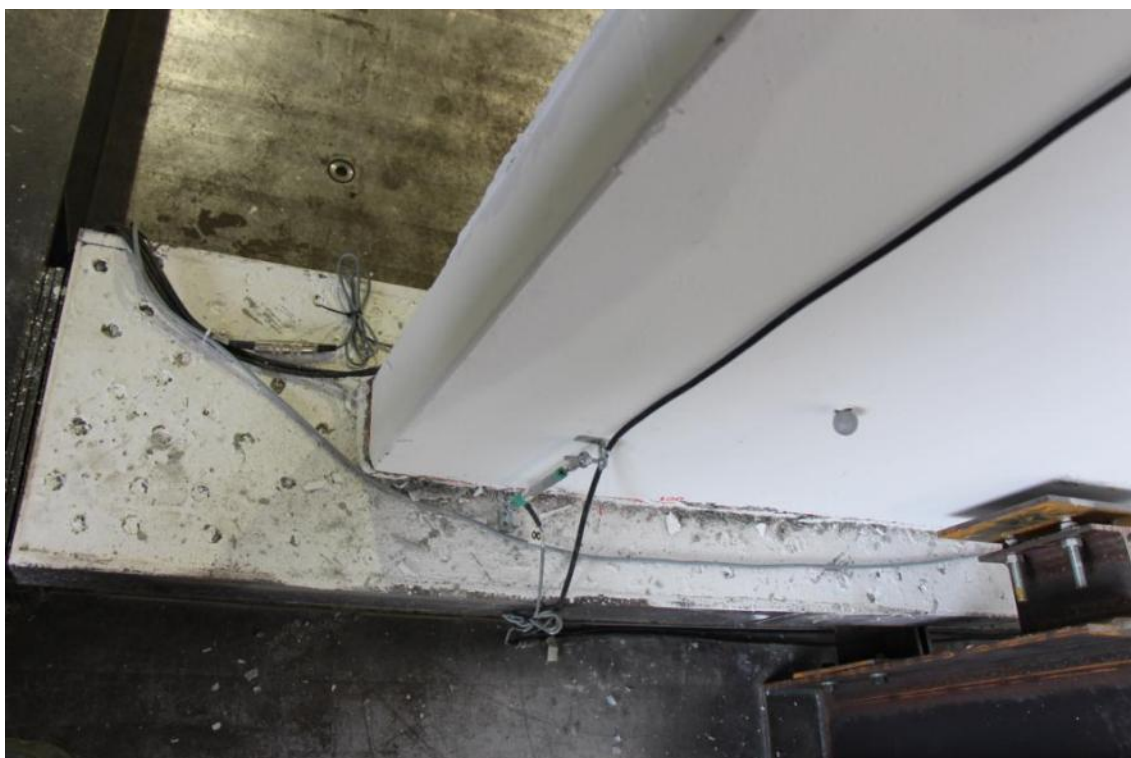
**Figure 305. Crack running through the entire width of the first-storey stability wall – Corner, side view.**

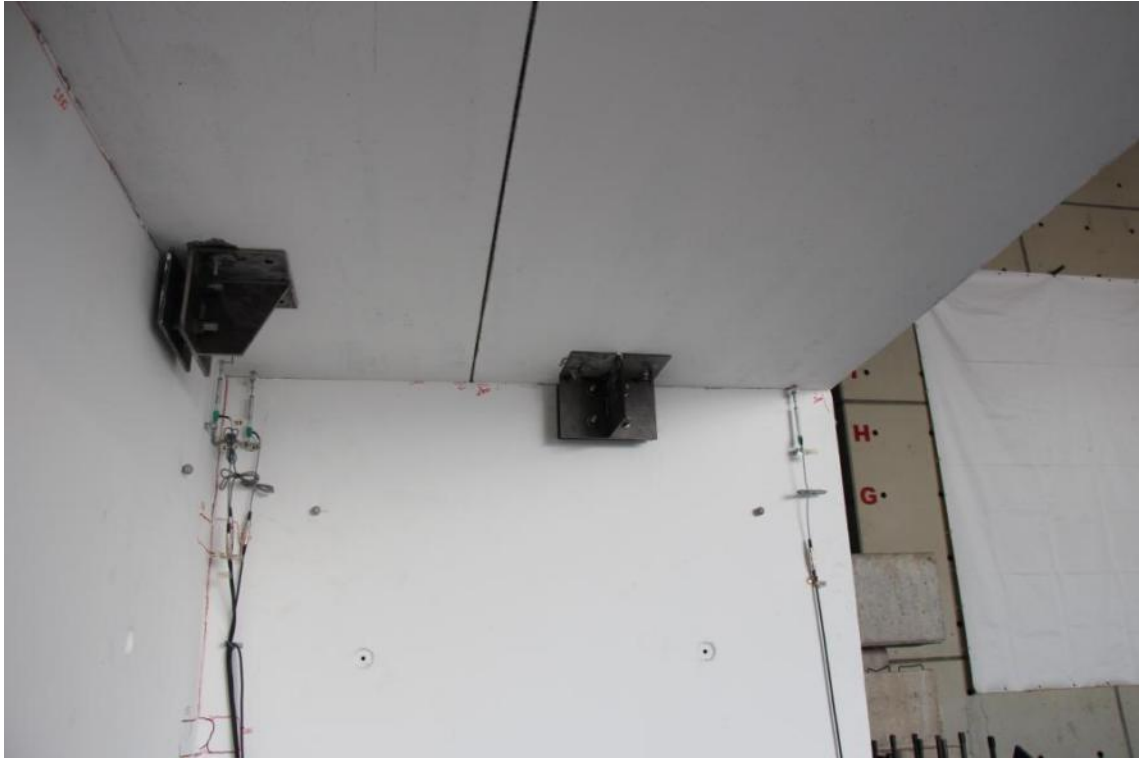
**Figure 306. Concrete damage/chipping at the top of the first-storey lateral wall 1L2.**

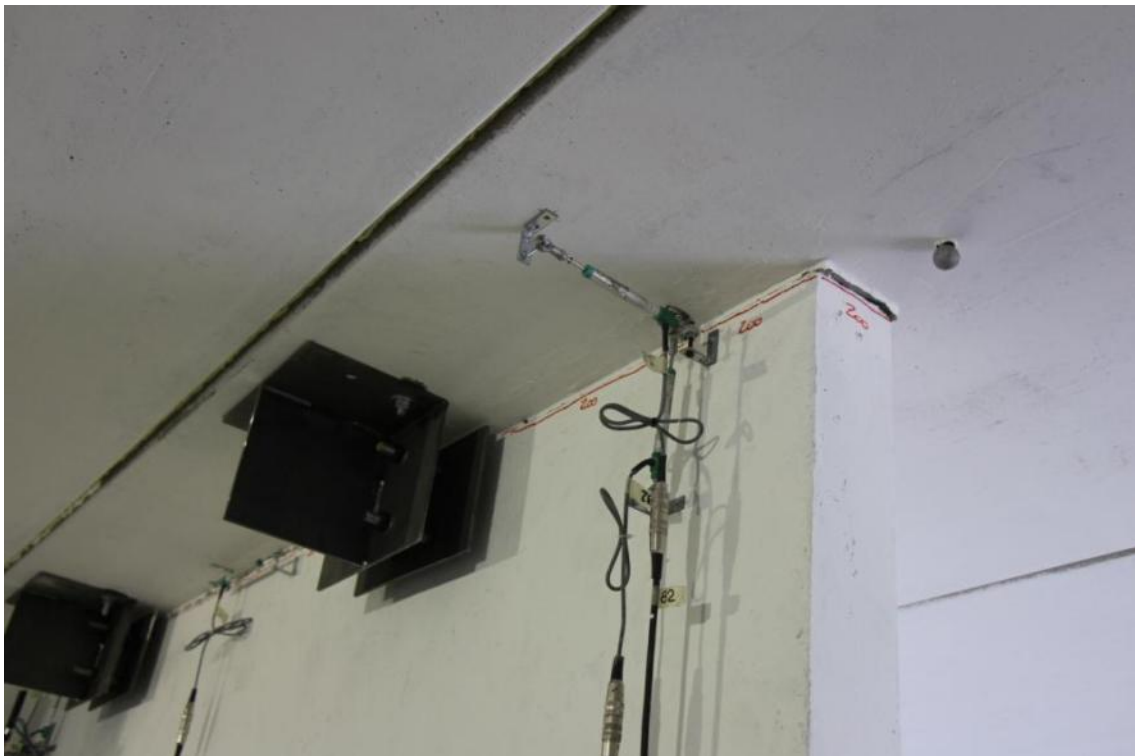
**Figure 309. Damage pattern of the mortar joint between the second-storey stability wall and slab.**

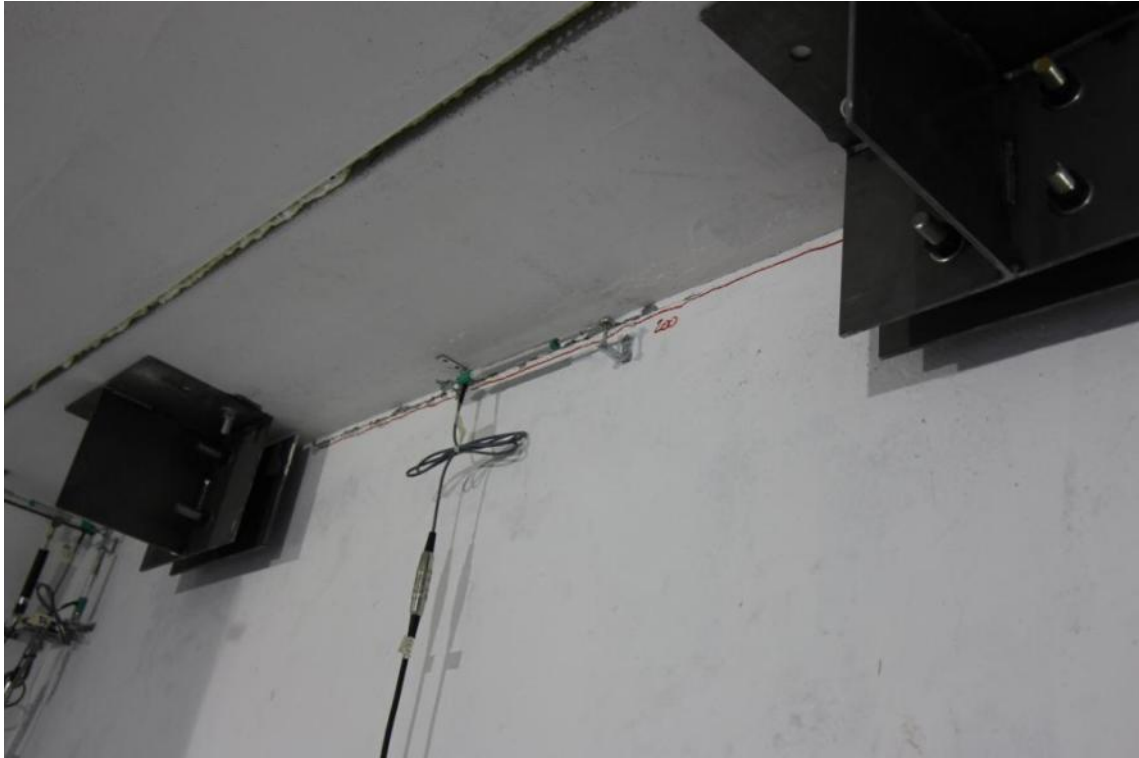
**Figure 310. Full-depth crack of mortar joint between the second-storey stability wall and slab.**

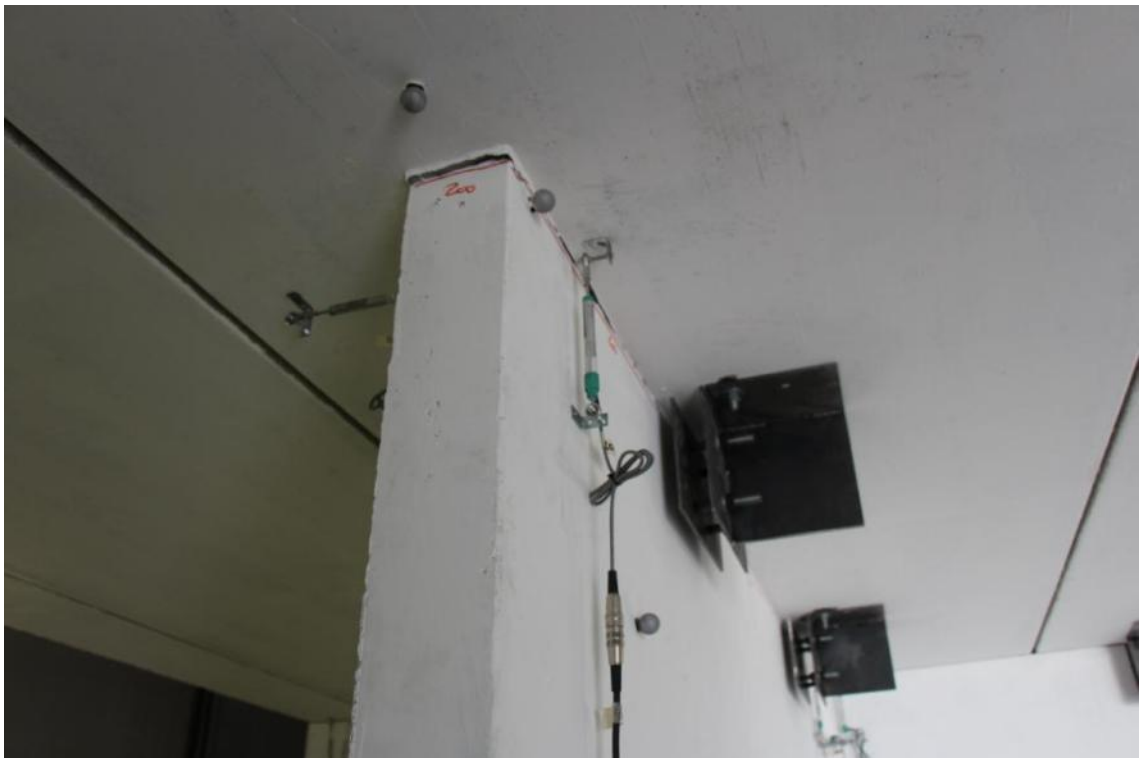
**Figure 311. Full-depth/full-width crack of mortar joint between the second-storey stability wall and slab.**

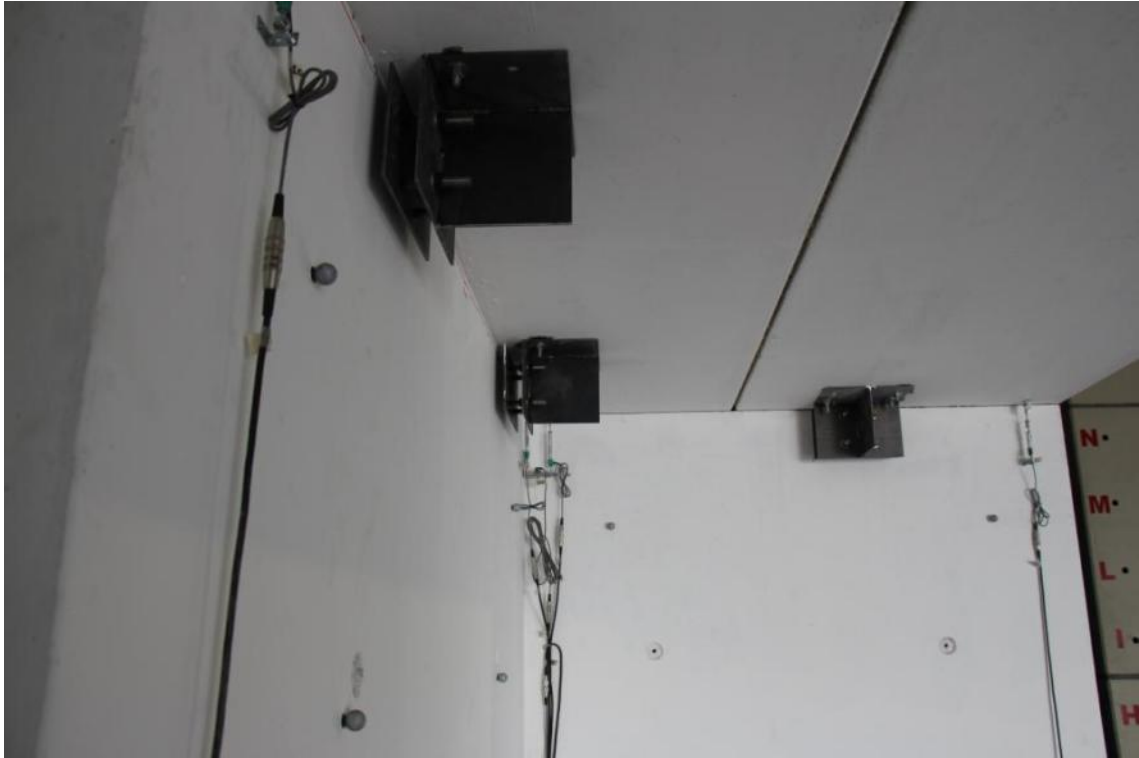
**Figure 312. Damage of the mortar joint beneath the second-storey slab and accumulation of displacements.**

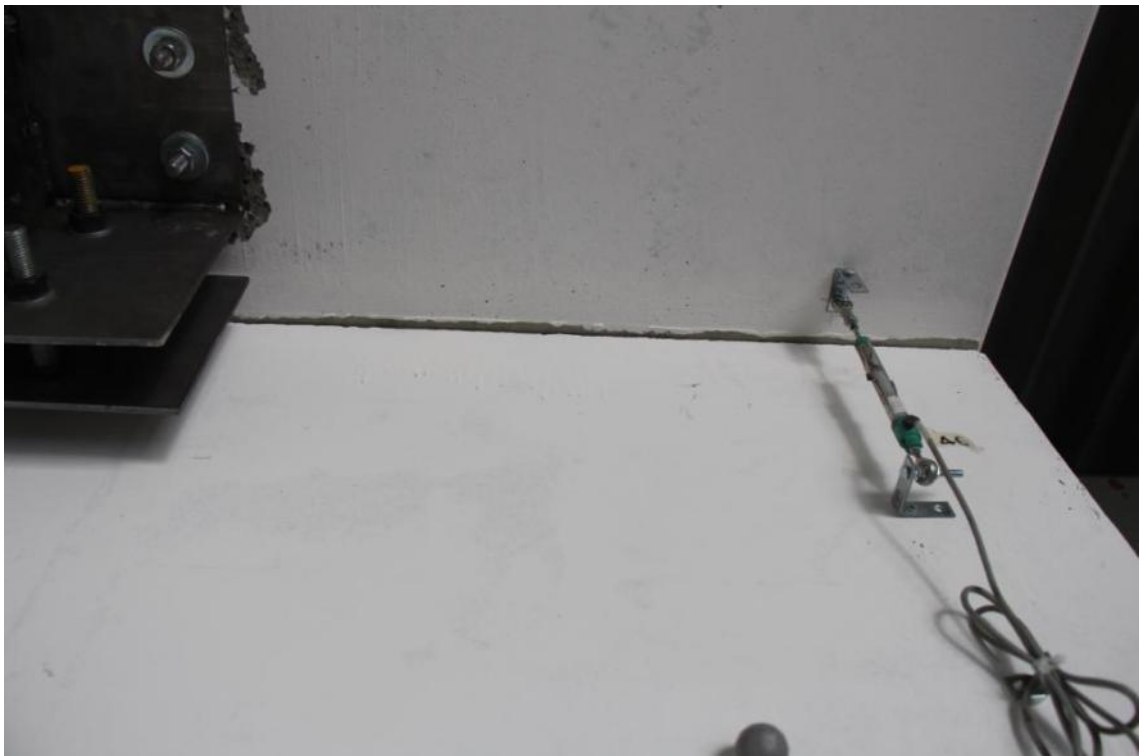
**Figure 313. Sliding of second-storey slab and accumulation of displacements – Detail of a lateral wall.**
