Nederlandse Aardolie Maatschappij B.V.

# Experimental campaign on RC buildings typical of the Groningen region: dynamic testing of a precast specimen

| LAB AND TESTS RESPONSIBLE | DOCUMENT AUTHOR | REVIEWER |
|---|---|---|
| Issue: 30/10/2017 | Document type:<br><br><b>Technical report</b><br>pages: 364 | File name:<br>EUC_BUILD5-test_campaign_report.pdf |

Brunesi E., Peloso S., Pinho R., Nascimbene R. (2017). *Dynamic testing of a full-scale two-storey RC precast wall-slab-wall structure representative of the Groningen building stock*. Report EUC215/2017U, European Centre for Training and Research in Earthquake Engineering (EUCENTRE), Pavia, Italy.

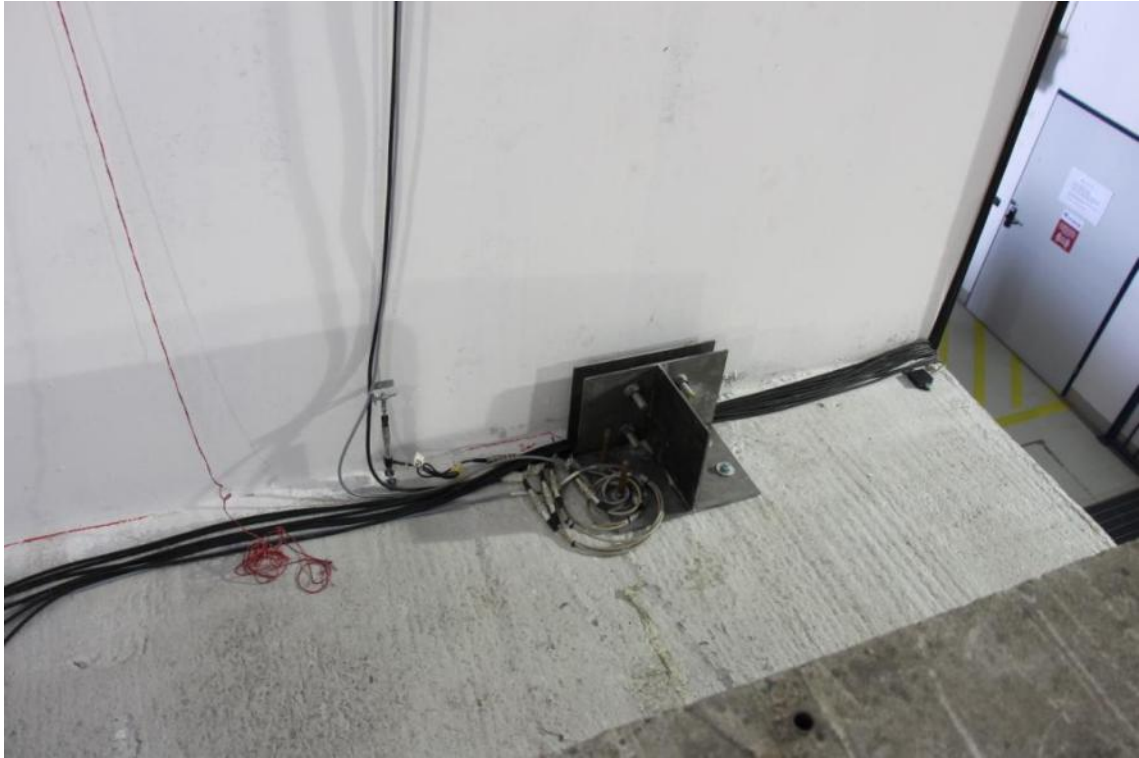
**Figure 314. Development of a full-height vertical crack between adjacent lateral walls – North side.**

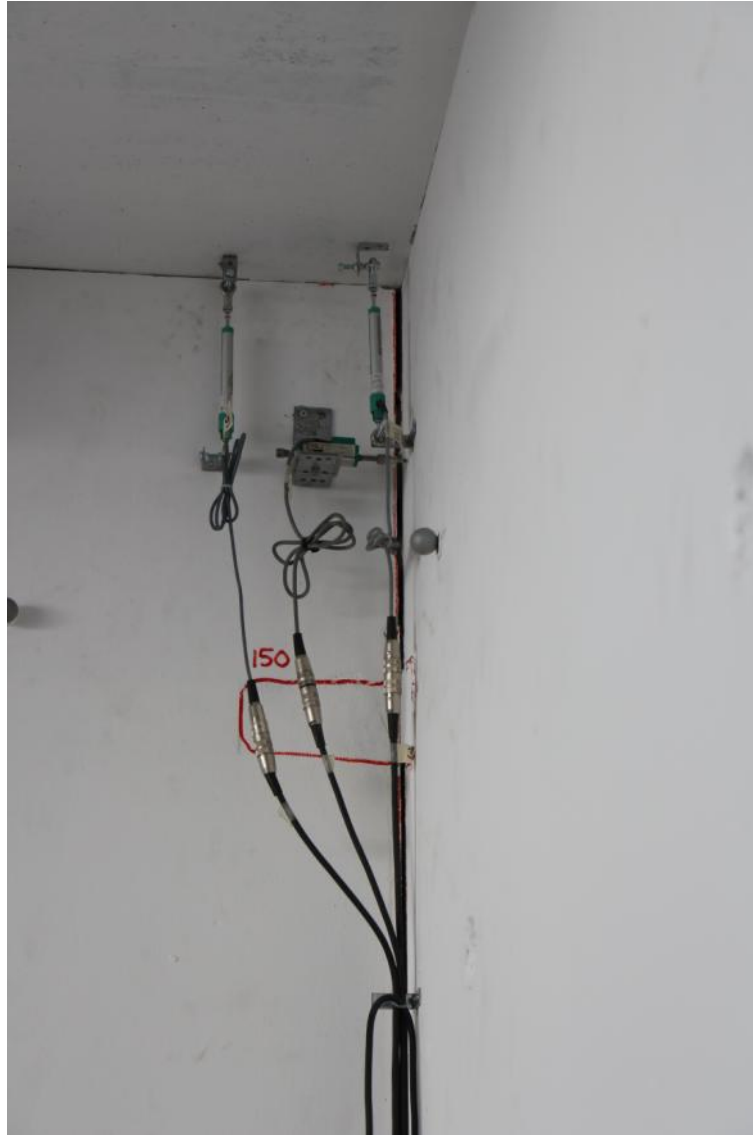
**Figure 316. Damage in the top panel joint and gap opening between stability and lateral walls – West face.**

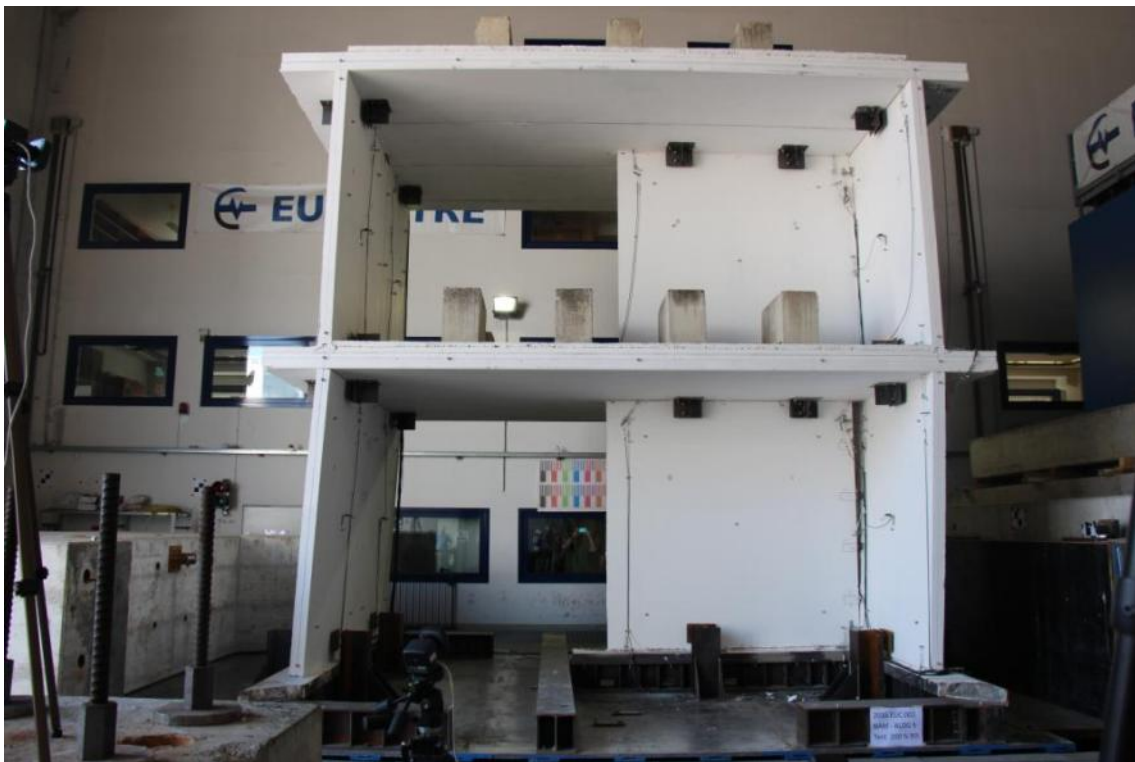
**Figure 317. Deformed shape of EUC-BUILD5 specimen at the end of dynamic testing.**

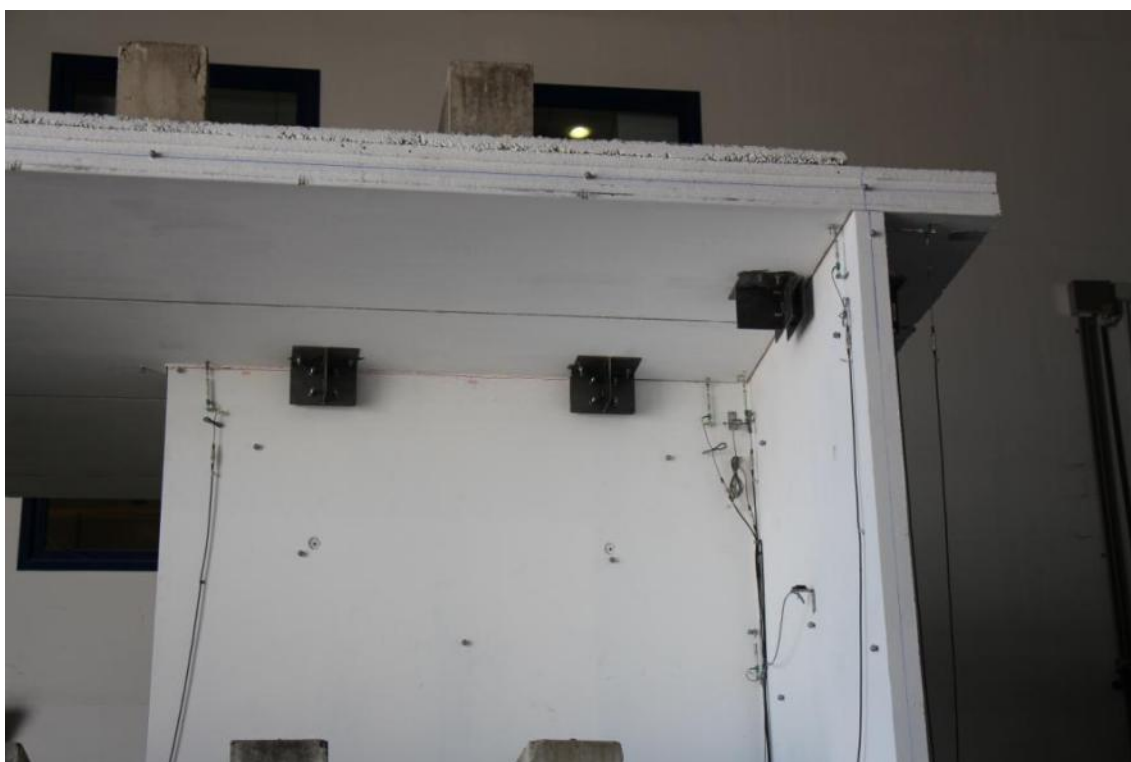
**Figure 319. Accumulation of permanent displacements at the second storey of the test specimen.**

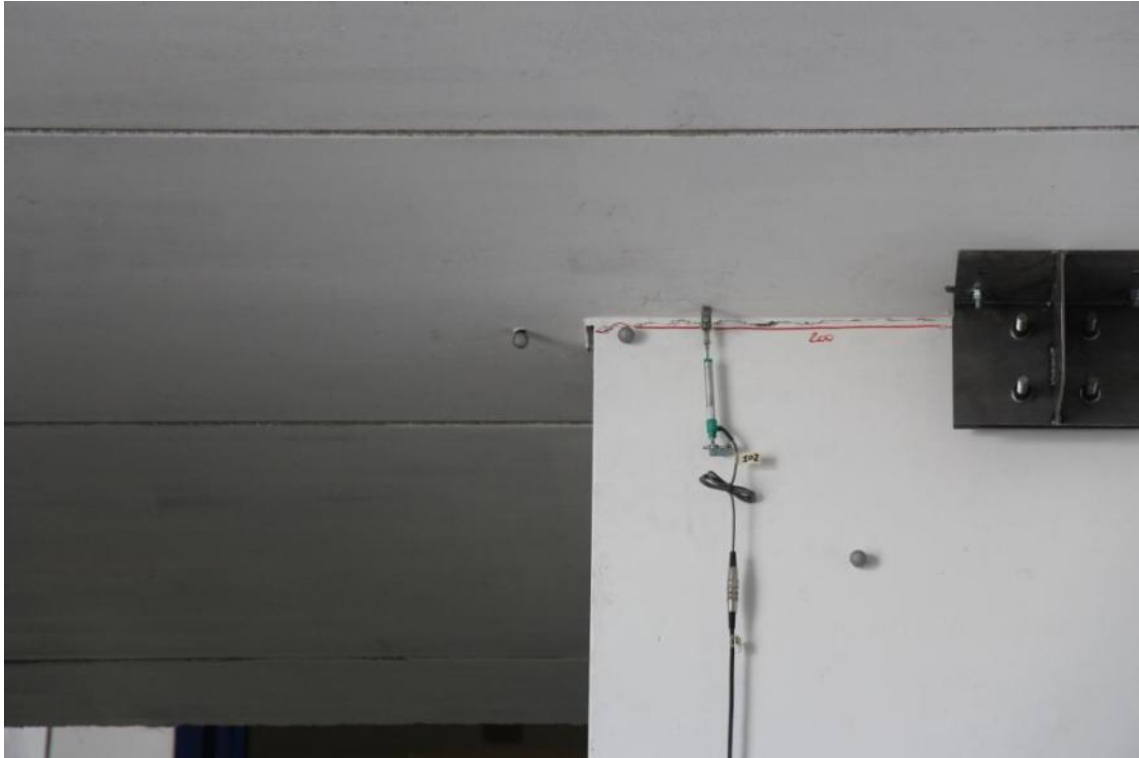
**Figure 320. Detail of damage pattern in the mortar joint beneath the second-storey slab – West-side view.**

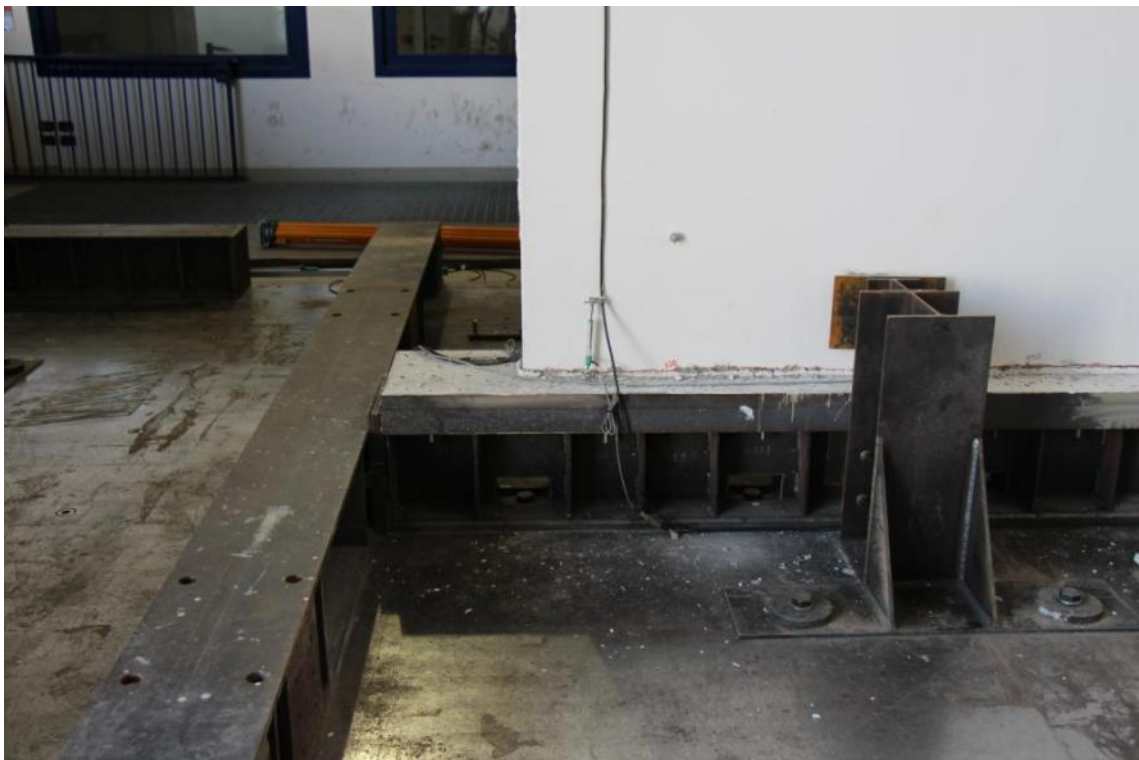
**Figure 321. Sliding and concrete crushing at the base of the first-storey stability wall – West-side view.**

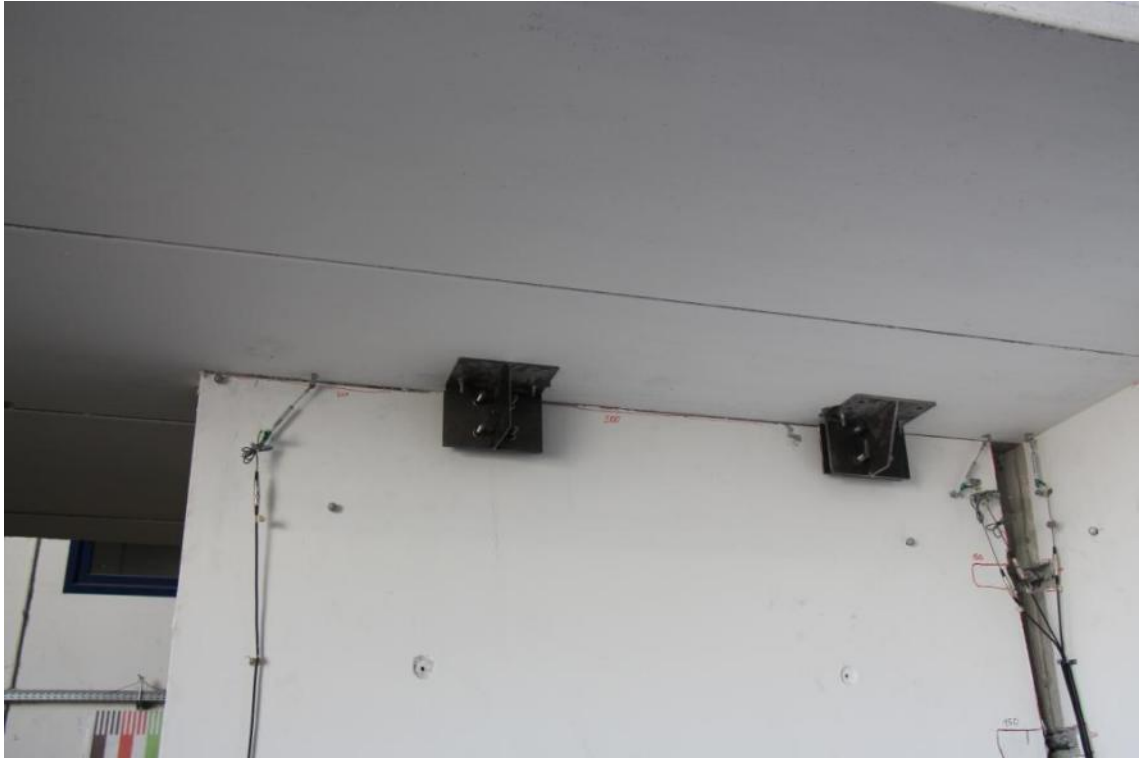
**Figure 322. Connection failure and damage pattern in the mortar joint beneath the first-storey slab.**

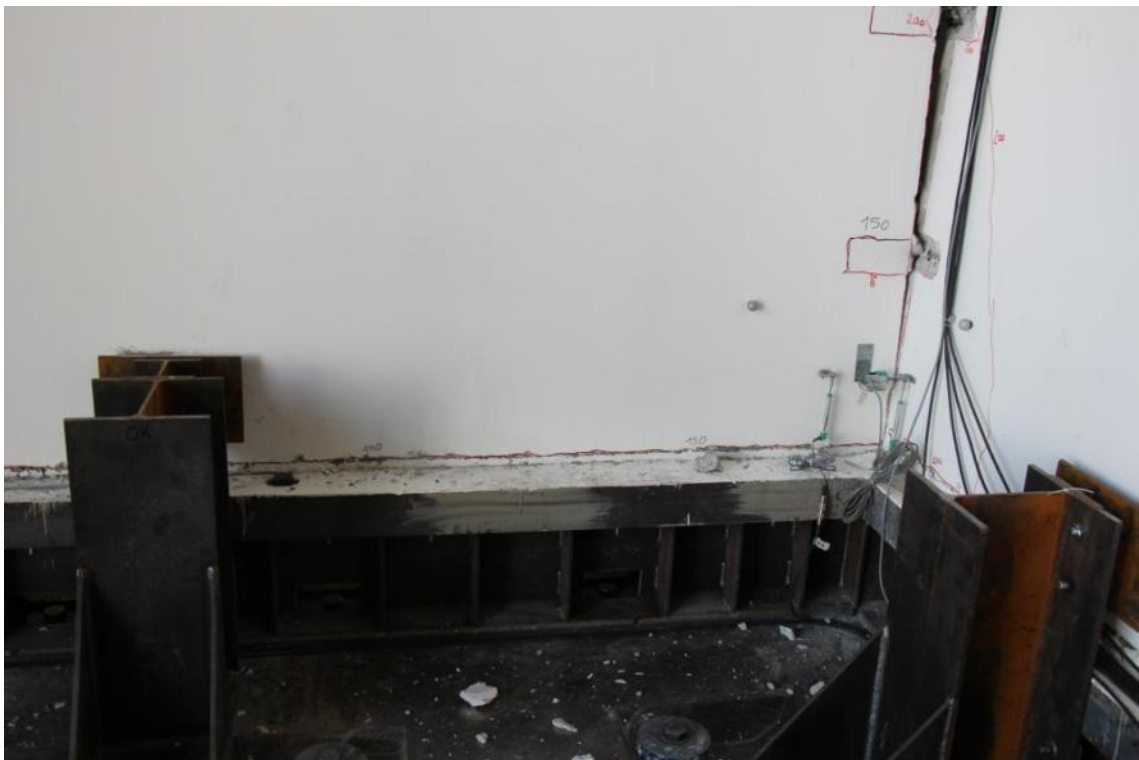
**Figure 323. Failure of bottom three-way joints damage pattern at the base of the stability wall.**

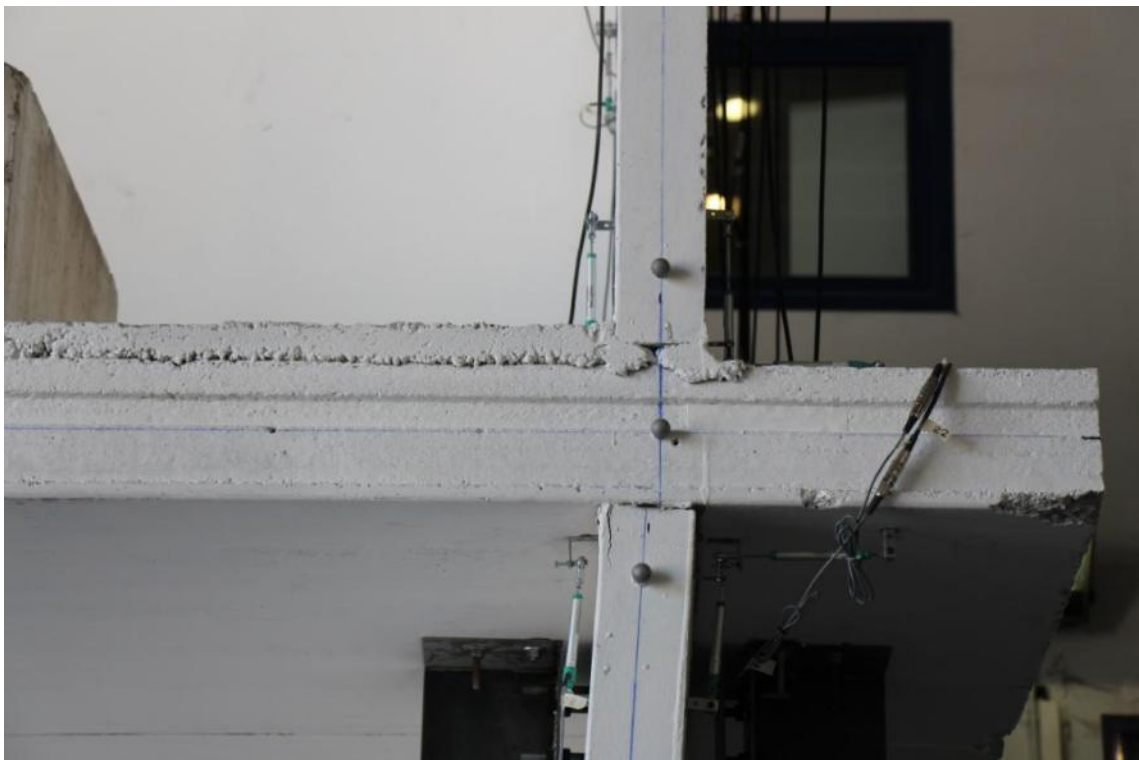
**Figure 335. Detail of concrete spalling/crushing at the top of lateral wall 1L2.**

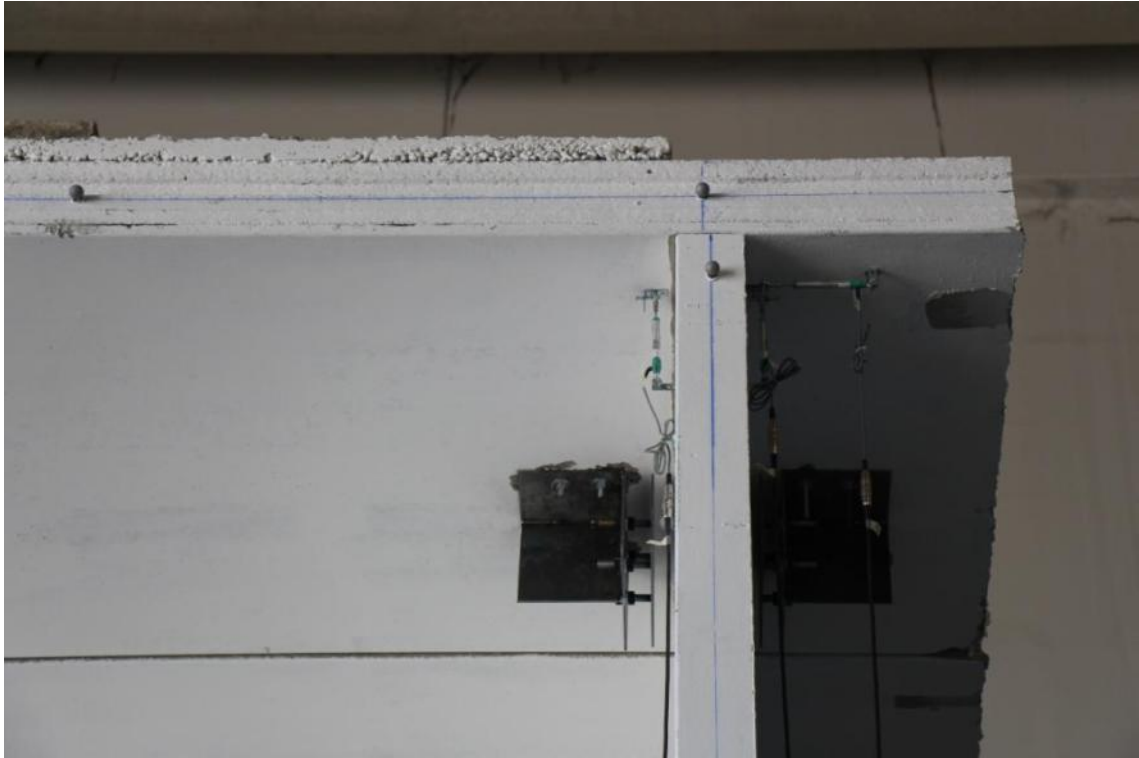
**Figure 336. Sliding of second-storey slab on the precast wall – South side of the specimen.**

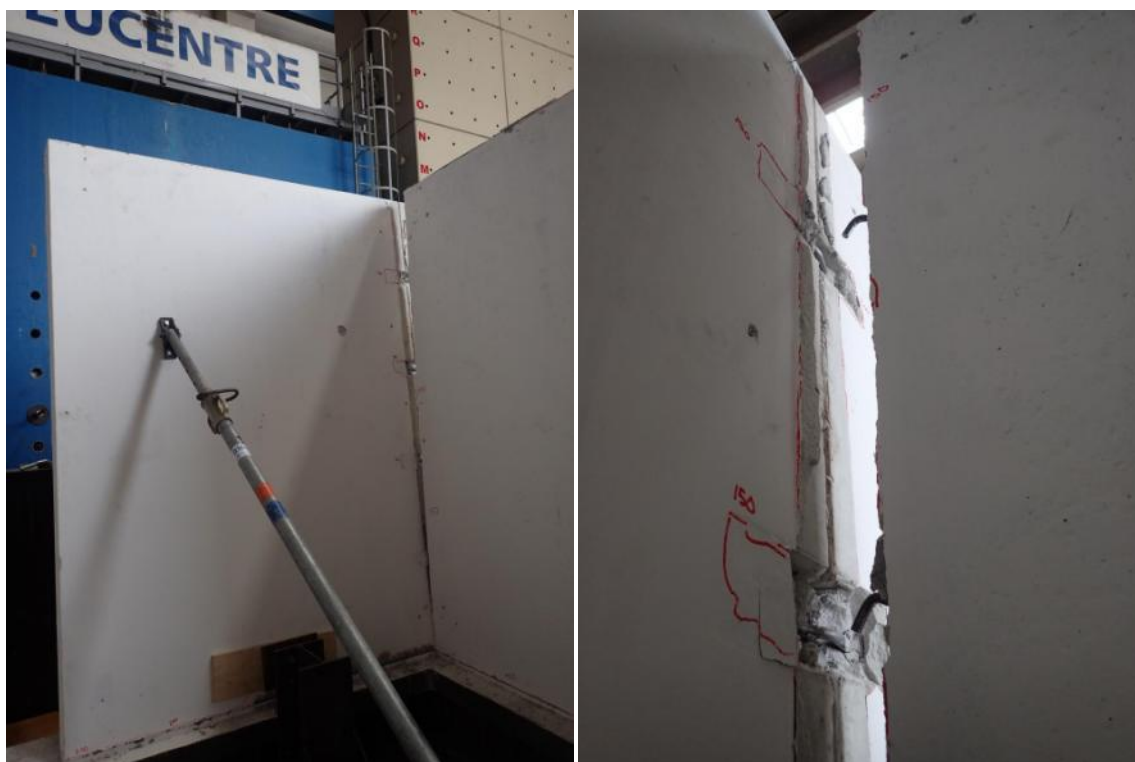
**Figure 541. Diagonal props for lateral stability and detail of the damage state of steel connectors.**

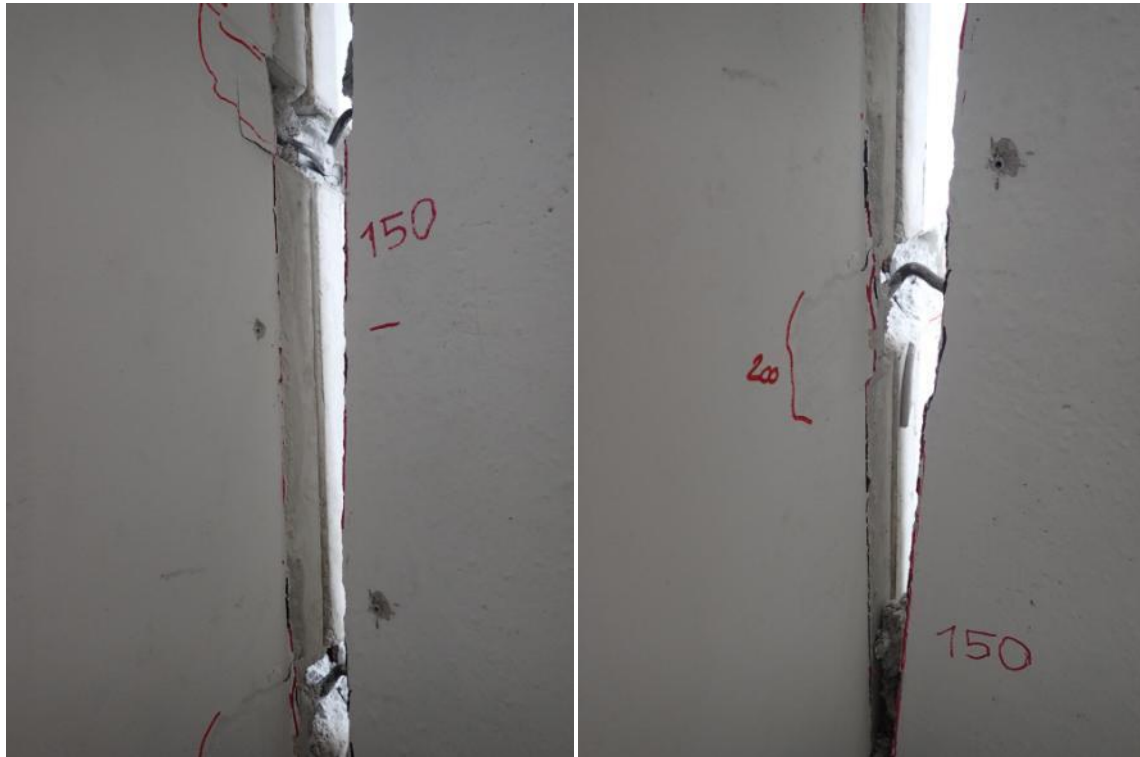
**Figure 542. Permanently-bent steel connectors embedded in the sockets of the stability wall.**
