# UWS2 Test Report

This document summarizes the observed behavior and overall test results of the second wall unit, UWS2.

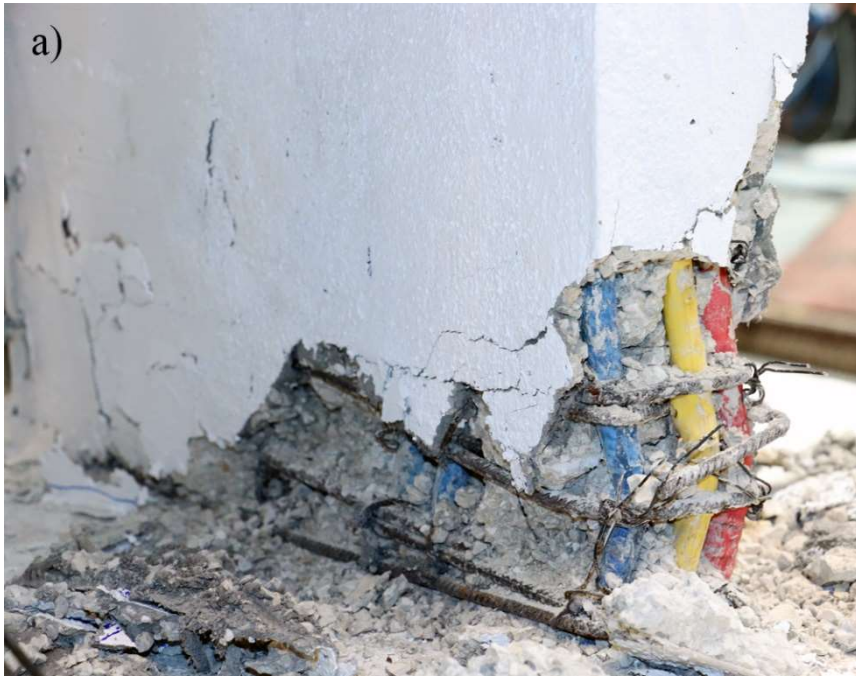
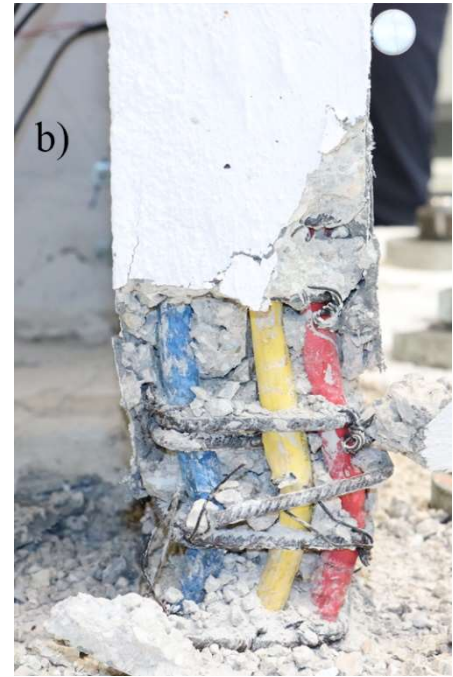
Further concrete crushing at both flange boundary ends was observed during GM7, exposing the longitudinal FeSMA bars (encased in two layers of plastic heat shrink, to promote debonding as discussed above, and guarantee electrical insulation) in these regions (Figure 1). During GM7, UWS2 reached its highest recorded in-plane west-east drift ( $\delta_{WE} = 2.39\%$ ), which was approximately 13% lower than that of UWS1. As with UWS1, the subsequent bi-directional accelerations of GM8 caused severe crushing of the north-east flange boundary end (Figure 8). The attained maximum drifts of  $\delta_{WE} = 1.97\%$  and  $\delta_{NS} = 0.56\%$ , along with a rotation of  $\theta_{max} = 24.8$  mrad, also led to noticeable buckling of the longitudinal rebars in this boundary end (Figure 8). The buckling behavior observed in UWS2 was consistent with the trends seen in UWS1.

**Figure 1 Failure locations of unit UWS2 at the base of Flange Two after GM8. The longitudinal rebars were wrapped in colored heat shrink plastic for the purpose of electrical insulation with the rebar cage, and to promote debonding.**
