# OUT-OF-PLANE TWO-WAY BENDING SHAKING TABLE TESTS ON SINGLE LEAF AND CAVITY WALLS

## Research Report

Protocol EUC137/2018U

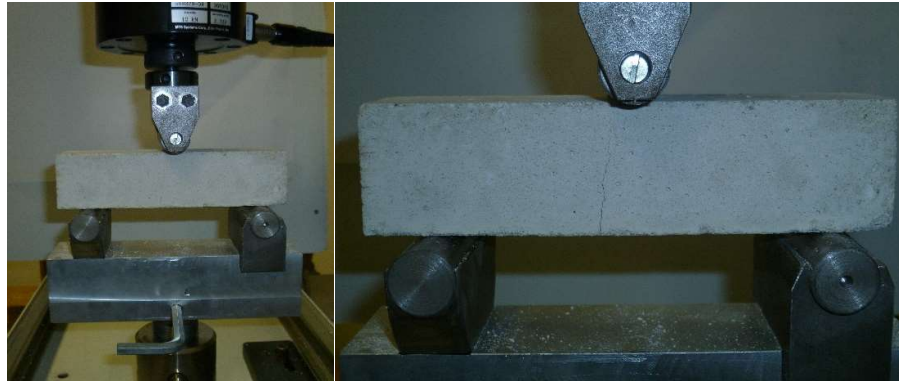
*Figure 2:3: Test setup in the laboratory for determination of flexural strength of mortar.*

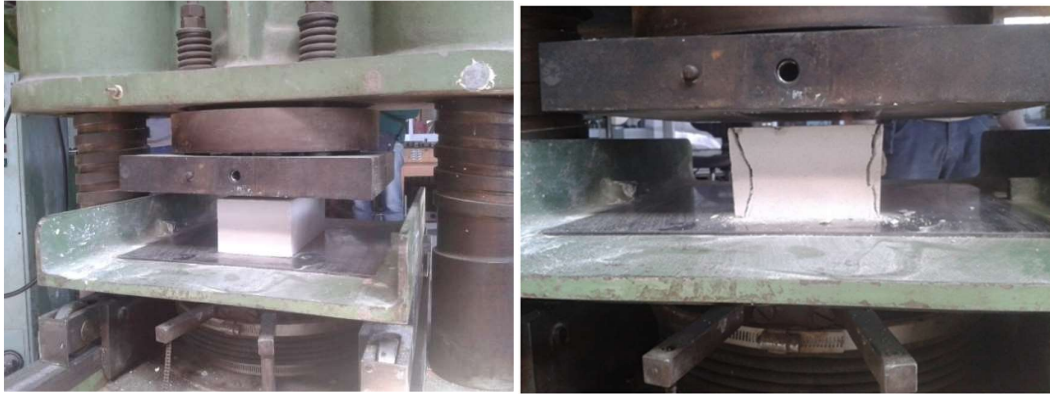
*Figure 2:6: Test setup in the laboratory (right) and failure of CS units (left) during determination of compressive strength of units.*

The compressive strength ( $f_b$ ) of the used bricks were evaluated in accordance with the guidelines of EN 772-1(2011). The bricks were laid such that the 212x102mm and 208x98mm lay flat on plate of the compression machine i.e. the bricks were in the normal laying plane. The applied load was constantly increased from zero until the failure of the unit (Figure 2:6). Normalized compressive strengths were obtained for the bricks by multiplying experimentally obtained strengths with a shape factor depending on the width and height of the masonry units. This data for the CS and clay units are summarised in Table 2.5. The distribution of compressive strengths for both type of units can be observed in Figure 2:7.

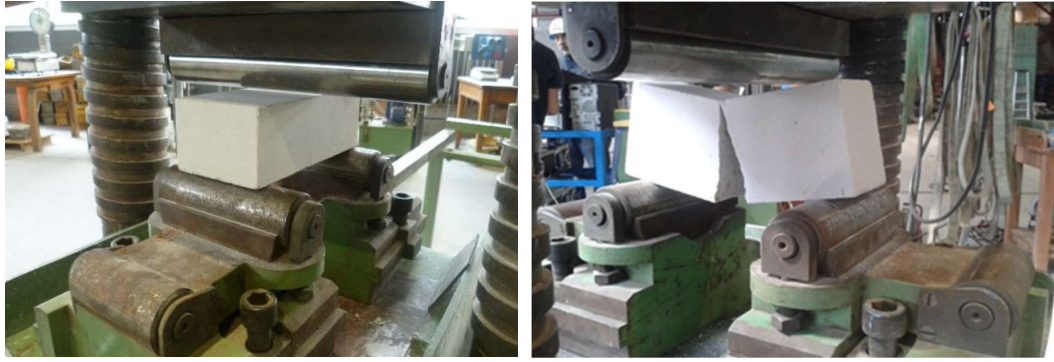
Figure 2:9: Test setup in the laboratory (right) and failure of CS units (left) during determination of flexural strength of units.

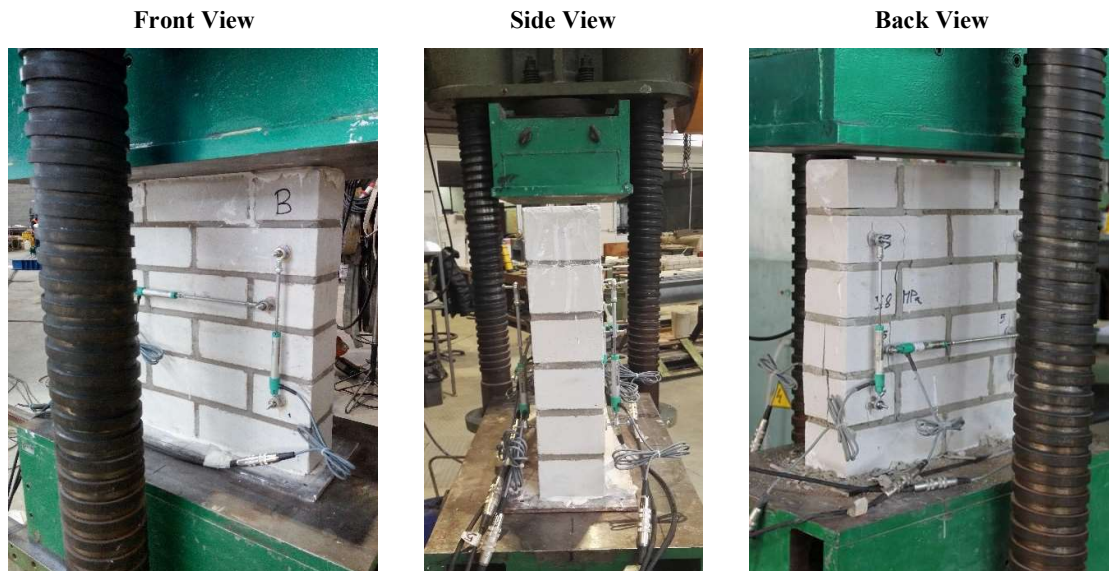
Figure 2:15: An instrumented CS compression wallette in the laboratory.

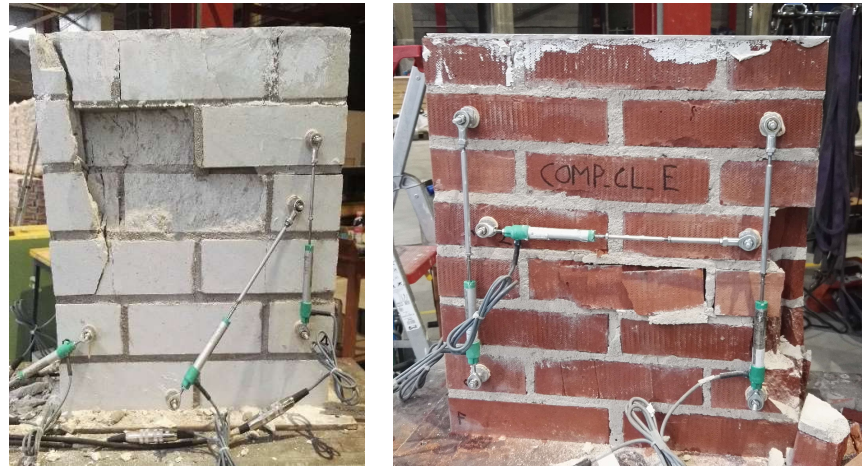
Figure 2:17: Failure of CS (left) and clay (right) wallette under compression perpendicular to bed joints..

by approximately 100 kN. After the third cycle of the third loading step, the vertical load was increased until the failure of the specimen (Figure 2:17). The loading history adopted for compressive testing of the masonry wallettes can be observed in Figure 2:16. The loading velocity adopted was consistent with the prescriptions of EN 1052-1:1998 which allowed calculating the elastic modulus of masonry along with the compressive strength.

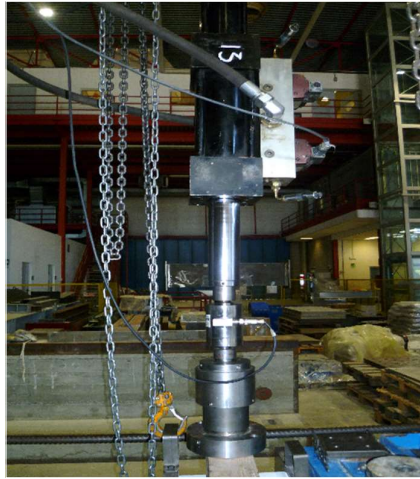
- The shear force  $F$  was applied by an actuator (functioning in displacement control) perpendicular to the central brick via two rollers placed on the inner brick and respecting the requirements of EN 1052-3 with respect to their distance from the two bed joints. This load was applied at a rate of 0.02 mm/sec respecting EN 1052-3 requirements limiting this rate to be between 0.1 MPa/min and 0.4 MPa/min and increased until failure;

*Figure 2:25: Actuator used to apply shear load to the specimen.*

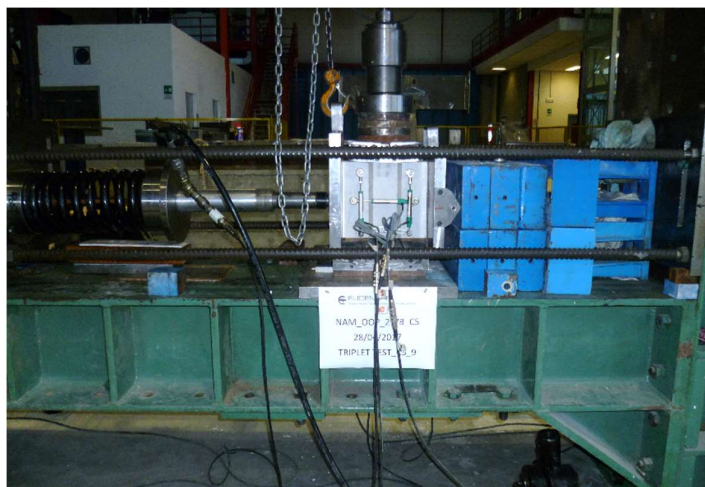
Figure 2:26: Test set-up in laboratory for evaluating the shear strength of masonry joints.

The resulting test set-up adopted for evaluating the shear strength of masonry joints in the laboratory can be seen in Figure 2:26. Different failure modes observed in the lab for CS masonry triplets can be seen in Figure 2:27, which are compliant with the acceptable failure modes defined for this characterisation test by EN 1052-3 (Figure 2:28).

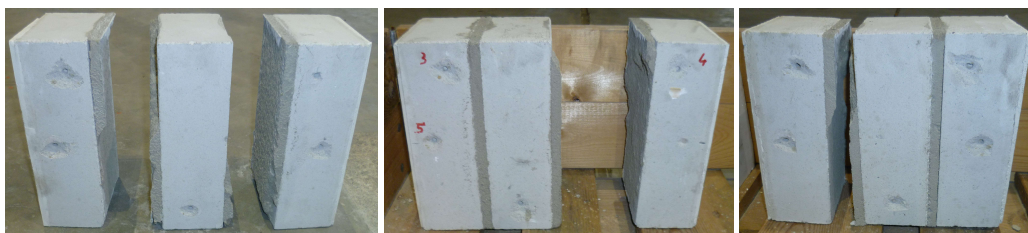
Figure 2:27: Failure modes observed for CS masonry triplets in the laboratory.

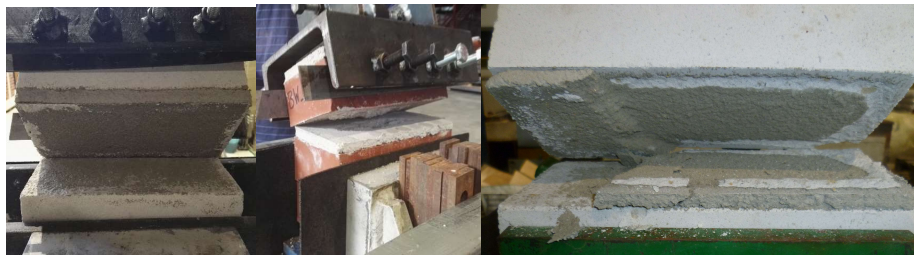
Figure 2:38: Example of failure modes from bond wrench tests in the laboratory.

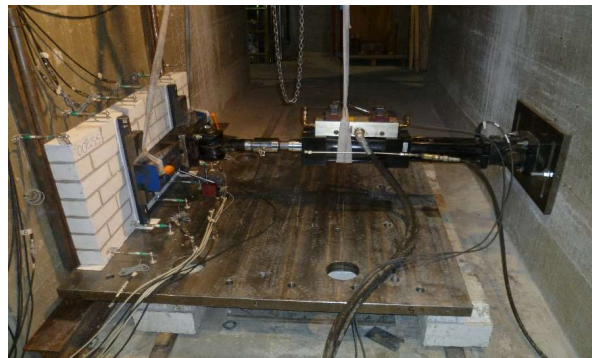
Figure 2:45: Test setup adopted in the laboratory for determining the flexural strength of masonry.

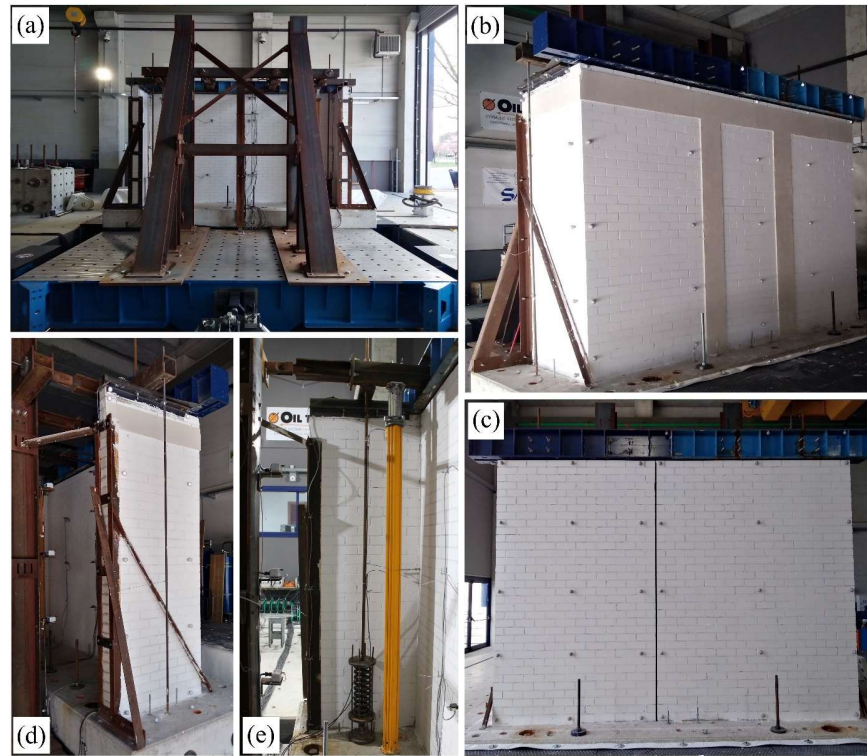
Figure 3.12: Testing layout: general view of the shaking table and the testing setup (a), general view of CS-000-RF2 (plaster applied to investigate non-structural damage, more details in section 3.2.3.2) (b) and CS-000-L1&L2 (c), return wall restrain system fixed with diagonal to the rigid frame (d), spring system for the application of the top overburden pressure and support for the uplift of the top beam (e).
