Nederlandse Aardolie Maatschappij B.V.

# **Experimental campaign on a clay URM full-scale specimen representative of the Groningen building stock**

| LAB AND TESTS<br>RESPONSIBLE | DOCUMENT AUTHOR | REVIEWER |
|---|---|---|
| Draft: 06/05/2016 | Document type:<br><br><b>Technical report</b><br>pages: 262 | File name:<br>EUC128_2016U_160720.pdf |

Graziotti, F., Tomassetti, U., Rossi, A., Marchesi, B., Kallioras, S., Mandirola, M, Fragomeli, A., Mellia, E., Peloso, S., Cuppari, F., Guerrini, G., Penna, A., Magenes, G. (2016). *Shaking table tests on a full-scale clay-brick masonry house representative of the Groningen building stock and related characterization tests*. Report EUC128/2016U, EUCENTRE, Pavia, IT

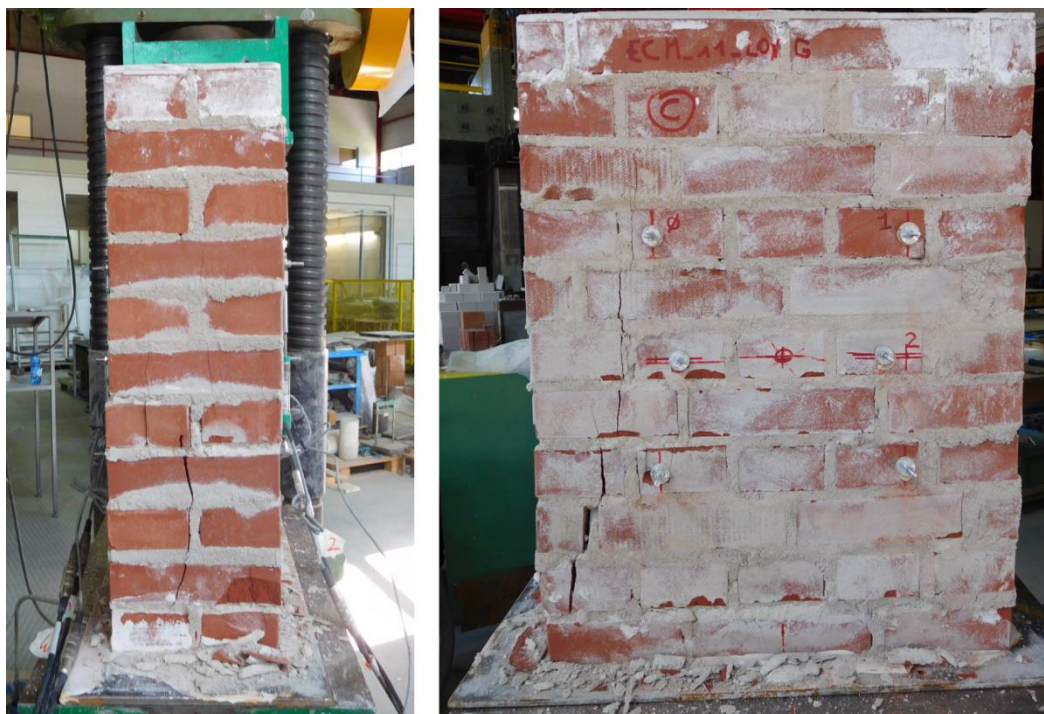
Figure 26. View of the cracks on wallette EC\_MAT\_2\_C after the test.

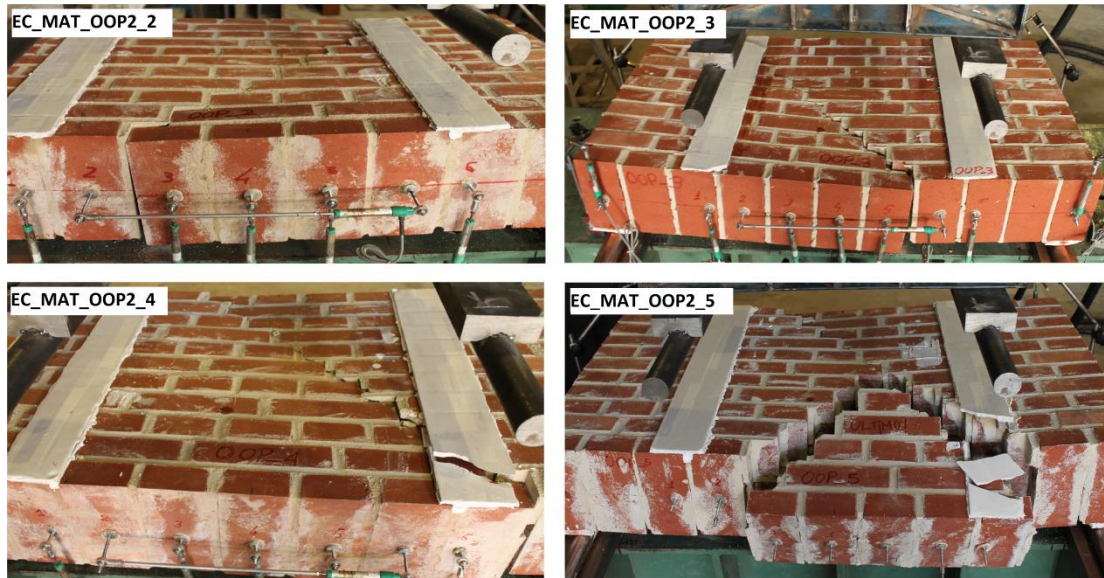
*Figure 42. Crack pattern after failure for specimens EC\_MAT\_OOP2-2 to 5*

Figure 42 and Figure 43 show the failures of the specimens. Note that the failure of the specimen EC\_MAT\_OOP2\_1 has not taken place within the length between the supports.

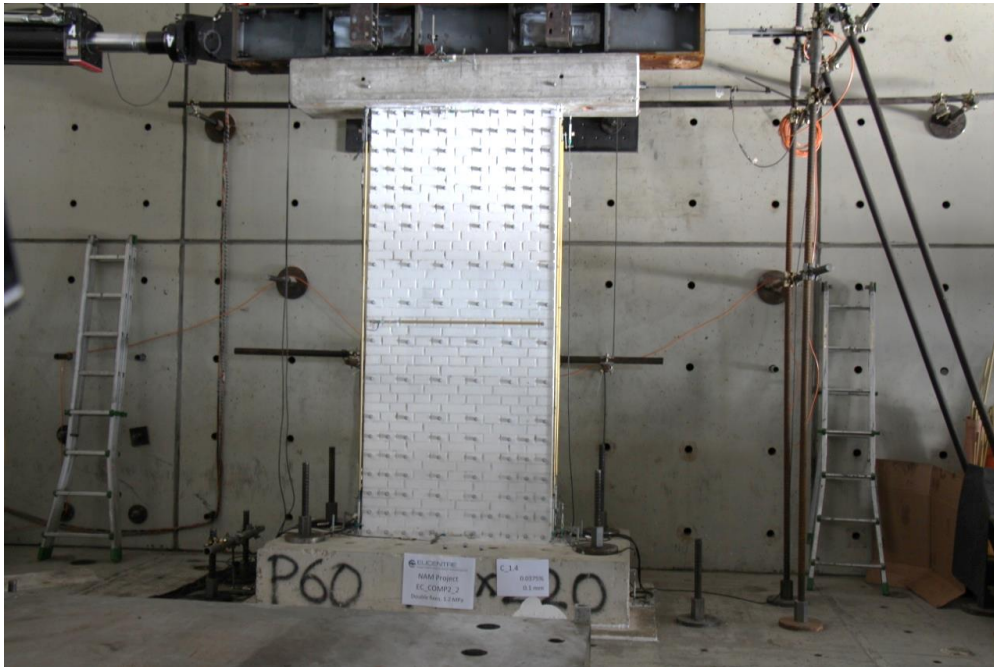
*Figure 90. Test set-up of EC\_COMP2-2.*

EC\_COMP2-2 is the second of the three slender piers to be tested. It was subjected to in-plane cyclic quasi-static tests performed under overburden of 1.2 MPa. The specimen was 1.2 m long and 2.71 m high, with fixed boundary conditions at both top and base. Figure 90 reports the test set-up of EC\_COMP2-2.

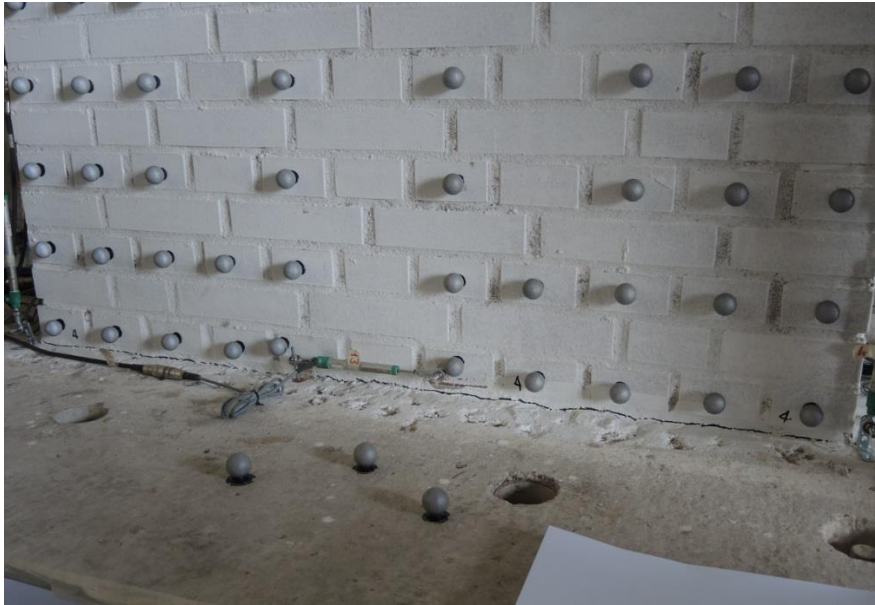
Figure 92. EC\_COMP2-2: Horizontal crack along the base of the specimen.

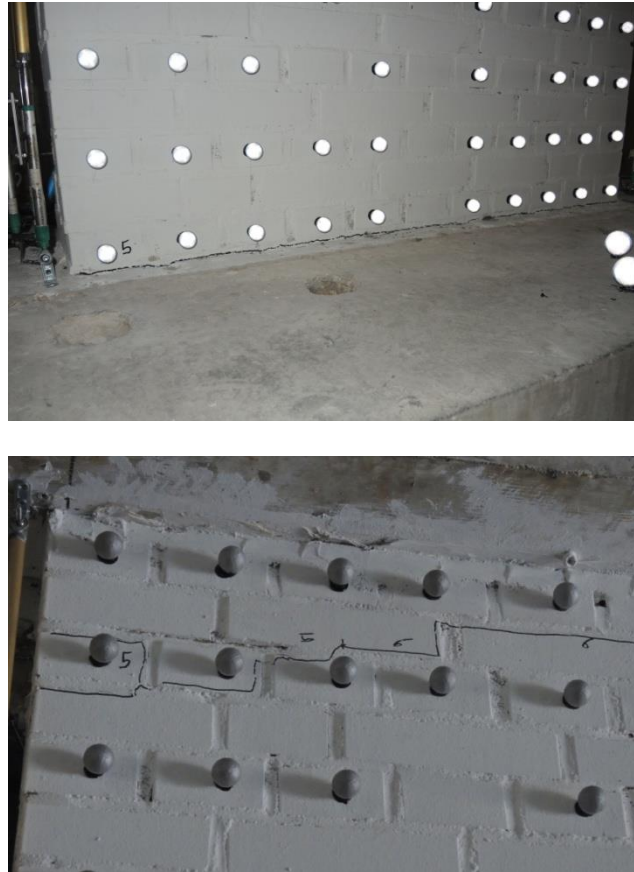
*Figure 104. EC\_COMP2-3: Horizontal cracks along the base and the top of the pier, associated with its flexural behaviour.*

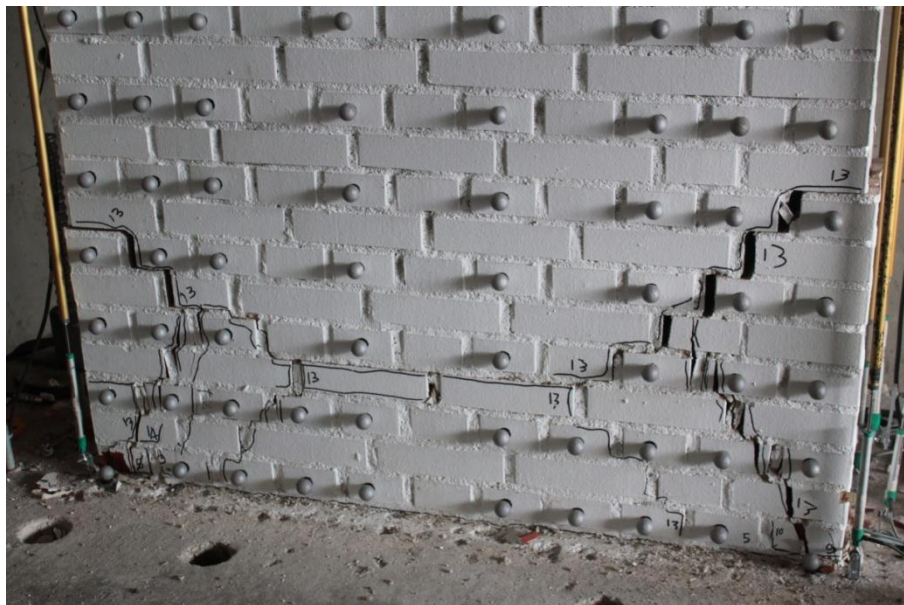
*Figure 105. EC\_COMP2-3: Development of toe crushing mechanism at the base of the pier.*

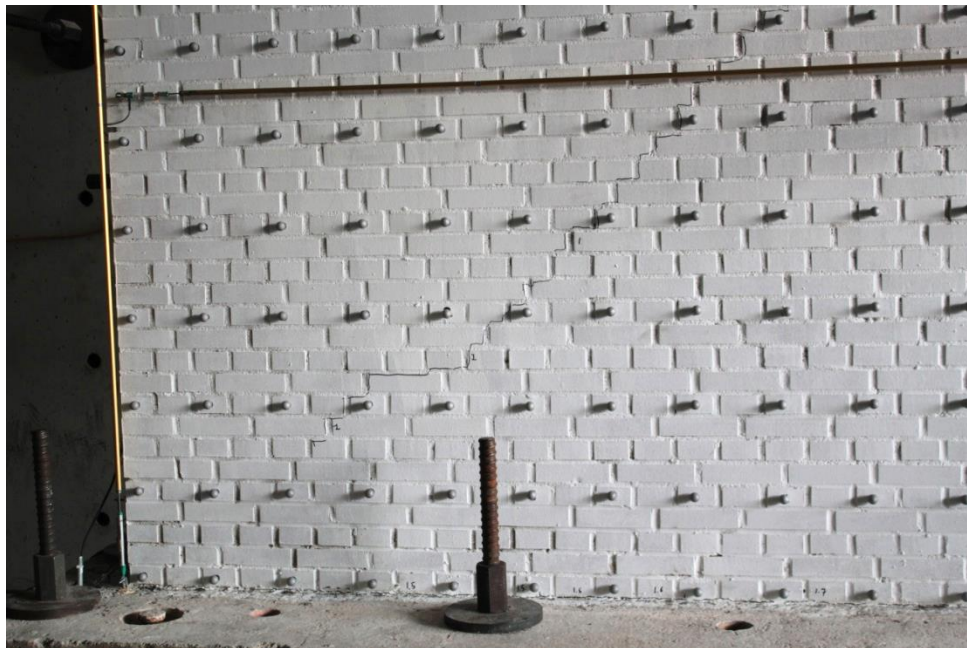
*Figure 116. EC\_COMP2-4: Diagonal cracks appear in the middle of the pier after loading cycle 1\_D.*

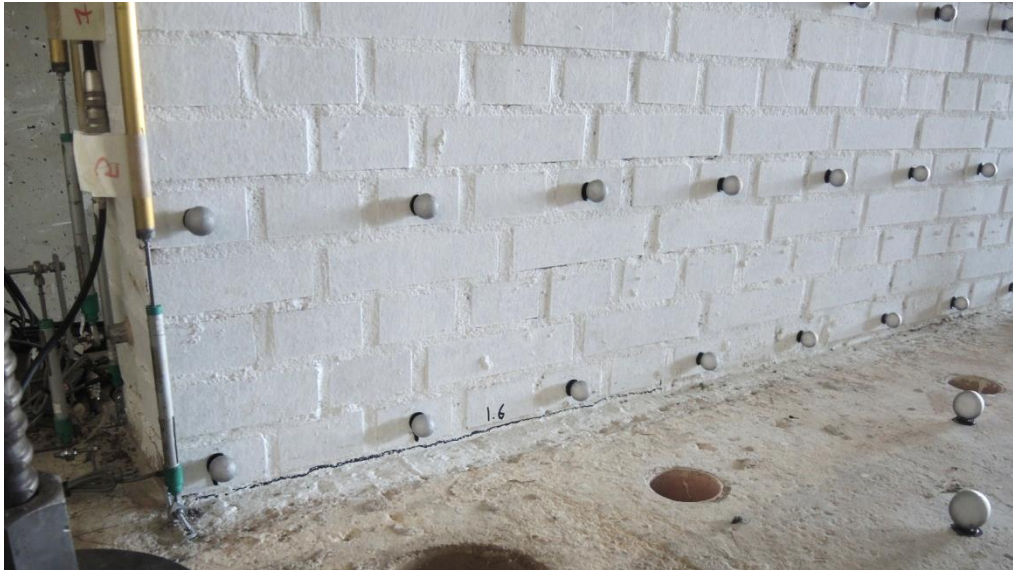
*Figure 127. EC\_COMP2-5: Horizontal cracks along the base of the pier.*

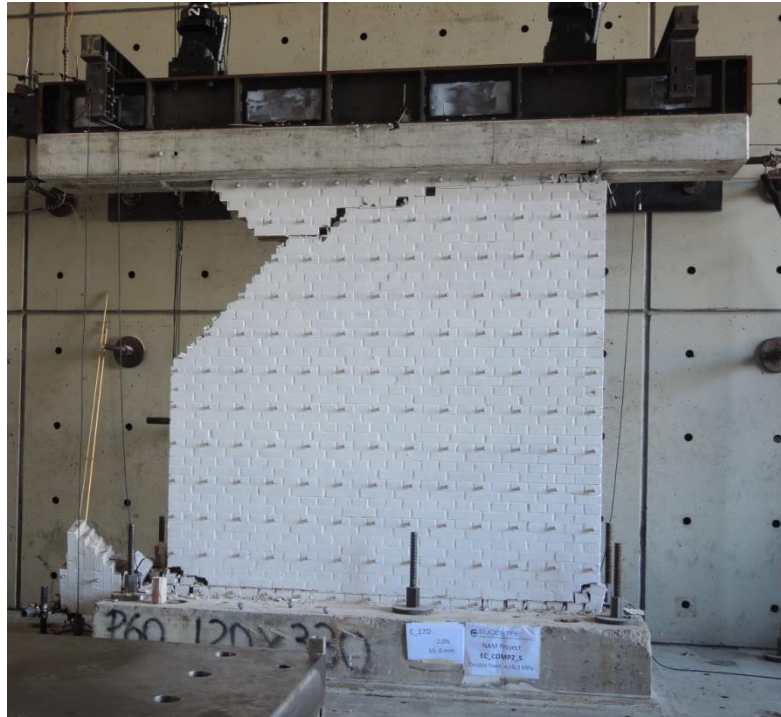
*Figure 129. EC\_COMP2-5: Damage pattern of the pier at the end of the test.*

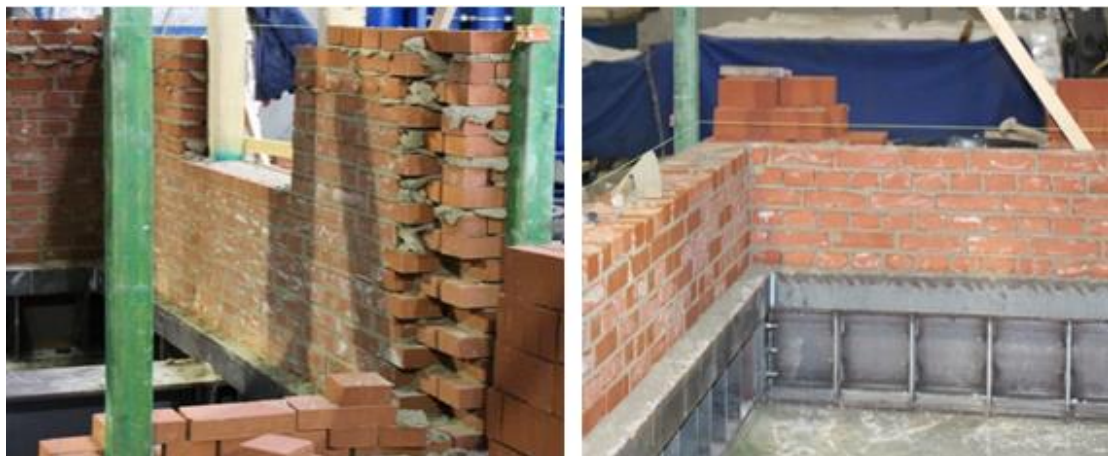
*Figure 152. Test-house perimeter walls during the construction works and detail of the foundation.*

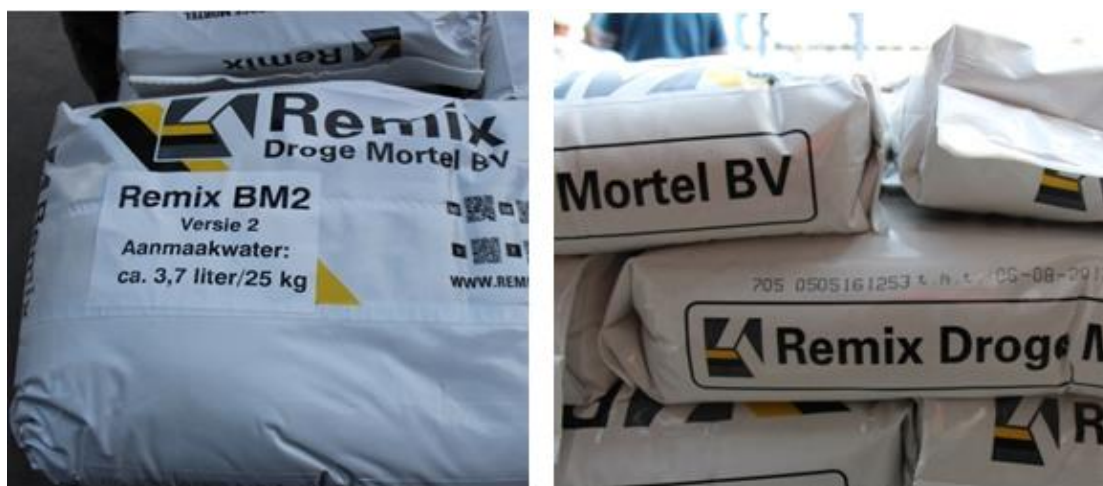
Figure 153. Type of mortar used and ID code.

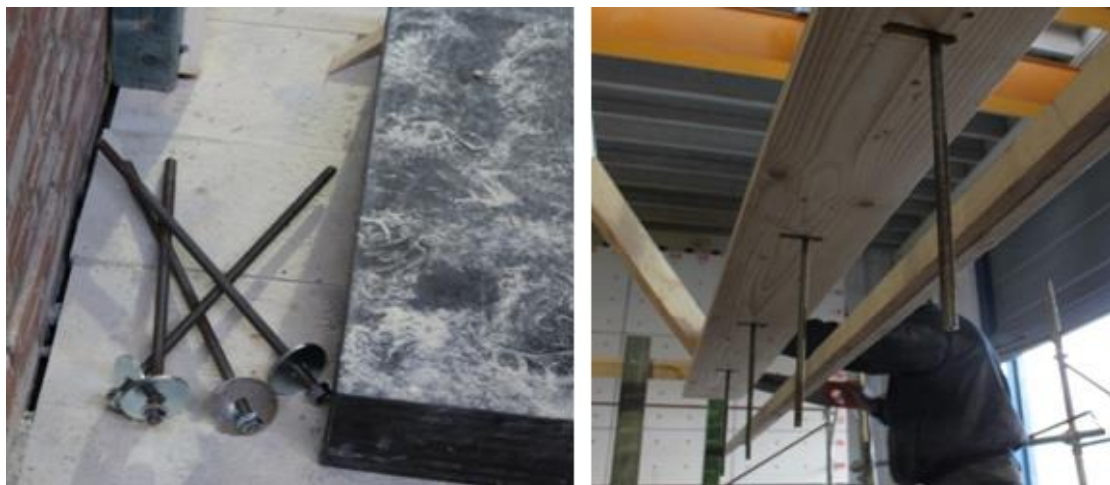
*Figure 199. Threaded bars M12*

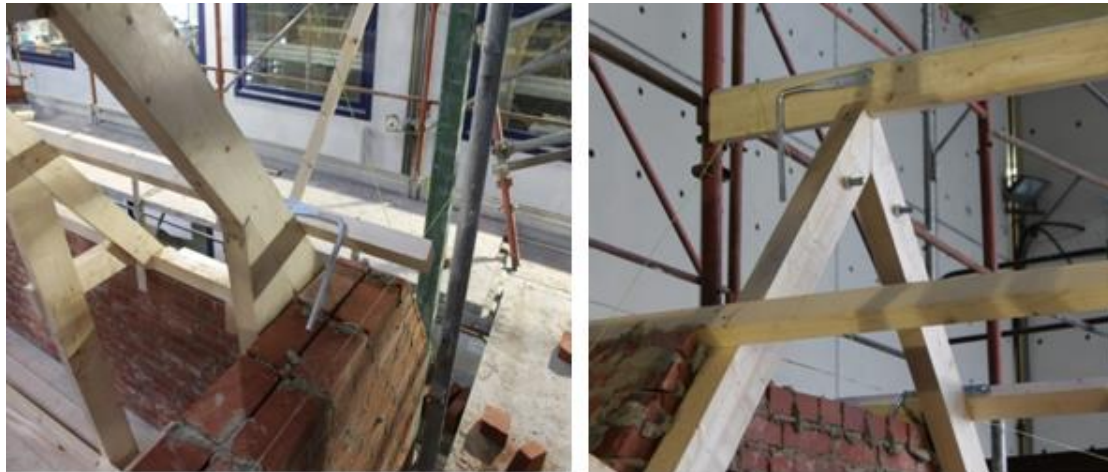
*Figure 200. Details of one of the L-shaped anchor of the south gable (left) and of the south-end ridge beam (right) during the construction works.*

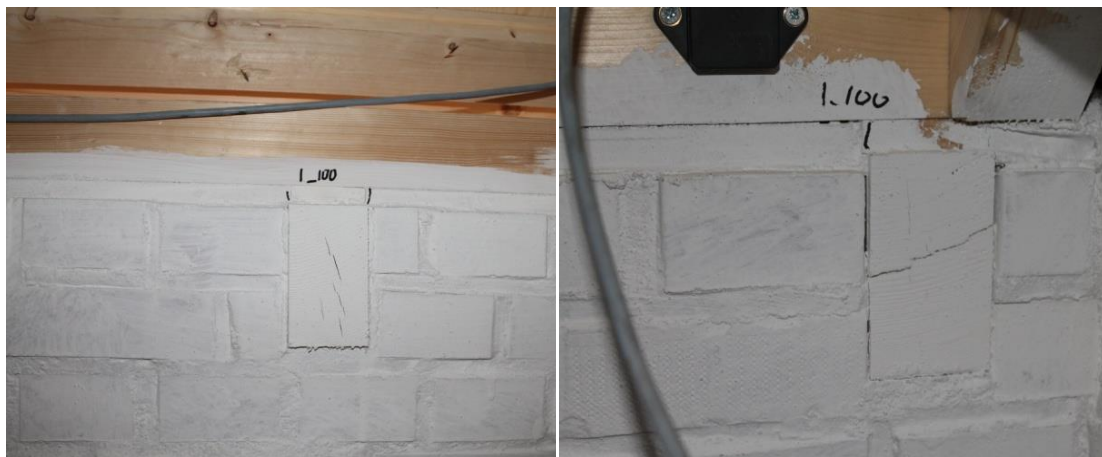
*Figure 227. Formation of cracks around gutter beams (left), and along the interface wall plates-masonry (right).*

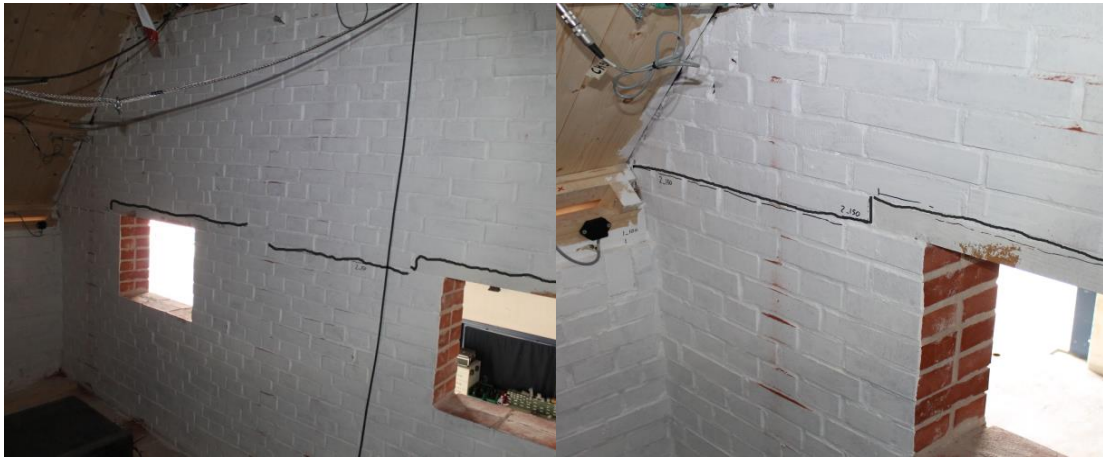
*Figure 229. Horizontal cracks above the North gable opening.*

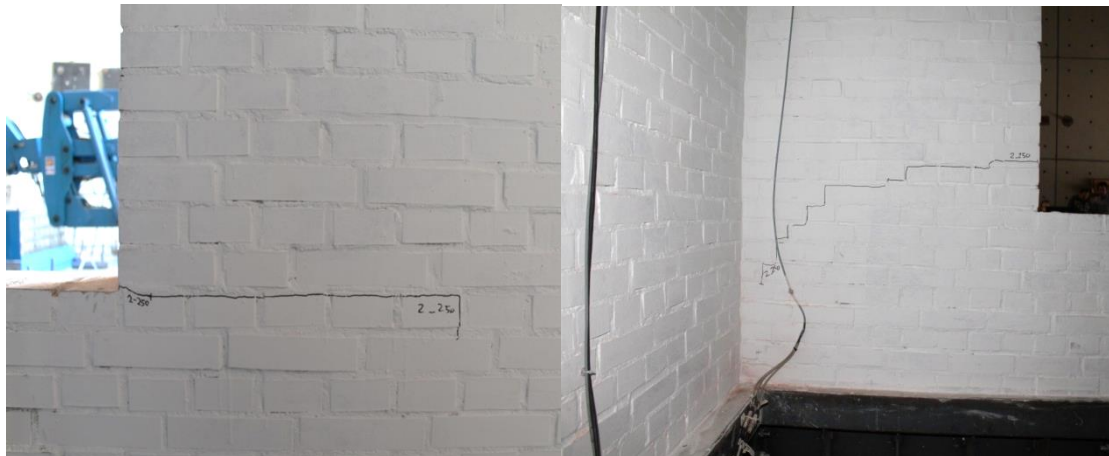
*Figure 234. Cracks due to flexure on the base of the piers PW1 (left), and PW4 (right) of the West façade.*

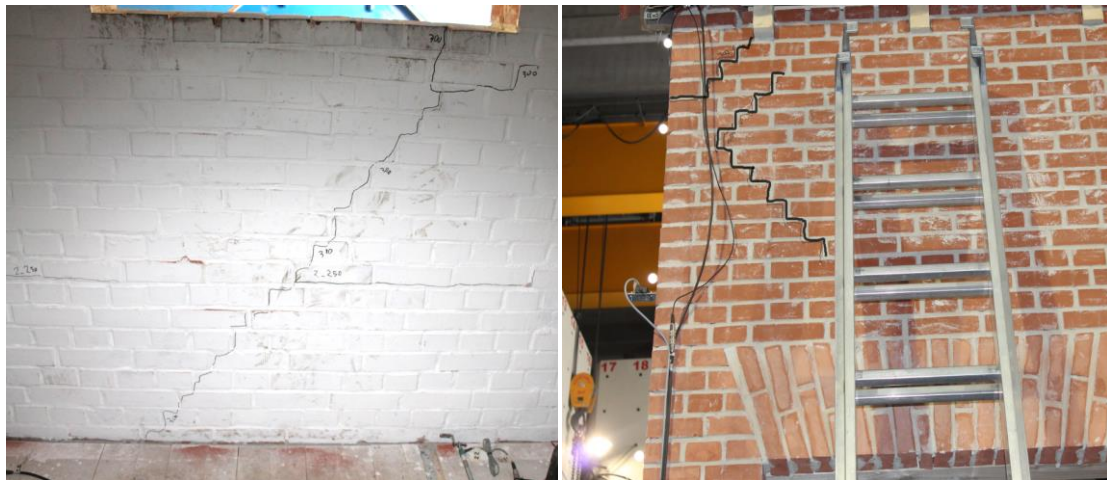
Figure 236. Cracks associated with the development of an out-of-plane mechanism of the gable of the Southern façade: diagonal crack at an angle of  $45^\circ$  (left), and cracks at the intersection with the top of the eastern façade (right).

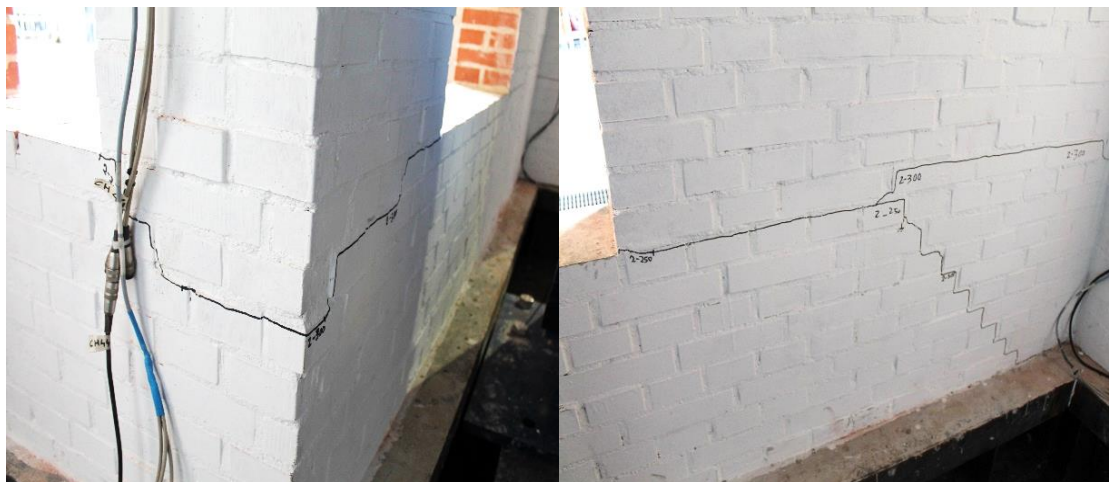
*Figure 239. Cracks at the base of the piers of the West façade, indicative of their rocking behaviour: pier PW2 (left), and pier PW1 (right).*

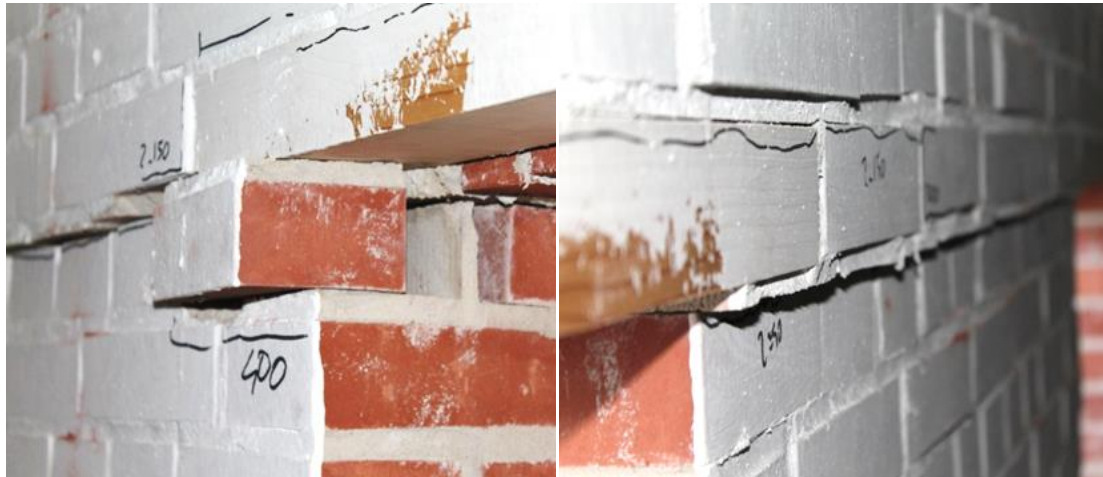
*Figure 241. Failure through horizontal cracks in the gable of the Northern facade.*

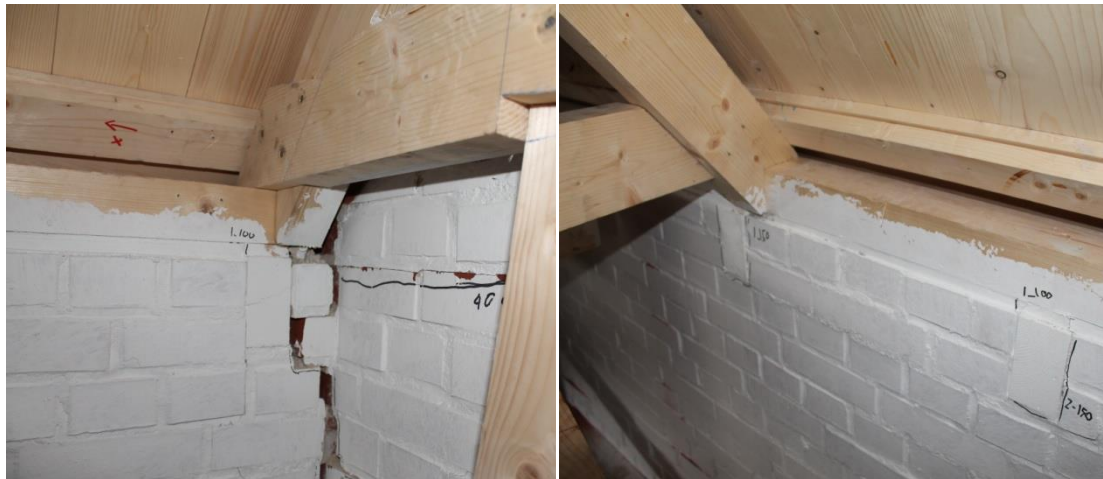
*Figure 245. Roof supports at South-East corner (left), and East wall (right).*

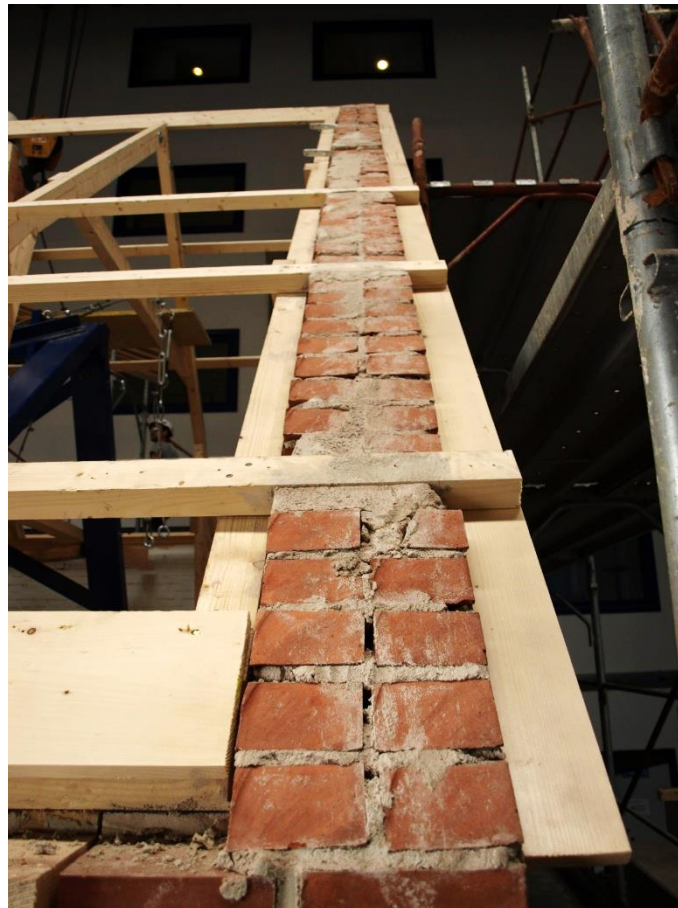
*Figure 247. Well-restrained connection of the roof timber beams to the South gable wall.*

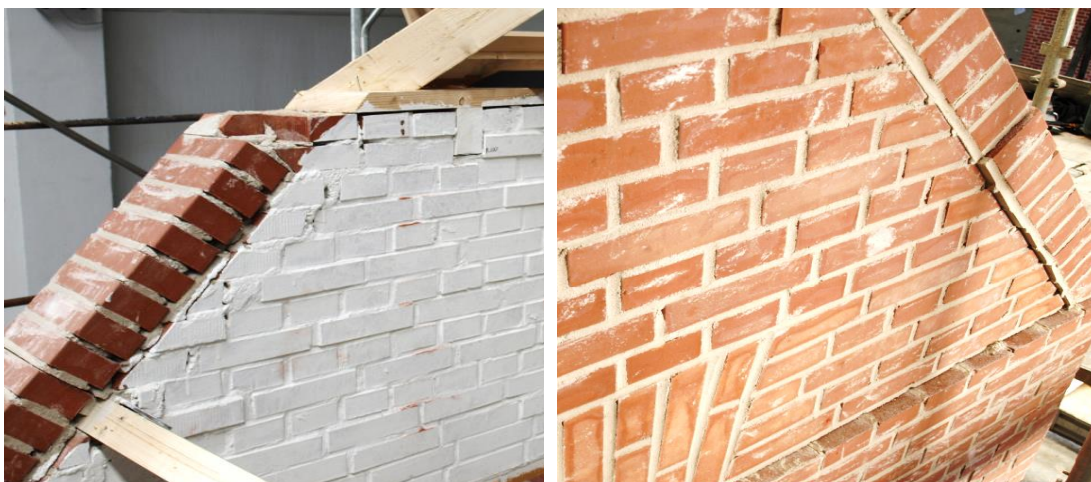
*Figure 248. Cracks due to pounding of the roof on the North gable (left), and South gable (right).*

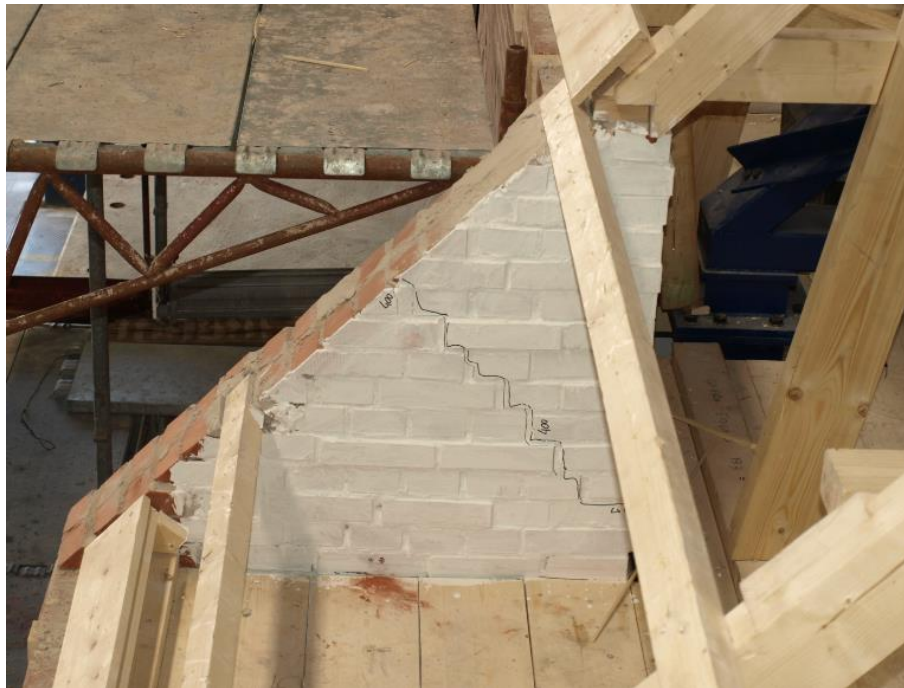
*Figure 249. Crack due to pounding of the roof on the small parapet of the West façade.*

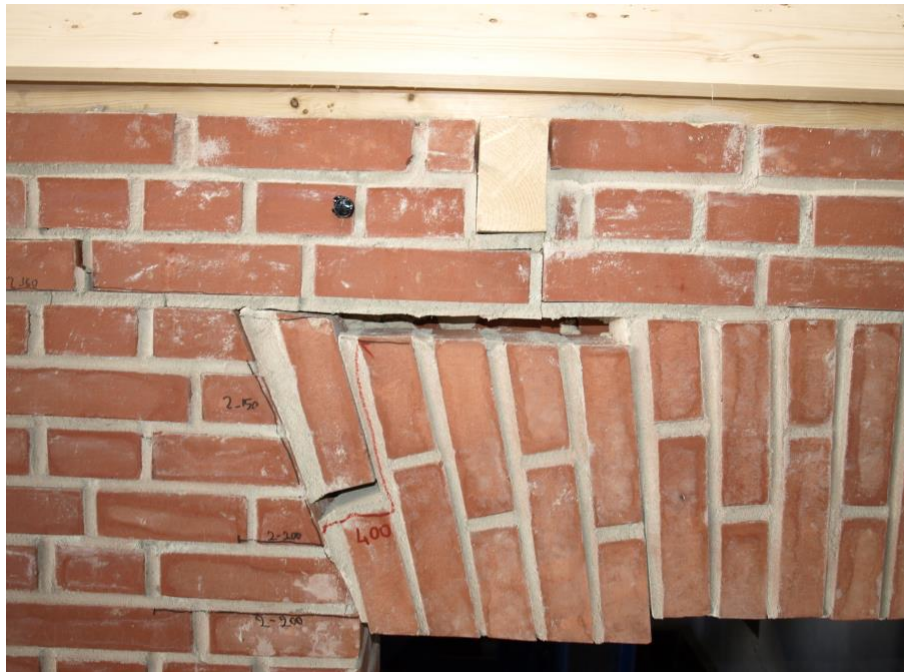
*Figure 252. Near Collapse status of the lintel of the southern opening on the West façade.*
