# Experimental seismic performance of a full-scale unreinforced clay-masonry building with flexible timber diaphragms

This paper presents the results of a unidirectional shake-table test performed on a full-scale, single-storey unreinforced masonry building. The specimen represented a typical detached house of the Groningen region of the Netherlands, consisting of double-wythe clay-brick unreinforced masonry walls, without any specific seismic detailing. The building prototype included large openings and a reentrant corner, causing a discontinuity in one of the perimeter walls. The floor was made of timber beams and planks, resulting in a flexible diaphragm. The roof, characterized by a very steep pitch, consisted of a series of timber trusses connected by wood purlins and boards. The two façades perpendicular to the shaking direction were designed to represent two typical gable geometries. An incremental dynamic test was conducted up to the near-collapse state of the specimen, using input ground motions compatible with induced-seismicity scenarios for the examined region. This paper summarizes the main characteristics of the specimen and the shake-table experimental results, illu

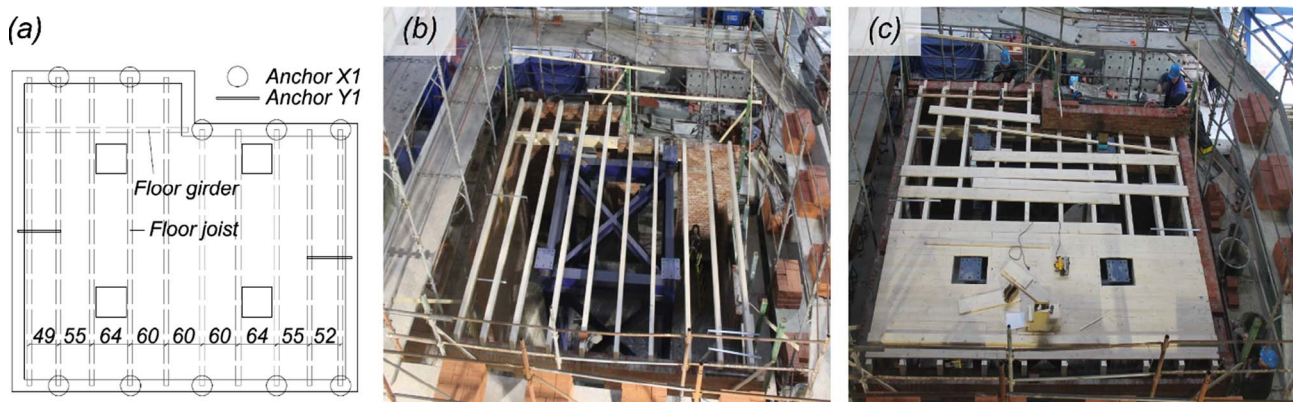
Fig. 4. First-floor framing: (a) floor framing plan with wall-to-diaphragm connections; (b) floor joists during construction; (c) floorboards during construction (units of cm).

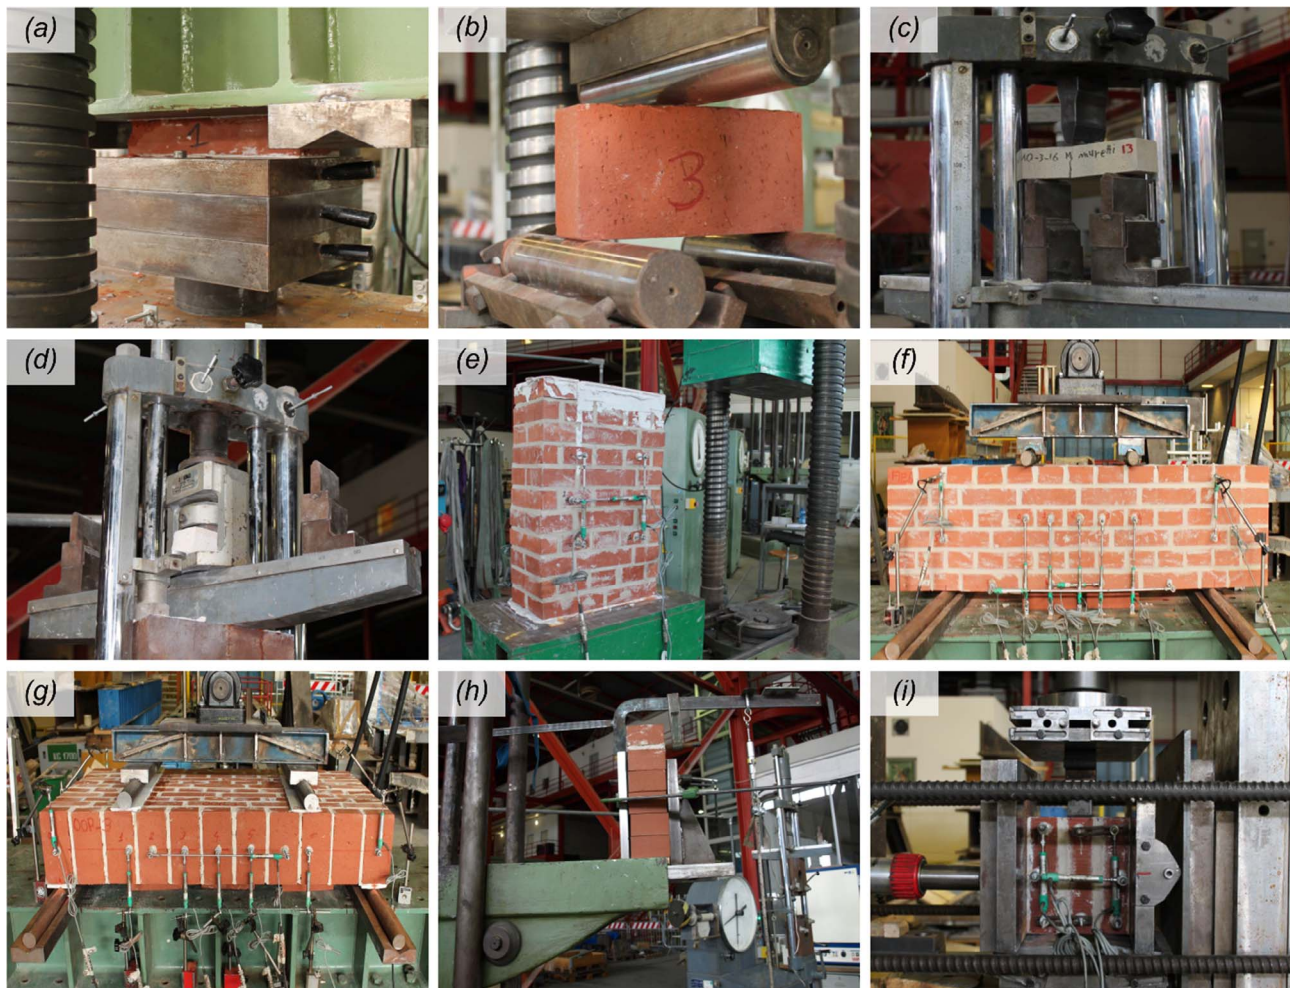
**Fig. 8.** Mechanical characterization tests: (a) compression test on a clay brick; (b) three-points bending test on a clay brick; (c) three-points bending test on a mortar specimen; (d) compression test on a mortar specimen; (e) compression test on a masonry wallette; (f) four-points in-plane bending test; (g) four-points out-of-plane bending test; (h) bond wrench test; (i) shear test on a triplet.

A mechanical characterization campaign was conducted on the clay-brick masonry of the building prototype at the DICAr laboratory of the University of Pavia. The testing series comprised strength tests on clay units (Fig. 8a and b) and mortar samples (Fig. 8c and d), as well as compression and bending tests on small masonry assemblies (Fig. 8e, f, and g), bond wrench tests (Fig. 8h) and triplet tests (Fig. 8i).

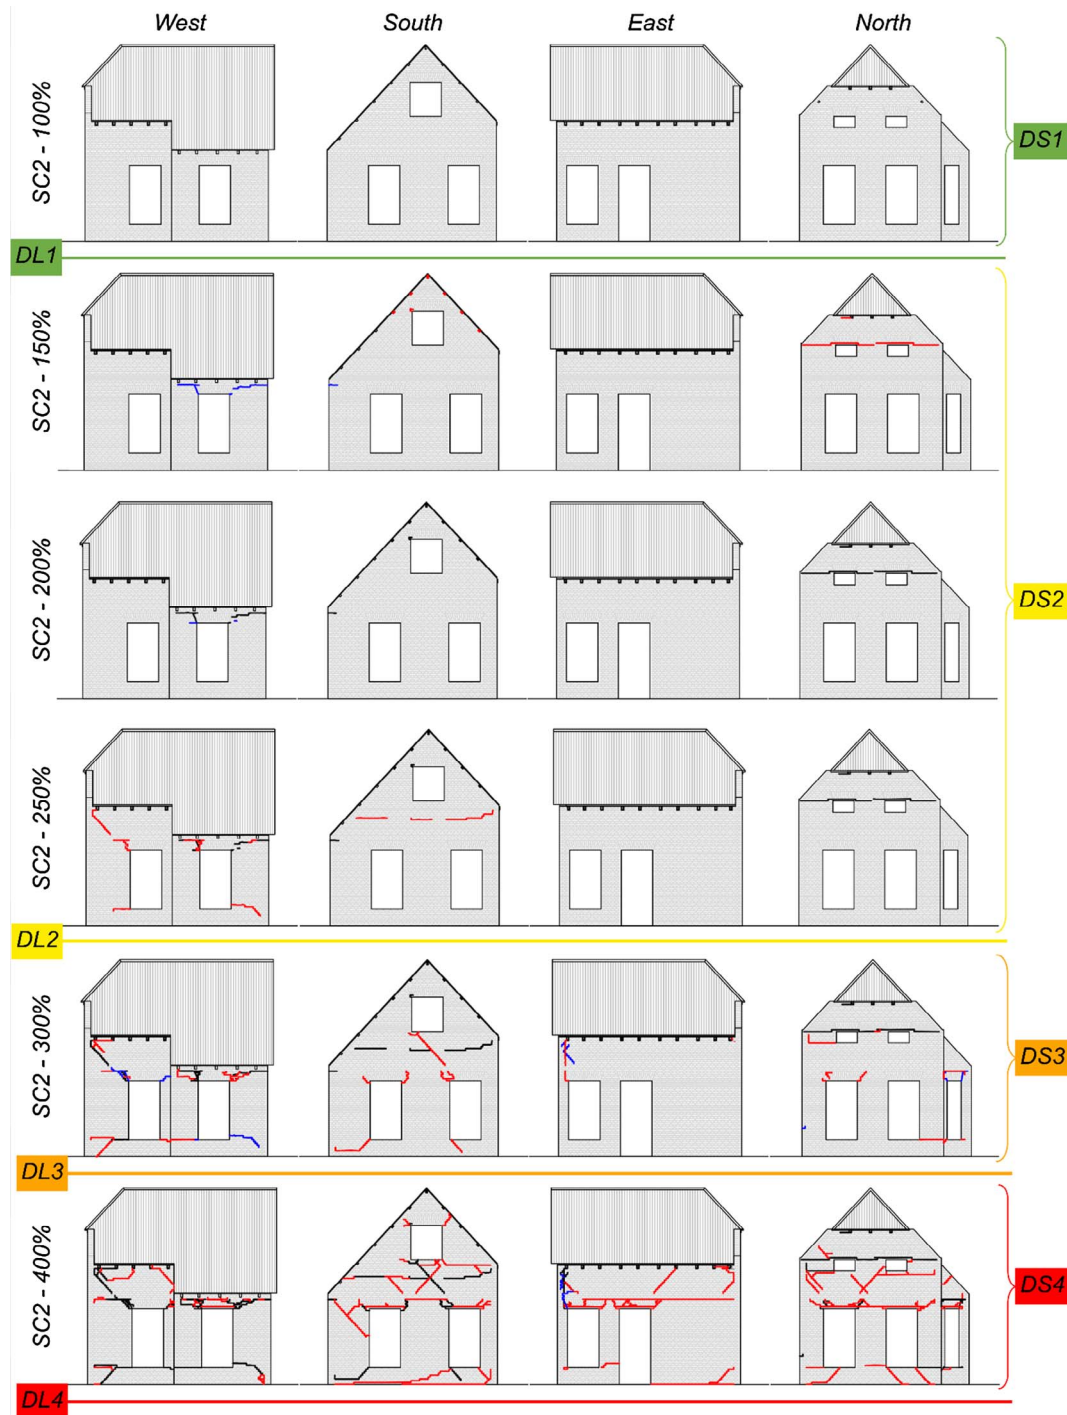
Fig. 13. Evolution of the specimen crack pattern. Cracks marked in red were observed from inside, in blue from outside. Cracks marked in black were already detected in previous test runs. (For interpretation of the references to colour in this figure legend, the reader is referred to the web version of this article.)

At the end of every shaking test, structural damage was surveyed in detail and cracks were accurately mapped. Fig. 13 shows the evolution of the overall damage pattern. Cracks marked in red and blue were observed at the end of the annotated test run on the internal and external side of the walls, respectively. Cracks shown in black had already been detected after previous shaking runs.
