Experimental campaign of horizontal cladding wall panels connection in industrial precast reinforced concrete buildings

September 2024

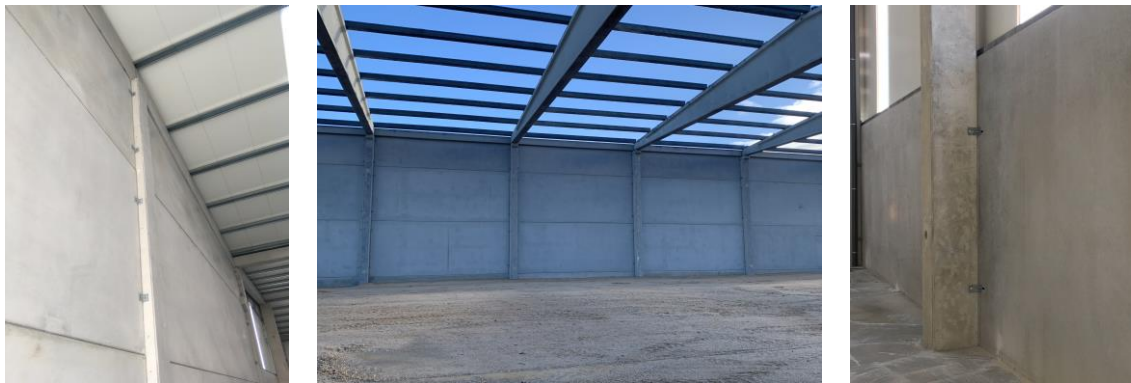
Figure 1 - Typical Portuguese industrial building with horizontal cladding panels.

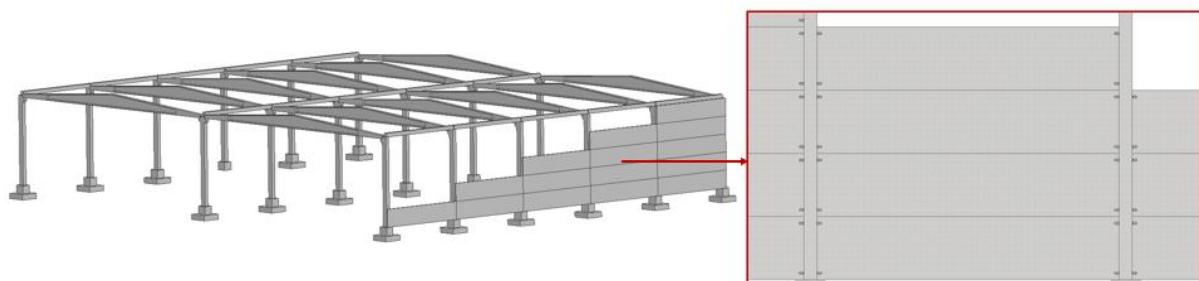
Figure 2 – Three-dimensional overview of an industrial PRC building with façade panels and associated connections.

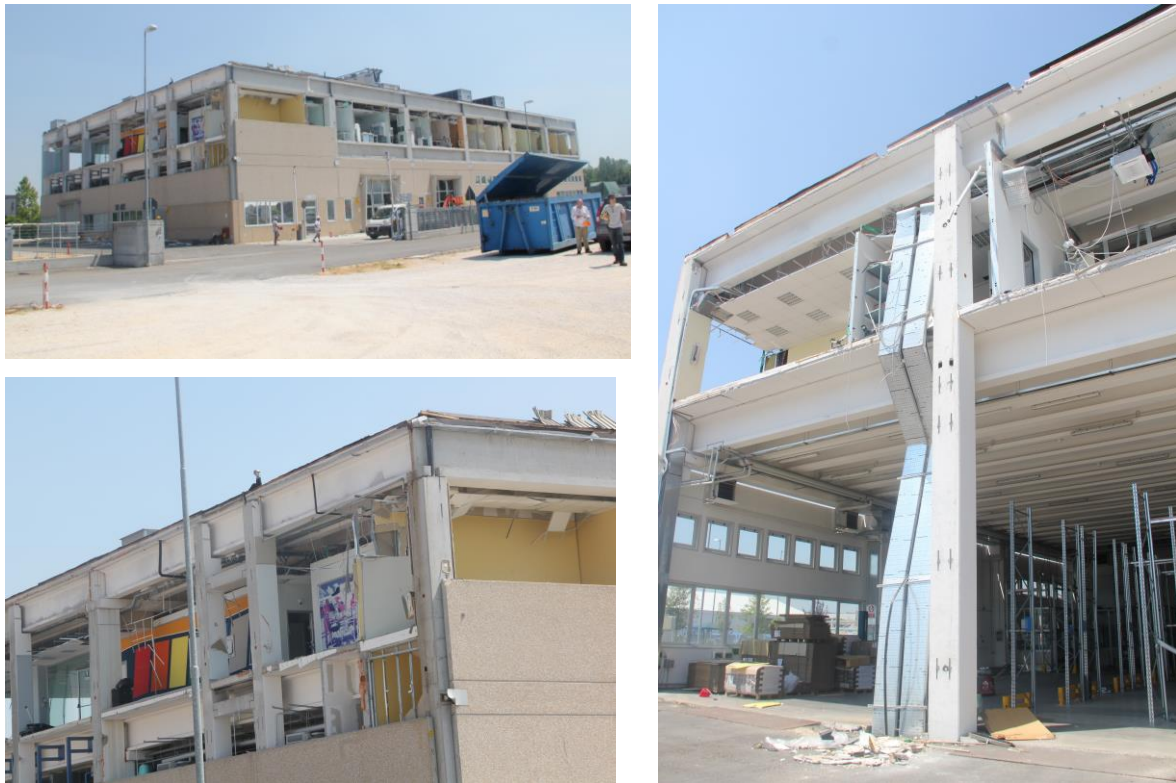
Figure 3 – Precast cladding failures.

During recent earthquakes in Italy and Turkey, several precast buildings have exposed their vulnerability, highlighting structural and non-structural damages, most related to deficient transferring of horizontal forces, namely in the connections between elements (Arslan et al., 2024; Batalha et al., 2019; Sagbas et al., 2024). According to Del Monte et al (Del Monte et al., 2019), Italian earthquakes, such as L'Aquila 2009 and Emilia 2012, have emphasized some critical issues in the behavior of cladding-to-structure devices used in the past (Figure 3). The damage observed in these recent earthquakes showed that these elements can have a significant contribution on the structural behavior of the building and should be considered when designing the structure (Arslan et al., 2024; Batalha et al., 2019; Bellotti et al., 2023; Lamperti Tornaghi et al., 2022; Magliulo et al., 2015; Ostetto et al., 2021, 2023). Cladding-to-structure connections play key roles in the safety, performance, and economics of both the cladding system as well as the main structure itself (Del Monte et al., 2019).

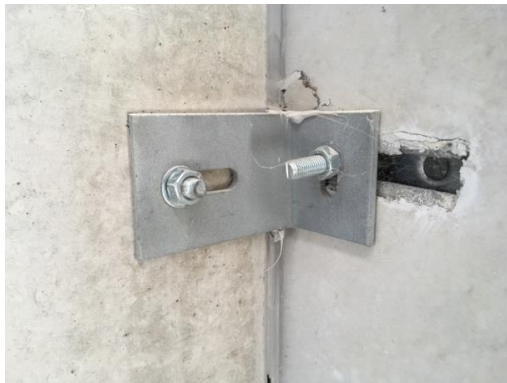
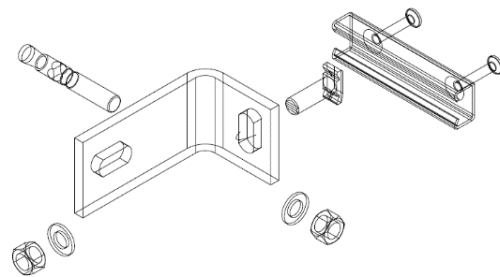
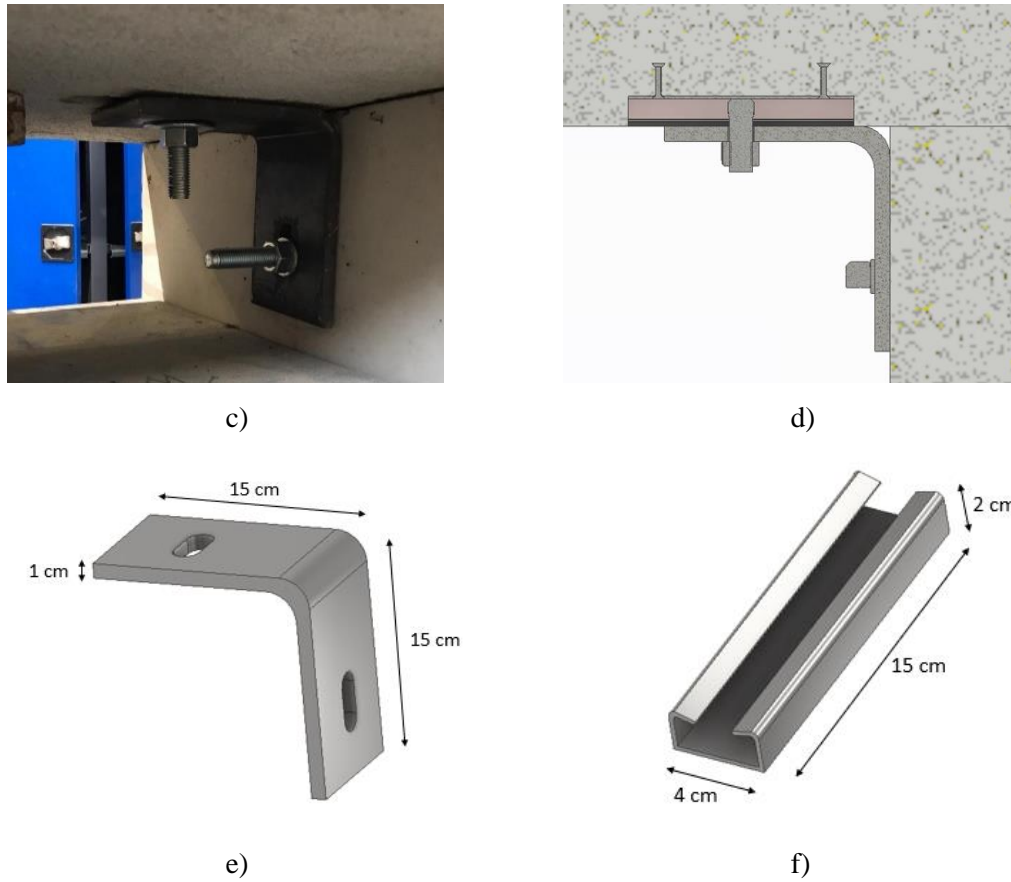
Figure 4 - Details of cladding-to-column connection: a) Commonly used connection; b) Connection accessories; c) Connections used in the tests; d) Front view of the connection; e) Steel angle plate dimensions; f) Channel dimensions.

The experimental campaign is focused on the configuration of Isostatic Sliding-Frame for horizontal panels. This type of non-load-bearing connection is usually composed of anchor channels pre-installed in the panels, steel angle plate fixed with a hammerhead bolt, nuts, washers, and bolts to fix the steel angle plate on the columns. The hammerhead bolts are for anchoring the channels and they are provided with sliding blocks to prevent them from locking, so that they can slide freely inside the channel profile. (Figure 4).

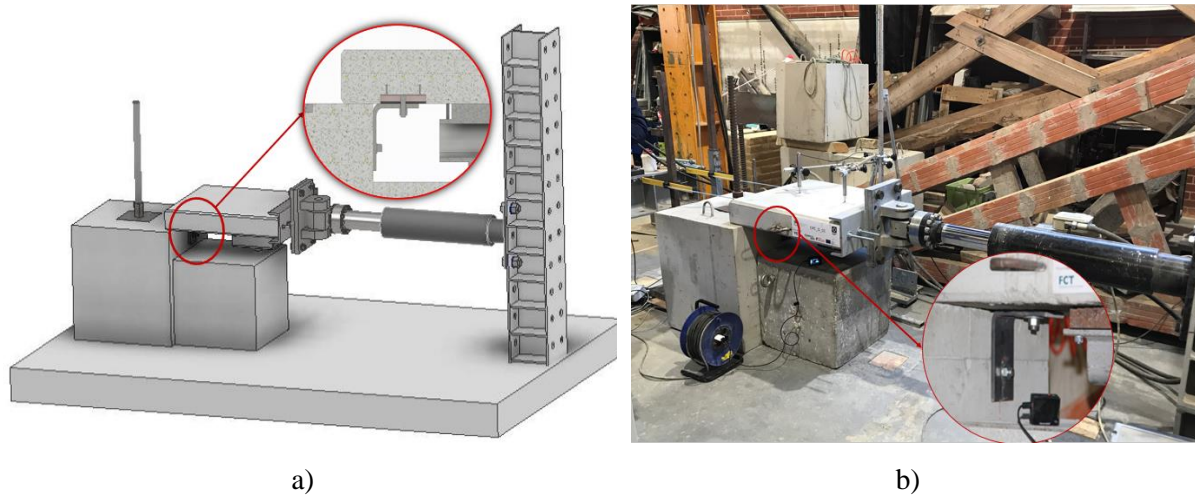
Figure 5 – Schematic testing of the cladding-to-column connection in-plane: a) Test scheme; b) General view.

Two test systems were developed to characterize the in-plane (Figure 5) and out-of-plane (Figure 6) behavior of the cladding-to-column connection. The detail of the specimens was established through the work of the typical properties of Portuguese industrial precast buildings presented by Rodrigues et al. (Rodrigues et al., 2020) to represent a cladding-to-column connection of a typical Portuguese industrial PRC building. The tests are based on quasi-static cyclic tests of the hysteretic type, according to recommendations of FEMA 461 (FEMA 461, 2007). The connection is located at the end of the panel with the column. To ensure the fixation of the column, it was fixed to the reaction slab with a prestressing of 400kN in all the tests.

The in-plane tests (Figure 5) were carried out through a horizontal displacement imposed by a hydraulic actuator with a maximum capacity of 200 kN and ± 400 mm stroke. The actuator was positioned to be centered horizontally with the connection.

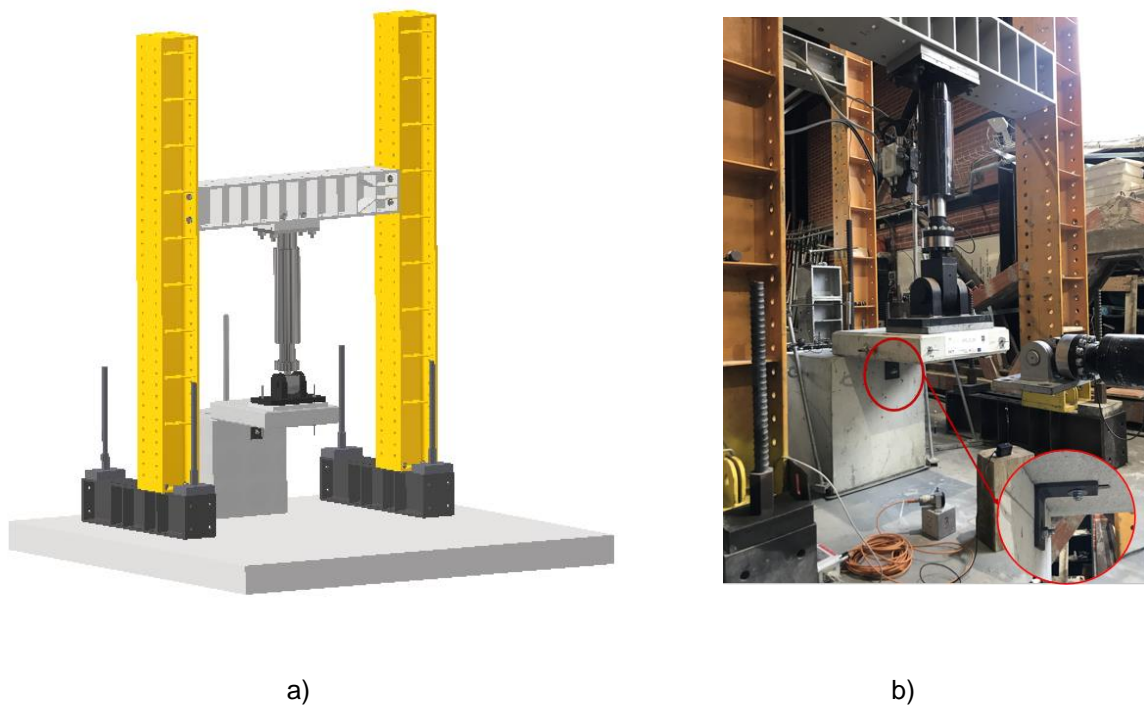
Figure 6 - Schematic testing of the cladding-to-column connection out-of-plane: a) Test scheme; b) General view.

The out-of-plane tests (Figure 6) were carried out through a vertical displacement imposed by a hydraulic actuator with a maximum capacity of 200 kN and a stroke of ± 200 mm. The actuator was positioned vertically, to be centered with the connection.

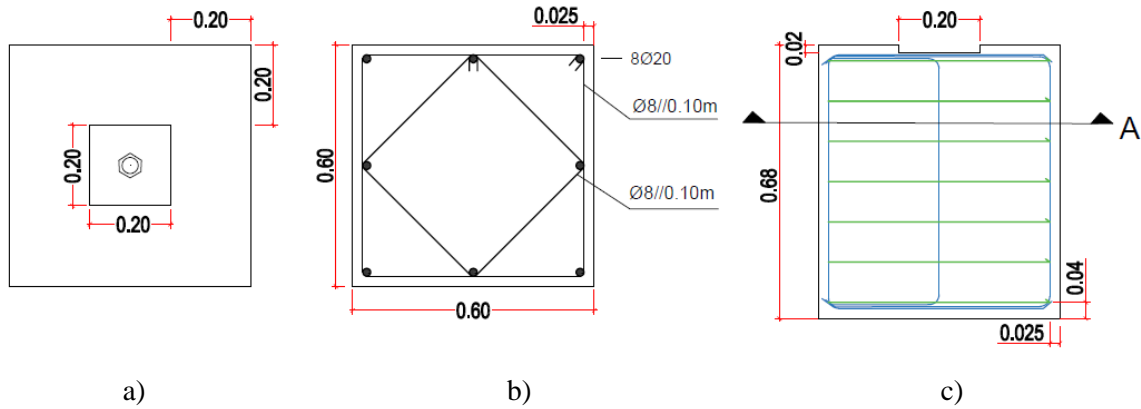
Figure 7 - Columns detailing: a) Top view; b) Section A; c) Front view.

The detailing of the columns is presented below in the Figure 7. The columns have a rectangular cross section of $0.60 \times 0.60 \text{ m}^2$ with 0.68 meters high, the longitudinal reinforcement comprises eight 20 mm diameter bars and, on the transverse reinforcement, of 8 mm diameter stirrups spaced at 0.10 m. All the

specimens have a 25 mm of cover. The columns have been fixed through a 40 mm diameter bar from the specimen's center to the reaction floor.

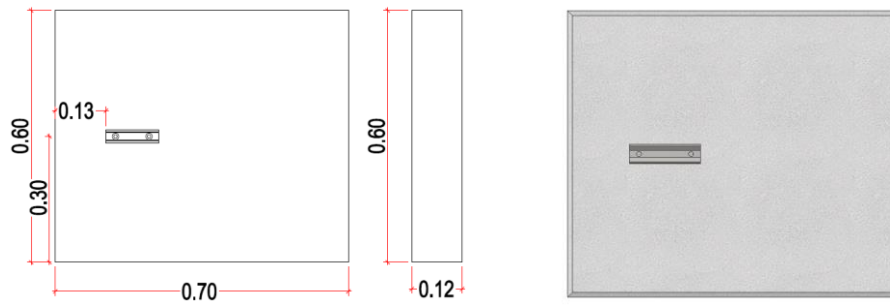
Figure 8 - Panel detailing.

Regarding the panel, a fraction of the facade panel was considered (0.12x0.7x0.6m), corresponding to the model typically adopted for facade panels of 12cm thickness, present in Figure 8.

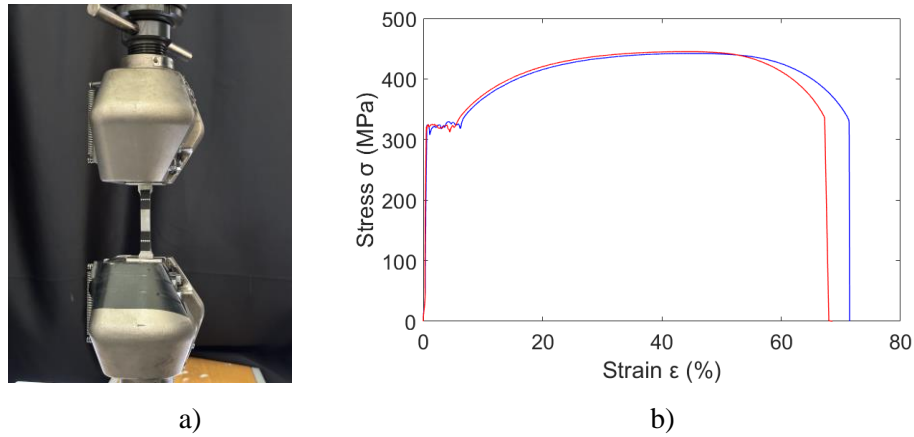
Figure 9 - Material property diagram of steel angle: a) Tensile Test; b) Stress(σ)-Strain (ϵ) curves.

The connection comprises an M16 bolt for securing the steel angle to the column and an M16 T8.8 hammerhead bolt for anchoring the channels. To obtain precise data on the properties of the steel angle (Figure 4e) used, tensile tests were conducted on two specimens cut from the steel angle. The specimens measured 10.08 mm in width and 0.3 mm in thickness. The test results were employed to generate simplified material models of stress (σ) versus strain (ϵ) curves. The tests validated that the material

corresponded to the S275 steel class. The stress-strain diagram of the steel specimens is presented in Figure 9.

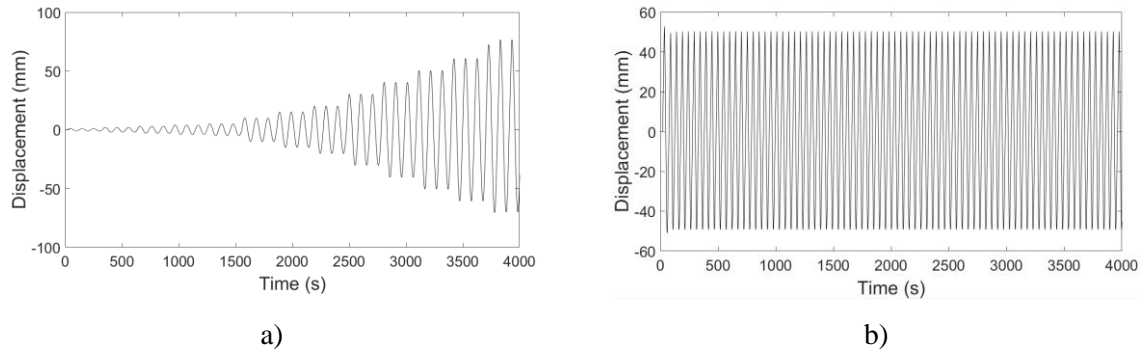
Figure 10 - Imposed displacement-time histories: a) Increase in amplitude; b) Sinusoidal.

For the cyclic loading protocol applied with a sinusoidal cyclic displacement increasing amplitude, displacements history at frequency of 0.01 Hz. This displacement history was designed to capture stiffness and strength degradation through cycle repetition. Each displacement level was repeated three times, with increments from 0 to 5 mm in 1 mm steps, from 5 to 20 mm in 5 mm steps, and from 20 to 100 mm in 10 mm steps (see Figure 10a). The test protocol and velocities are similar to the tests performed on friction connections used by different authors (Dal Lago et al., 2017b; Dal Lago & Lamperti Tornaghi, 2018), where was also verified that cyclic tests performed with a reduced speed reach very similar results with respect to those performed at full speed.

For the sinusoidal cyclic loading, displacements were applied at a frequency of 0.025 Hz with a displacement of 50 mm. The objective of this test was to capture stiffness and strength degradation through continuous repetition without contact with the concrete (see Figure 10b).

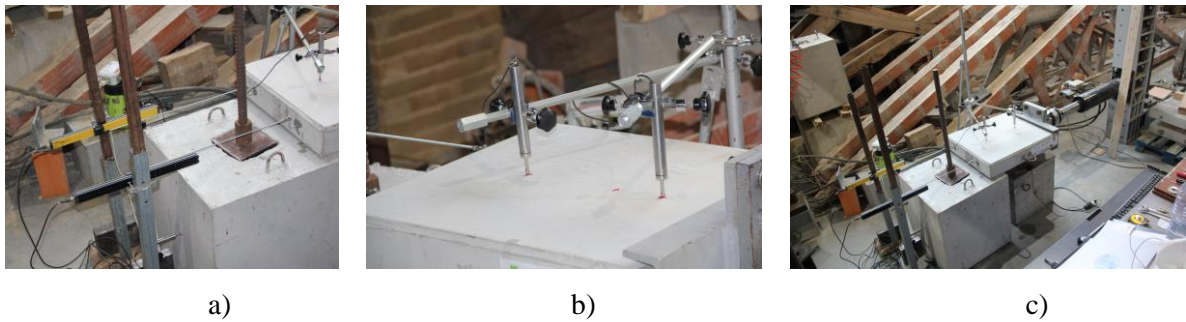
Figure 11 - Displacement instrumentation scheme adopted in the in-plane test a) Transducers on the side of the panel; b) Transducers at the top of the panel; c) General view.

The imposed load was monitored through a load cell, and the applied displacement was measured using external displacement transducers. The instrumentation scheme adopted for in-plane tests is presented in Figure 11. Two displacement transducers (LVDT) were positioned at the top of the panel to control the rotation (Figure 11b), and another two on the side of the panel to control the displacement (Figure 11a). An extra LVDT was positioned at column level to control possible elevation/rotation of the column lateral.

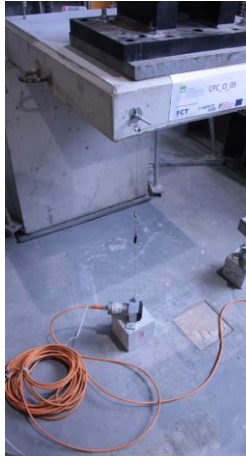
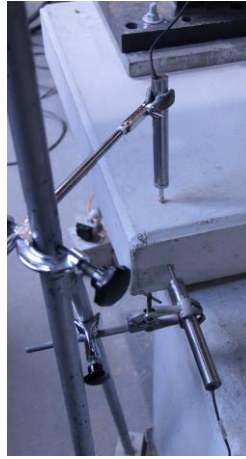
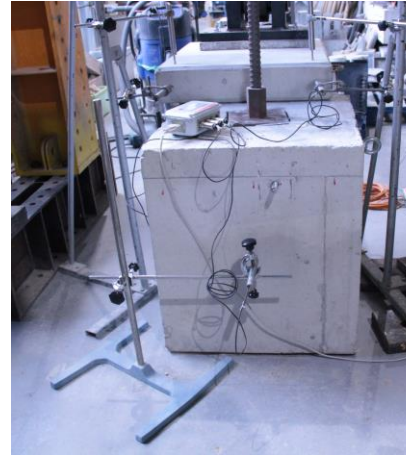
Figure 12 - Displacement instrumentation scheme adopted in the out-of-plane test: a) Transducers on the front side of the panel; b) Transducers on the top and side of the panel; c) Transducer at the column.

For the out-of-plane tests, two LVDTs were used on the front side of the panel to control the displacement (Figure 12a), a further two on the top of the panel and two on the side of the panel to control the rotation (Figure 12b). An additional LVDT was positioned at the column level to check any column lift/rotation (Figure 12c).

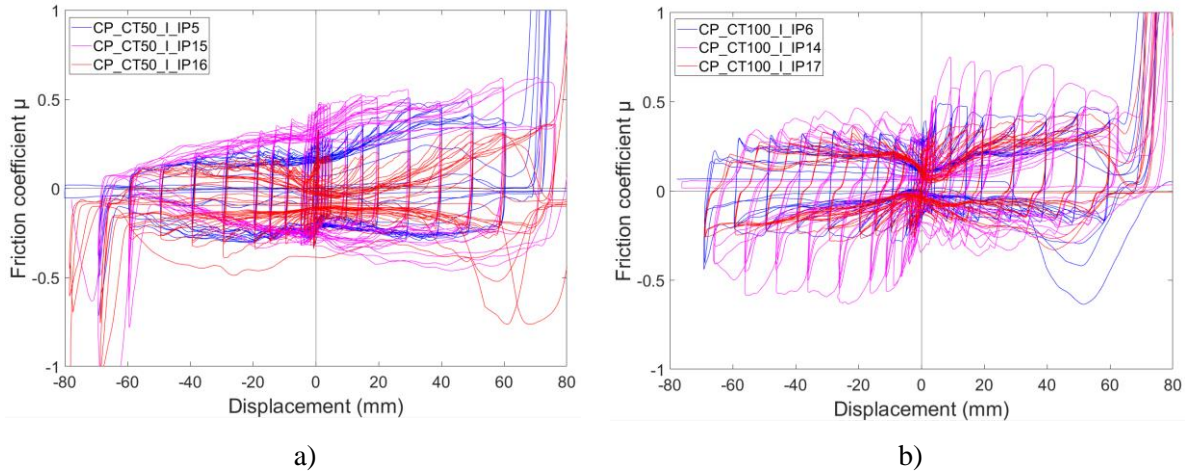
Figure 14 - Friction-displacement curves from in-plane tests: a) 50 N.m tightness; b) 100 N.m tightness.

where, T is the hammerhead bolt tightness, K is a constant that depends on the bolt material and size, assumed to be 0.2, and d is the bolt diameter. Figure 14 shows the friction of in-plane tests, differentiated by bolt tightness. It should be mentioned that after 60/70 mm, the hammerhead bolt reached the end of the channel and, for this reason, the force observed was no longer correlated to the friction.

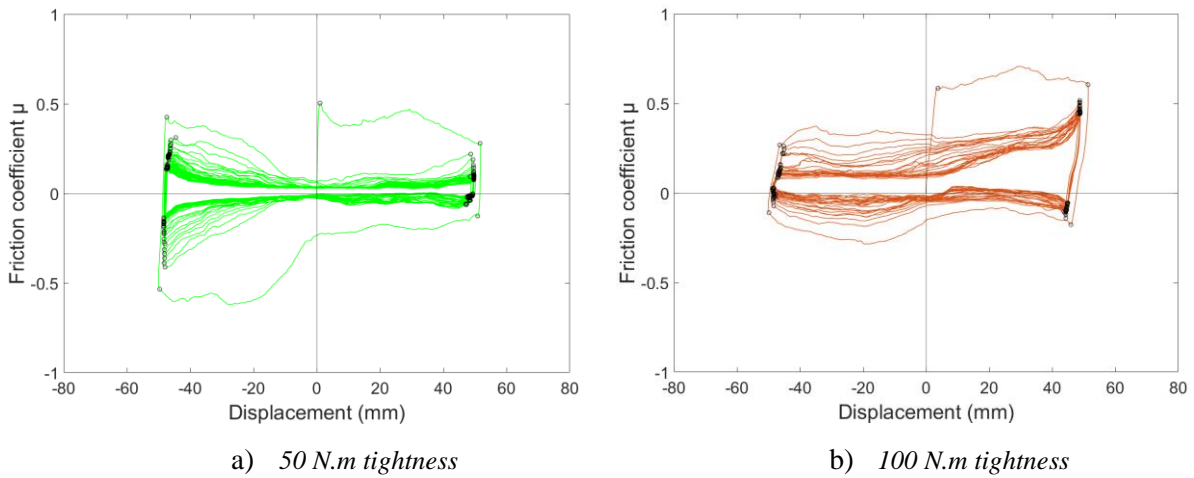
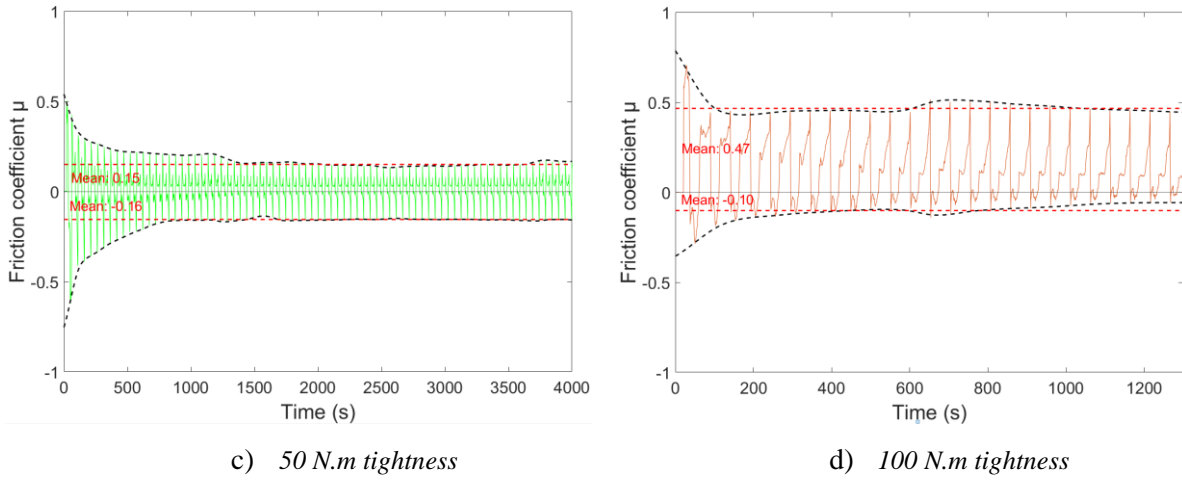
Figure 15 – Friction-displacement and friction-time curves from in-plane tests, of sinusoidal loads with static and dynamic coefficients of friction:

The friction static μ_s and dynamic μ_D coefficients were evaluated from the friction-displacement curves with sinusoidal imposed displacement. The static coefficient is calculated at the points where the absolute value of the force is maximum, while the dynamic coefficient is calculated at the points where the displacement is zero, as shown in Figure 15. The dynamic coefficient is represented in the figure by positive and negative averages. Figure 15c and 15d show the friction versus time curves for both tests. The red dashed line highlights the trend of the mean μ values, and the black dashed line highlights the trend of the maximum μ values.

The average static coefficient for the test with 50 N.m tightness in the hammerhead bolt was 0.13, while the average dynamic coefficient was 0.02. For the test with 100 N.m tightness in the hammerhead bolt, the average static and dynamic coefficients were 0.19 and 0.1, respectively.

Both the static and dynamic friction coefficients demonstrated a reduction over time, which can be attributed to the wear of the contact surfaces between the channel, steel angle plate and hammerhead bolt.

With regard to the friction-time curves, the difference between bolt tightness, both in terms of overall shape and values, is confirmed here. During the test with higher tightness, the friction coefficient declines rapidly from approximately 0.78 to 0.43 and stabilizes as shown in Figure 15d. Conversely, in the case of the test with medium tightness, the friction coefficient decreases gradually and reached a stable value of approximately 0.15 after 1400 seconds (Figure 15c).

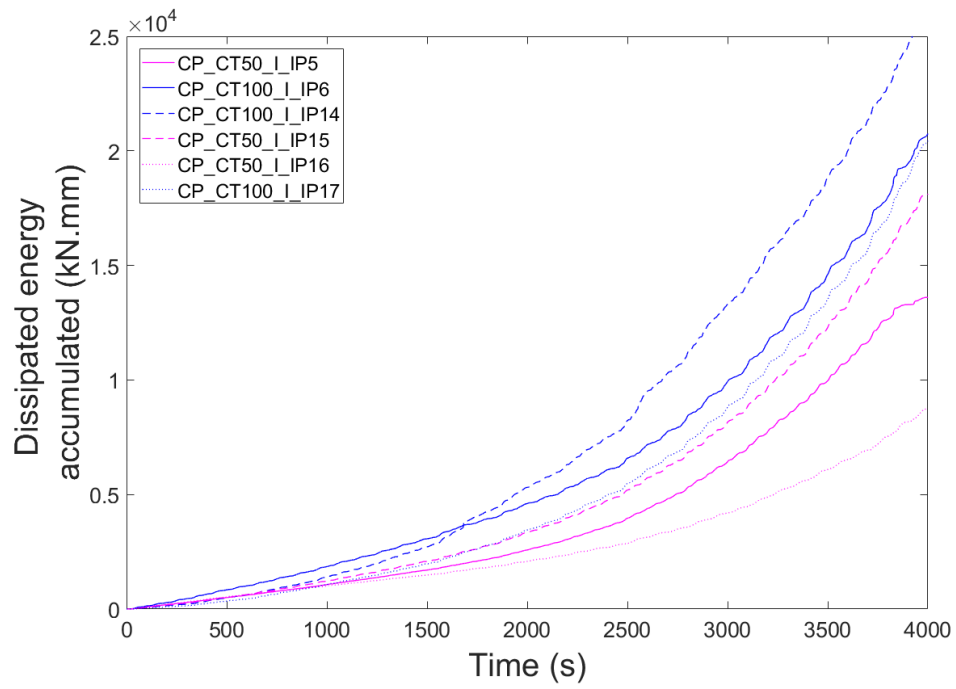
Figure 16 - Dissipated energy in-plane tests.

This subsection presents and discusses the dissipated energy observed in in-plane tests. Figure 16 illustrates the curves corresponding to all tests with increased displacement amplitude, showcasing the accumulated dissipated energy throughout the tests. The dissipated energy was calculated by summing the interior area of the force-displacement cycles.

These findings show that the energy dissipation capacity increases with higher bolt tightening. On average, there is a 25% increase in accumulated dissipated energy at the beginning of the test and a 40% increase by the end of the test with increased bolt tightening.

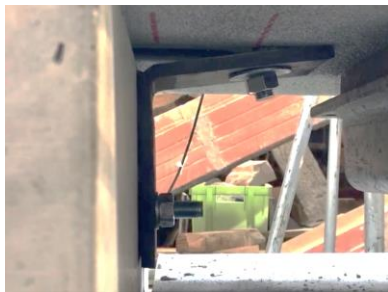
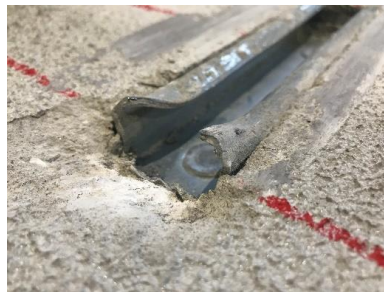
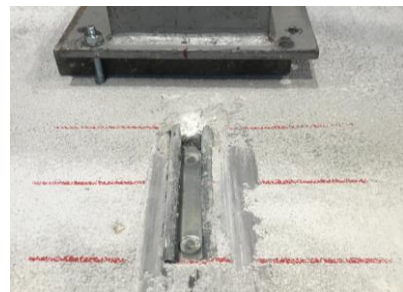
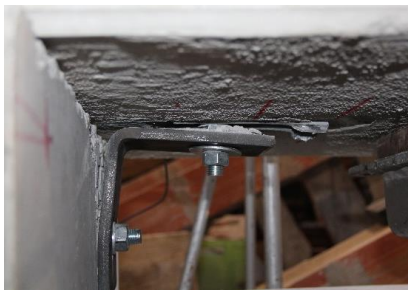
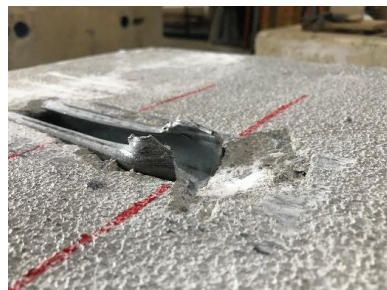
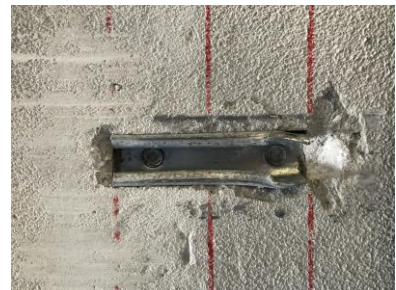
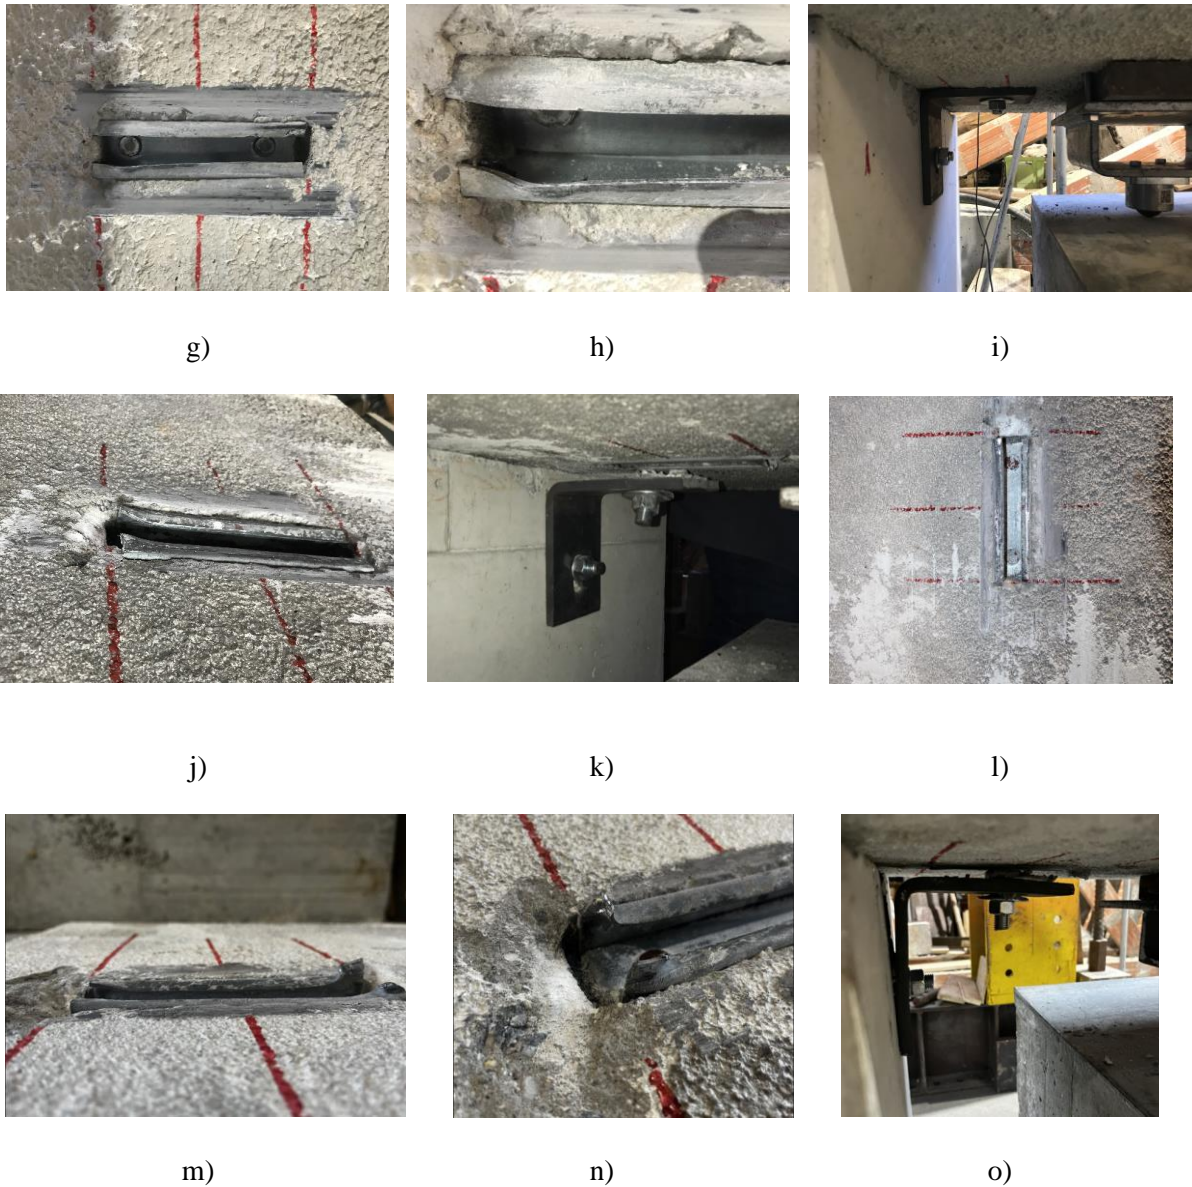
Figure 17 - Damages in the specimens from in-plane tests: a) Deformation of the angle plate CP_CT50_I_IP5; b) Failure of the channel CP_CT50_I_IP5; c) Panel after failure CP_CT50_I_IP5; d) Collapse of the anchor channel CP_CT100_I_IP6; e) Failure of the channel CP_CT100_I_IP6; f) Panel after failure CP_CT100_I_IP6; g) Channel deformation, no failure CP_CT100_S_IP7; h) Channel deformation CP_CT100_S_IP7; i) Angle plate not damaged CP_CT100_S_IP7; j) Failure of the channel CP_CT100_I_IP14; k) Collapse of the anchor channel CP_CT100_I_IP14; l) Panel after failure CP_CT100_I_IP14; m) Failure of the channel CP_CT50_I_IP16; n) Failure of the channel CP_CT50_I_IP16; o) Collapse of the anchor channel CP_CT50_I_IP16.

The most representative damages observed in each specimen from in-plane tests are presented in Figure 17, in the respective order of the tests.

The in-plane tests were carried out until the hammerhead bolt was expelled in the end of the canal. With increased displacements, plastic deformations were observed in the channel pre-installed in the panel, particularly when the bolt slides through the entire channel and came into contact with the concrete. Additionally, deformations in the steel angle plate were observed at larger displacements when the panel is pushed, resulting in contact between the hammerhead bolt and the concrete and subsequent lifting of

the panel (see Figure 17a). It can be seen that failure of the pre-installed channel in the panel is the cause of the connection failure, as illustrated in Figure 17b, 17e, 17f, 17j and 17n, leading to the hammerhead bolt being pulled out of the channel (see Figure 17d, 17k and 17o). Overall, based on the observed damages, the tested connection demonstrates good in-plane behavior for both high and medium tightening levels. In the sinusoidal tests, no failures were observed in the connections, only some deformations in the channel, as shown in Figure 17g, 17h and 17i.

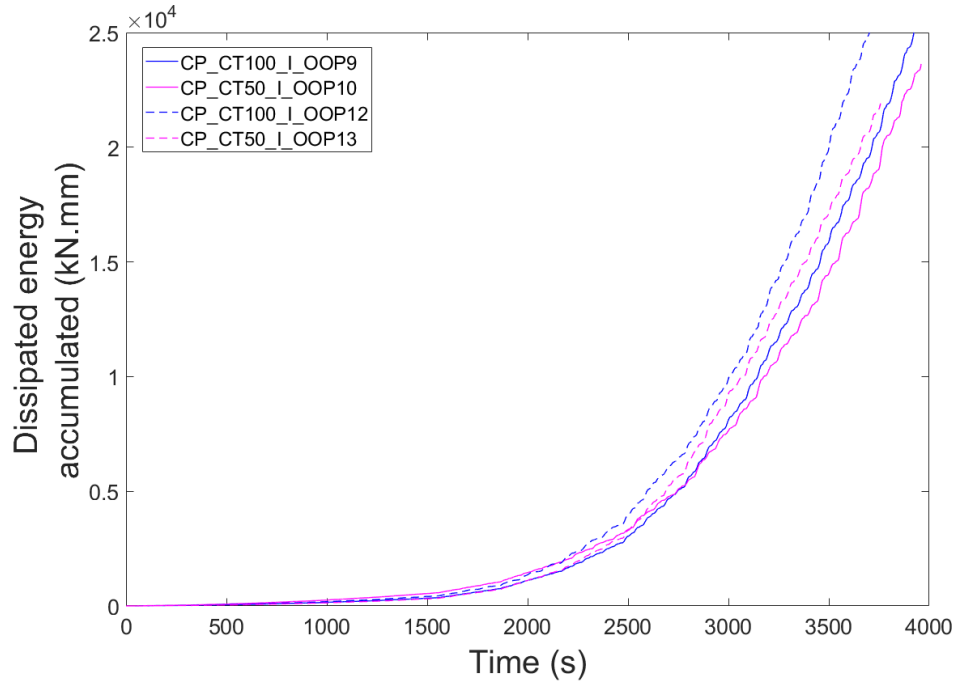
Figure 19 - Dissipated energy from out-of-plane tests

The energy dissipated in the out-of-plane experimental tests is presented and discussed in this subsection. Figure 19 presents the curves corresponding to all tests with increased displacement amplitude, and represents the dissipated energy accumulated throughout the test.

According to the results obtained, the out-of-plane tests also present an increase in the energy dissipation capacity with the increase in bolt tightness. However, the accumulated dissipated energy levels are more similar to those observed in the in-plane tests.

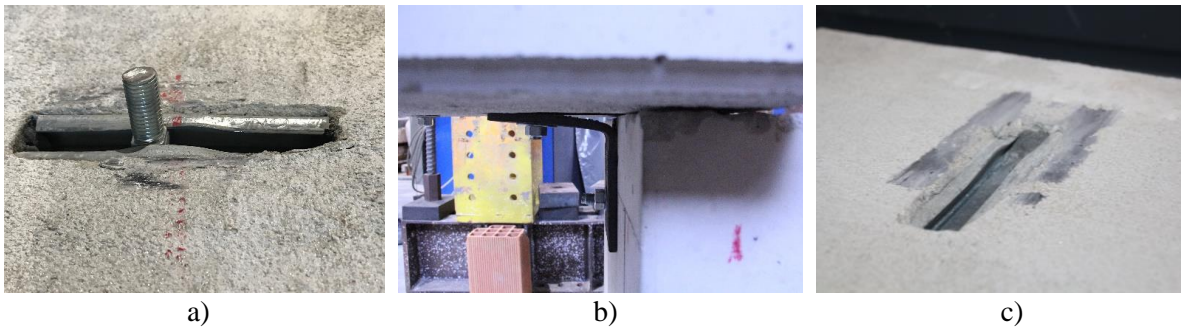
Figure 20 - Damages in the specimens from out-of-plane tests: a) Channel deformation, no failure CP_CT100_S_OOP9; b) Deformation of the angle plate CP_CT50_S_OOP10; c) Channel deformation, no failure CP_CT100_S_OOP11.

The most representative damages observed in each specimen are presented in Figure 20, in the order of the tests. In the out-of-plane tests, displacements reached up to 60 mm, which was the maximum allowed by the actuator due to its inclination and force capacity. No failures were observed in the connections during these tests, though some deformations were noted in the pre-installed channel in the panel and the angle plate, as shown in Figure 20. By the end of the tests, it was observed that the hammerhead bolt had lost its tightening tension.
