Nederlandse Aardolie Maatschappij B.V.

# Experimental campaign on RC buildings typical of the Groningen region: dynamic testing of a precast specimen

| LAB AND TESTS RESPONSIBLE | DOCUMENT AUTHOR | REVIEWER |
|---|---|---|
| Issue: 30/10/2017 | Document type:<br><br><b>Technical report</b><br>pages: 364 | File name:<br>EUC_BUILD5-test_campaign_report.pdf |

Brunesi E., Peloso S., Pinho R., Nascimbene R. (2017). *Dynamic testing of a full-scale two-storey RC precast wall-slab-wall structure representative of the Groningen building stock*. Report EUC215/2017U, European Centre for Training and Research in Earthquake Engineering (EUCENTRE), Pavia, Italy.

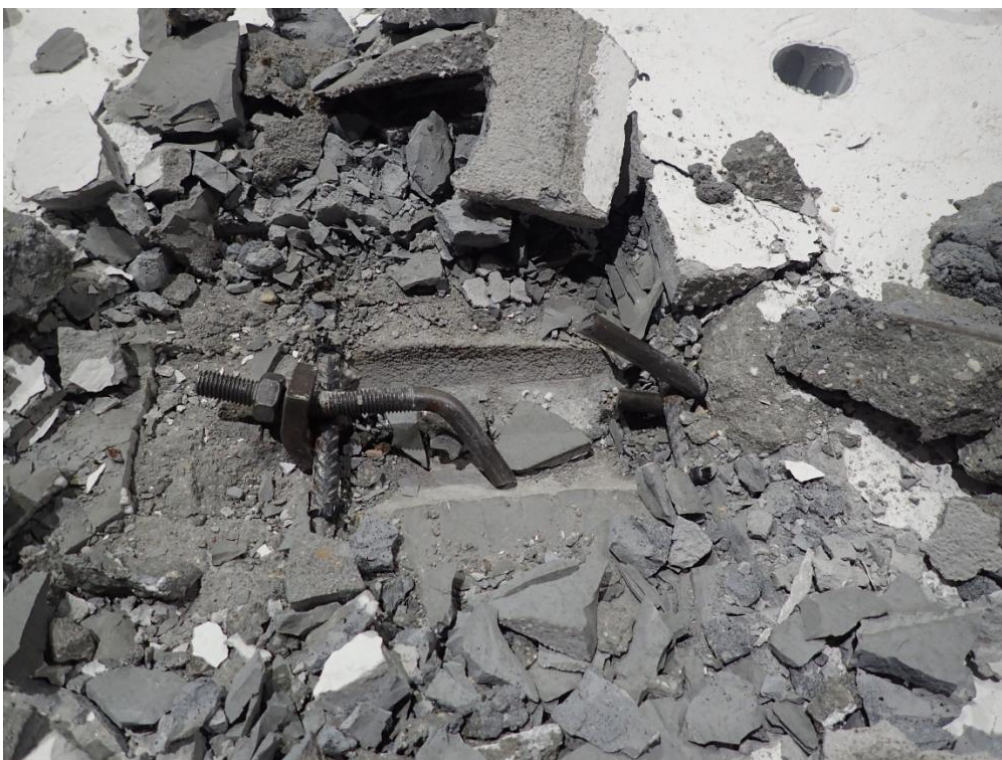
Figure 74 presents the axial force-axial displacement response curve obtained by the monotonic testing of specimen #1, whereas Figure 75 illustrates the type and level of damage for an imposed vertical displacement of 24 mm. It results evident that, after initial cracking, the two portions of the specimen were completely detached, apart from the mechanical connection or continuity ensured by the permanently bent steel connector lodged in the niche of the base portion of the specimen. A photograph showing the flexural failure mode of the upwardly-bent steel connector at the end of the test can be seen in Figure 76. It is worth specifying that this latter photo was taken after the removal of grout, when the steel connector had been already cut.

The specimen resisted a vertical force of about 13 kN for a displacement of 2 mm, after which value a drop in strength can be observed, since the force resisted at 5 mm was approximately equal to 10 kN. Due to a sort of catenary action mobilised by the steel connector, the resistance increased as the displacement was increased, and the specimen reached its maximum load-carrying capacity, which was slightly higher than 14 kN (for an imposed vertical displacement of about 23 mm). Once this displacement level was exceeded, softening started being observed because of the extensive damage (i.e. permanent flexural deformation) of the steel connector in the base connector socket.

**Figure 76. Failure mechanism of the steel connector at the end of the test (after cutting and removal of grout).**

Whilst the observed flexural failure mechanisms were very similar in form and type (see Figure 76, Figure 78, Figure 80, Figure 82 and Figure 84), the resistance was found to vary significantly, as far as the response of a specimen is compared to that of the other ones, and, in addition to that, the five curves had different variability for different levels of displacement. For displacements smaller than 5 mm, the capacity was shown to range approximately from 12 kN to 18 kN, with a mean of about 15 kN. The fork of the response curves narrows as the displacement increases, considering that a fairly constant resistance of about 14 kN was observed for displacements in the range 20-25 mm. The fork widens for larger displacements ranging from 25 mm to 35 mm, since softening was found in some cases and hardening in other ones. Failure and the subsequent strength drop started being observed for displacements slightly larger than 35 mm, though perhaps a 25 mm value constitutes a more sensible proposal as threshold for conventional failure of this type of connections/connectors.

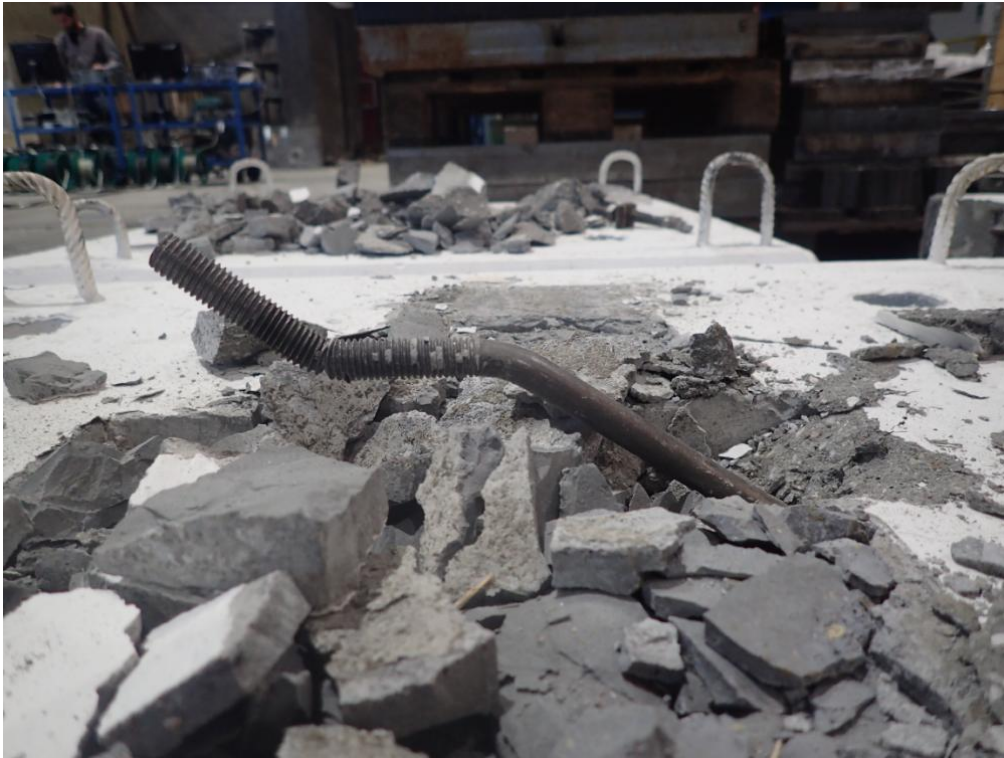
Figure 77 shows the cyclic force-displacement response curve of specimen #2, whereas the flexural failure mechanism of the steel connector is presented in Figure 78.

**Figure 78. Flexural failure mode of the steel connector – Specimen #2.**

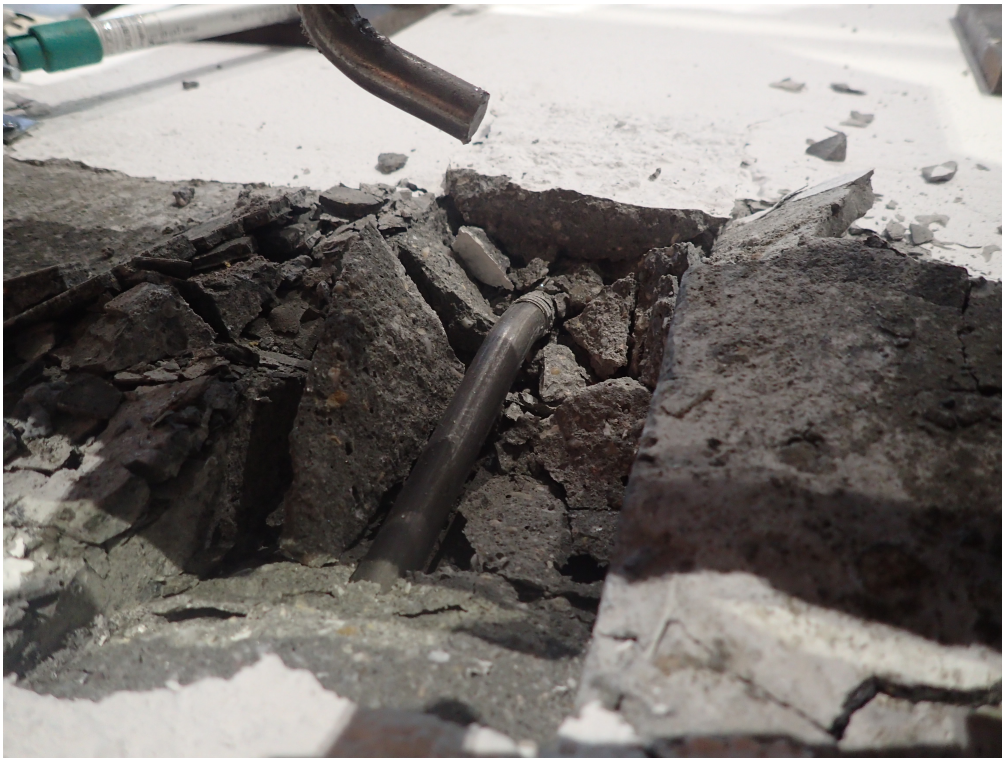
Figure 79 shows the cyclic force-displacement response curve of specimen #3, whereas the flexural failure mechanism of the steel connector is presented in Figure 80.

**Figure 80. Deformed shape of the two steel connectors at the end of the test – Specimen #3.**

As a general comment regarding damage/failure mechanism, it should be noted that, in some cases, the hook of the vertical connector opened up and the two portions of the specimen got disconnected, as shown by Figure 80.

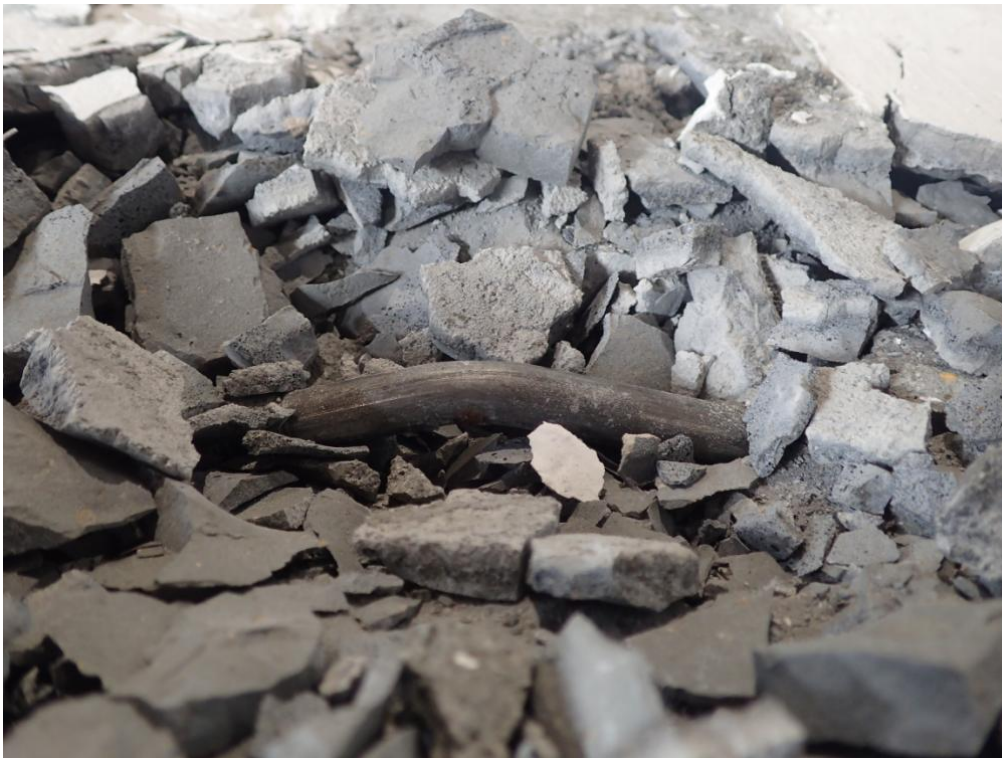
Figure 81 shows the cyclic force-displacement response curve of specimen #4, whereas the flexural failure mechanism of the steel connector is presented in Figure 82.

**Figure 82. Bending of the steel connector embedded in the bottom connector's socket – Specimen #4.**

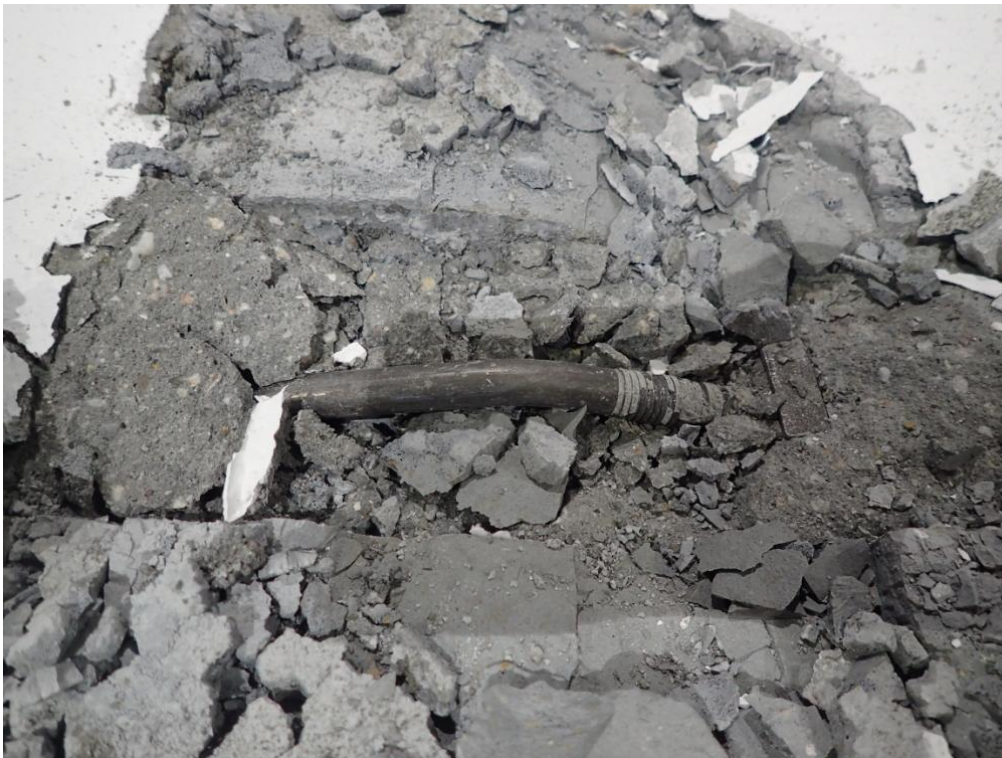
Figure 83 shows the cyclic force-displacement response curve of specimen #5, whereas the flexural failure mechanism of the steel connector is presented in Figure 84.

**Figure 84. Bending of the steel connector in correspondence to the anchoring region of the hook.**

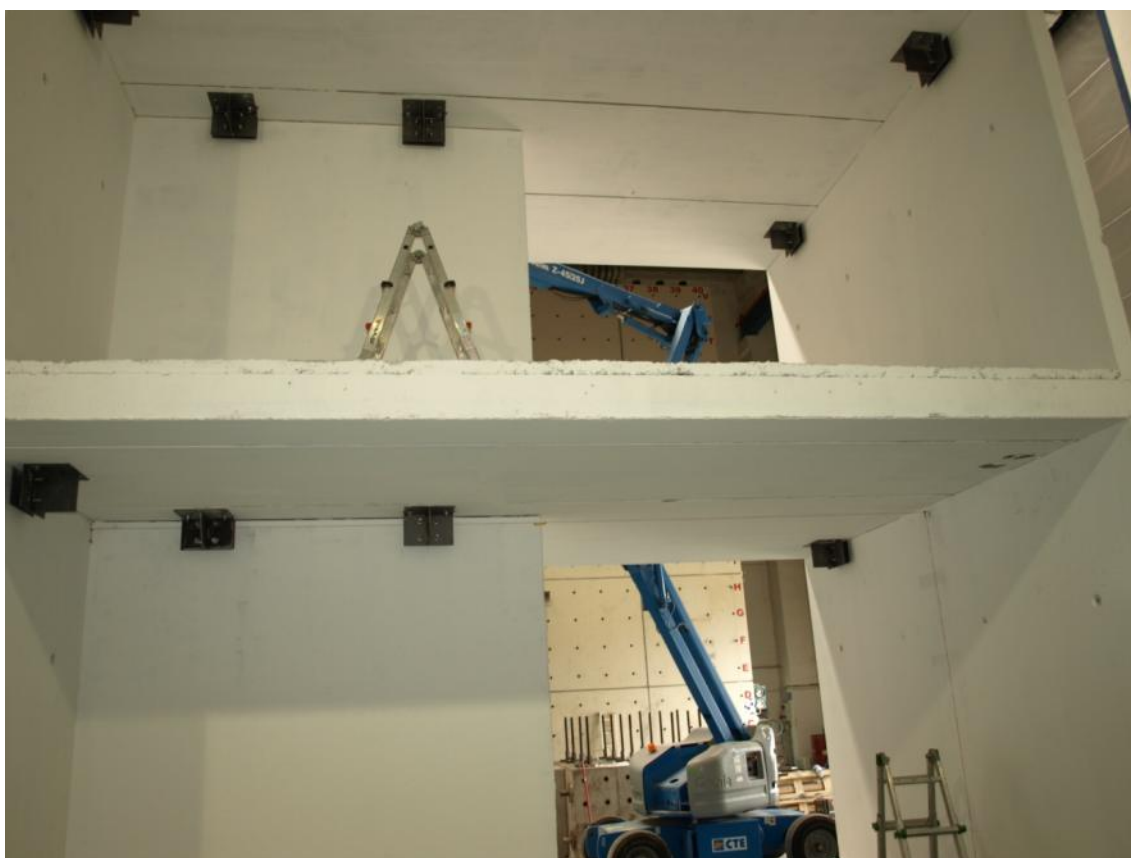
It is worthwhile to recall that although EUC-BUILD4 and EUC-BUILD5 specimens were conceived to be identical, the latter building featured after its erection a conspicuous gap between the stability walls and the floor slabs (and between the slab panels themselves), which instead was not at all evident in EUC-BUILD4. Construction process and details are thus of particular relevance and will be described extensively in a separate Section; detailed measurements of such gap, which was present at both first and second storeys, were taken and seemed to indicate the existence of a construction counter-flexure in the slab panels. Figure 93 presents a photograph of such gap.

**Figure 93. Gap between the stability walls and the slabs.**

After consultations with Groningen engineers and the Dutch contractor in charge of the construction process (i.e. Bouwborg), it was confirmed that during the erection of a building, when a gap is present, this is filled by means of the same non-shrink mortar employed for the other structural interfaces. Such a customary practice is usually operated in conjunction with the removal of the fabric felt layer so as to more effectively fill-in the gap.

In light of these considerations, the precast slab panels were propped-up to allow lab technicians to implement this intervention (see Figure 94). Further and more comprehensive details about these operations can be found in Section 5.3.

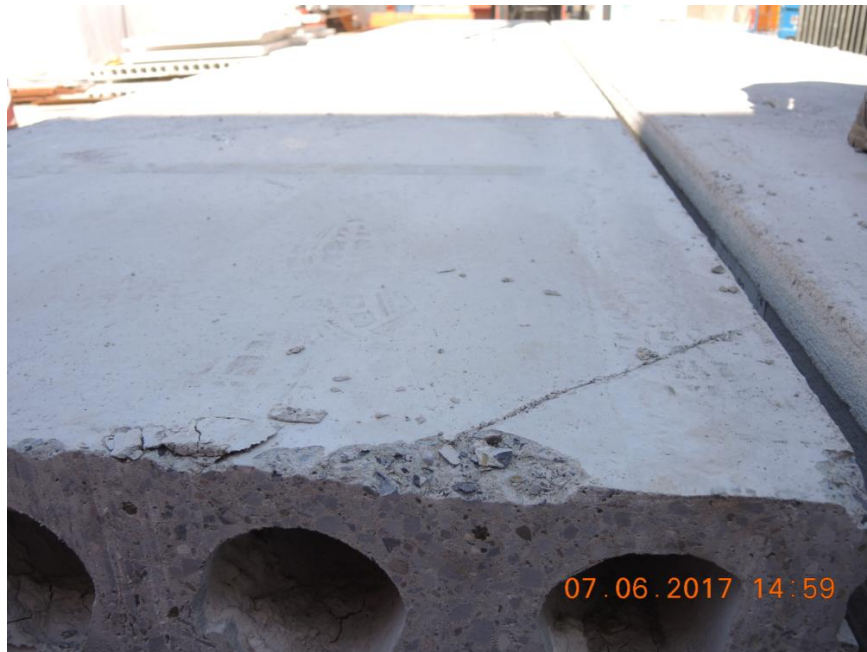
As far as the construction material is concerned, it can be noted that one of the slab panels featured a very minor “scratch” (see Figure 97), which clearly had no impact on its performance. One of the stability wall panels exhibited some damage in one of the lifting hook areas (see Figure 98), which again had no impact in the resistance of the panel.

**Figure 97.** Example of precast hollow core slab panel and detail of minor scratch at one of its ends.

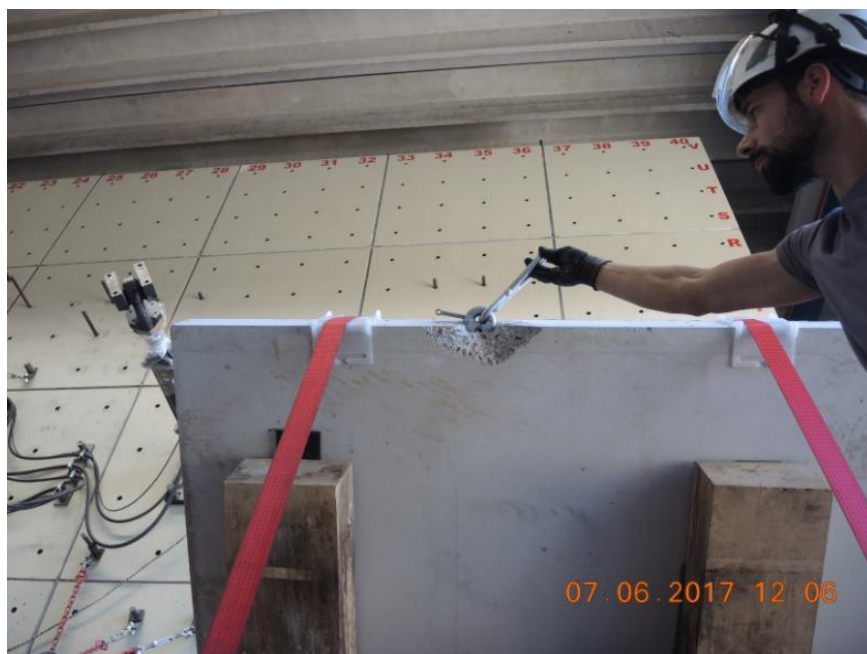
**Figure 98.** Detail of a stability wall panels featuring some damage in one of the lifting hook areas.

At close of the first day of construction, the first storey had already been erected without difficulties. The day after (i.e. June 20<sup>th</sup>), the second floor of EUC-BUILD5 was erected, thus allowing for the casting of the slabs topping to take place on the third day of construction, as initially planned. It can be reported that the damage observed in one of the stability walls (see Figure 98) did not affect the anchorage of the lifting hook.

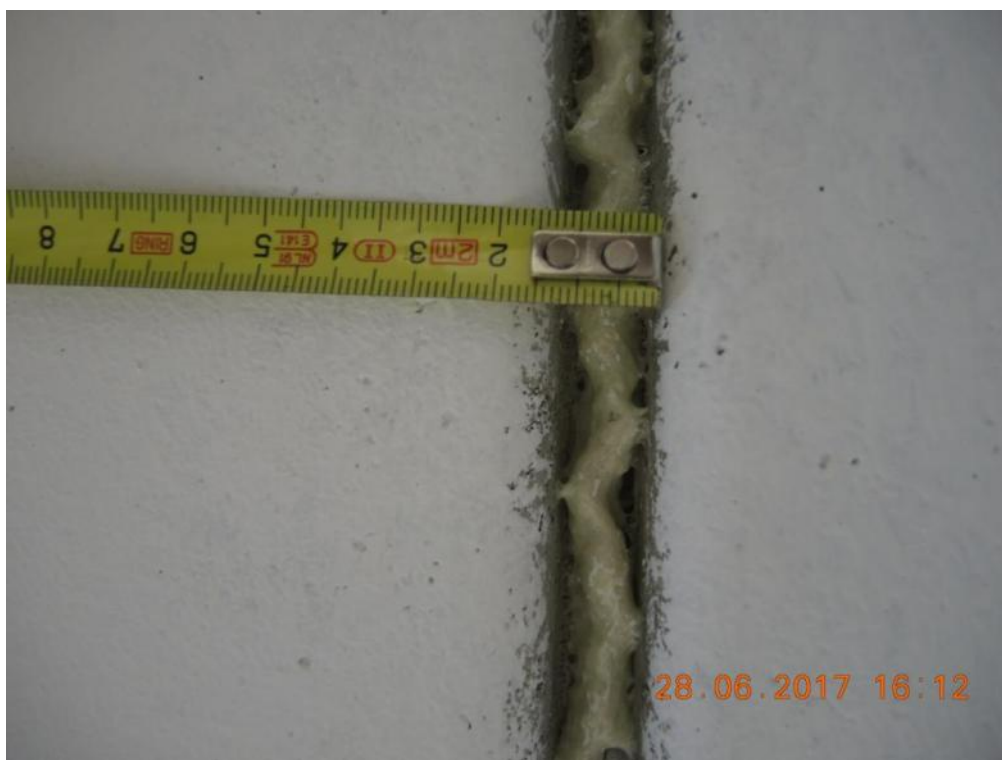
Once the construction of EUC-BUILD5 specimen had been completed, the structure was surveyed, and it was possible to notice the presence of a conspicuous gap between the stability walls and the slabs, which instead was not at all that evident in EUC-BUILD4. Different views of such gap can be observed from Figure 153 to Figure 155. Furthermore, Figure 156 and Figure 157 present photographs of the gap between the slab panels themselves. Detailed measurements of such a prominent gap, which seem to point out the existence of a construction counter-flexure in the slab panels, are presented in Figure 158.

**Figure 157. Enlarged view of the gap between the slab panels of EUC-BUILD5 specimen.**

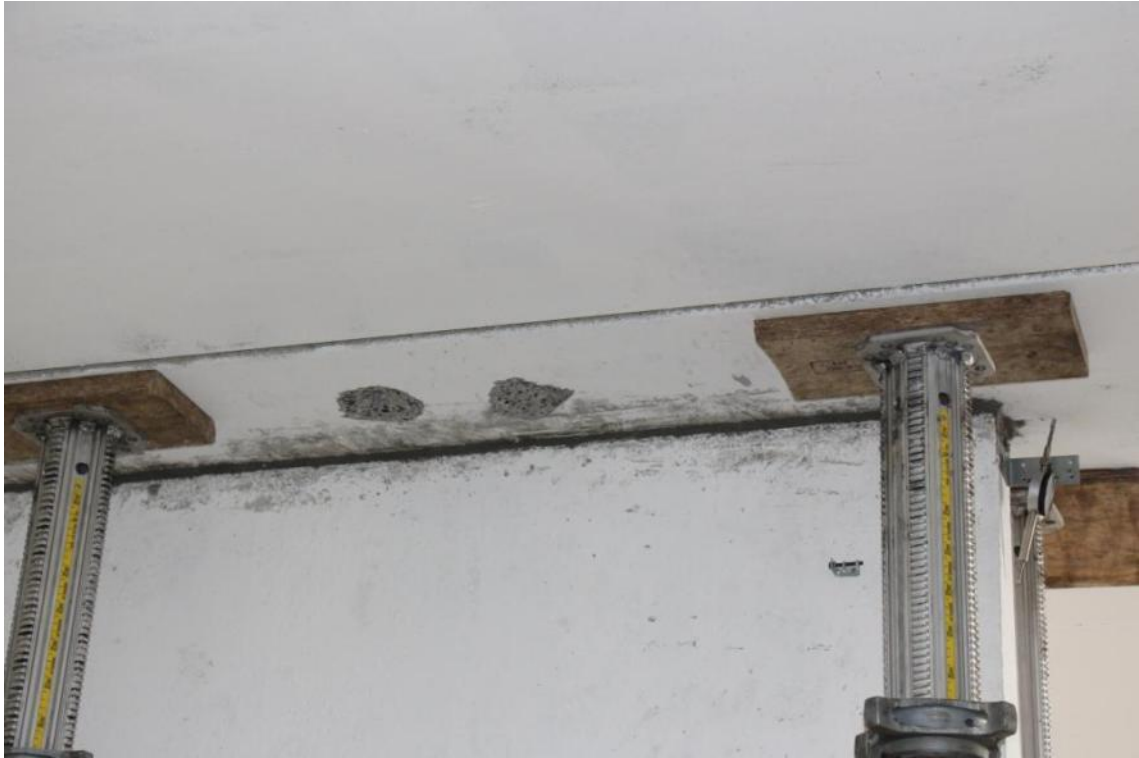
**Figure 160. Mortar filling intervention at the first-floor gap – Overall view of the mortar layer.**

As previously mentioned, laboratory technicians then implemented the “repair” intervention at the first and second storey of EUC-BUILD5 specimen, as documented by the following photographic sequence (Figure 159 to Figure 170). In particular, views of the mortar joint between the first-storey stability wall and the slabs are collected in Figure 159 to Figure 165, whilst details of the one between the second-storey stability wall and the slabs are documented in Figure 166 to Figure 170.

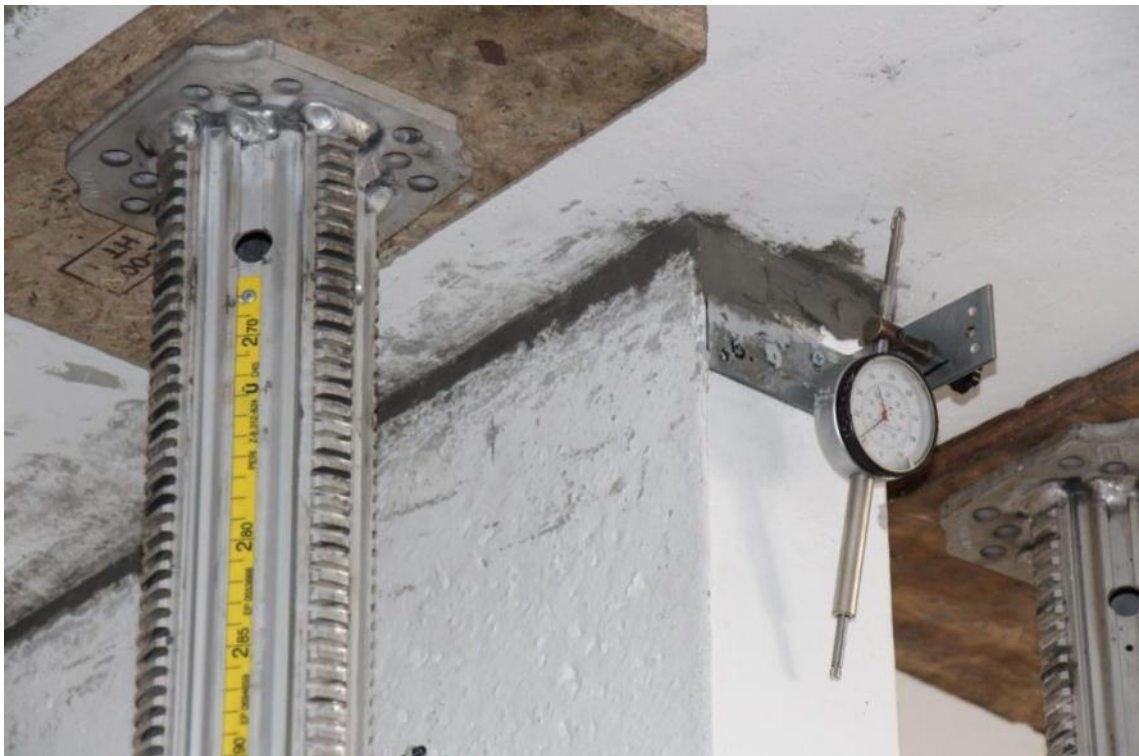
**Figure 161. Mortar filling intervention at the first-floor gap – Detailed view of the mortar layer.**

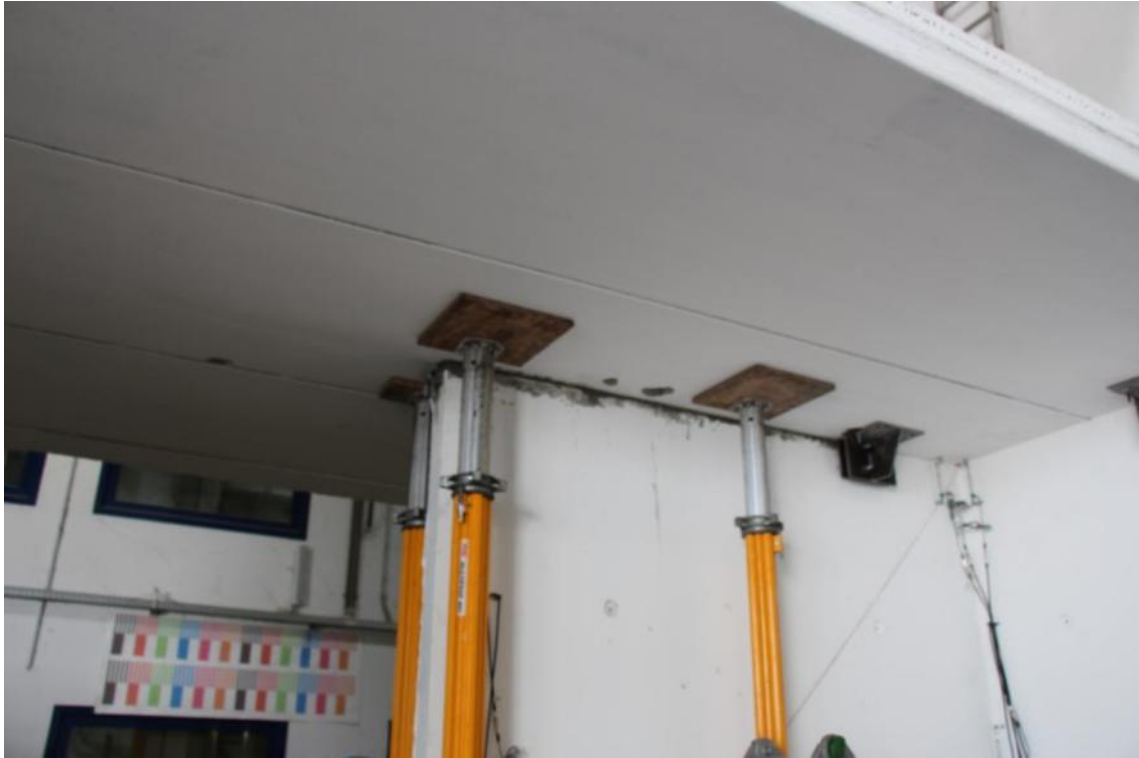
**Figure 162. Mortar filling intervention at the first-floor gap – Overall view of the West-sided wall face.**

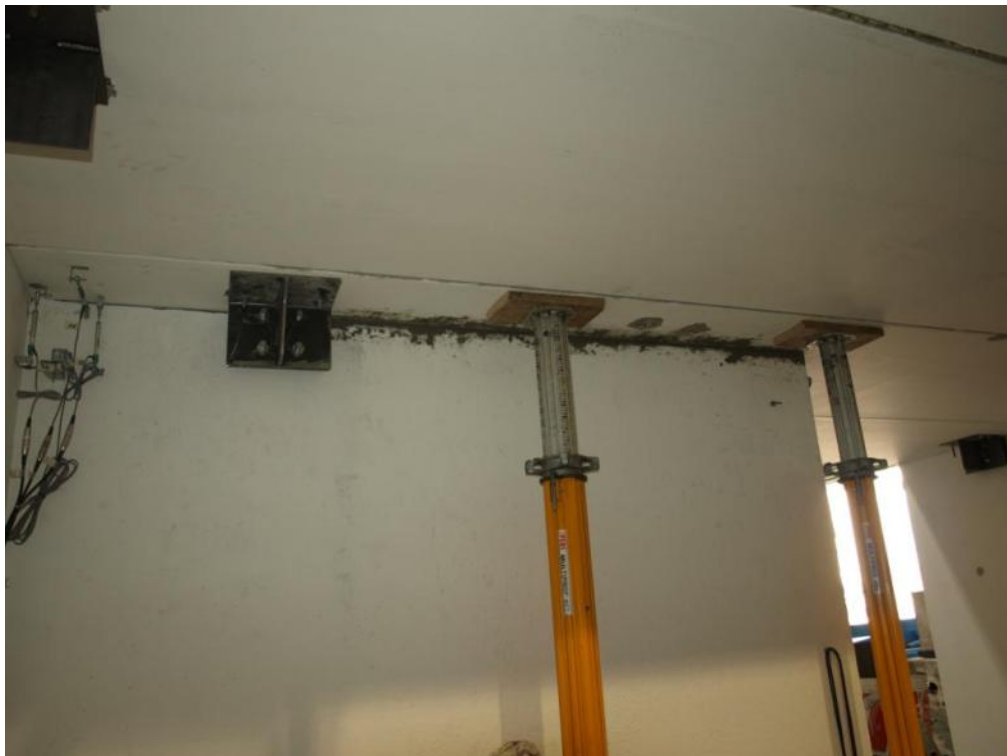
**Figure 163. Mortar filling intervention at the first-floor gap – Overall view of the East-sided wall face.**

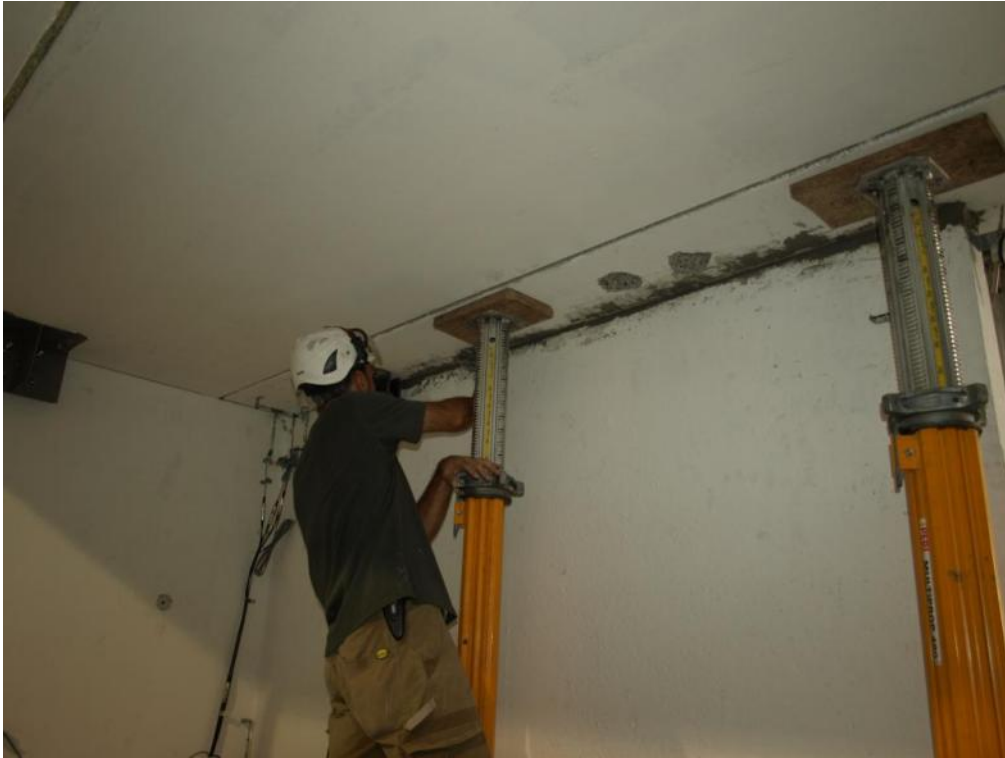
**Figure 164. Mortar filling intervention at the first-floor gap – East-sided wall face, South-sided wall edge.**

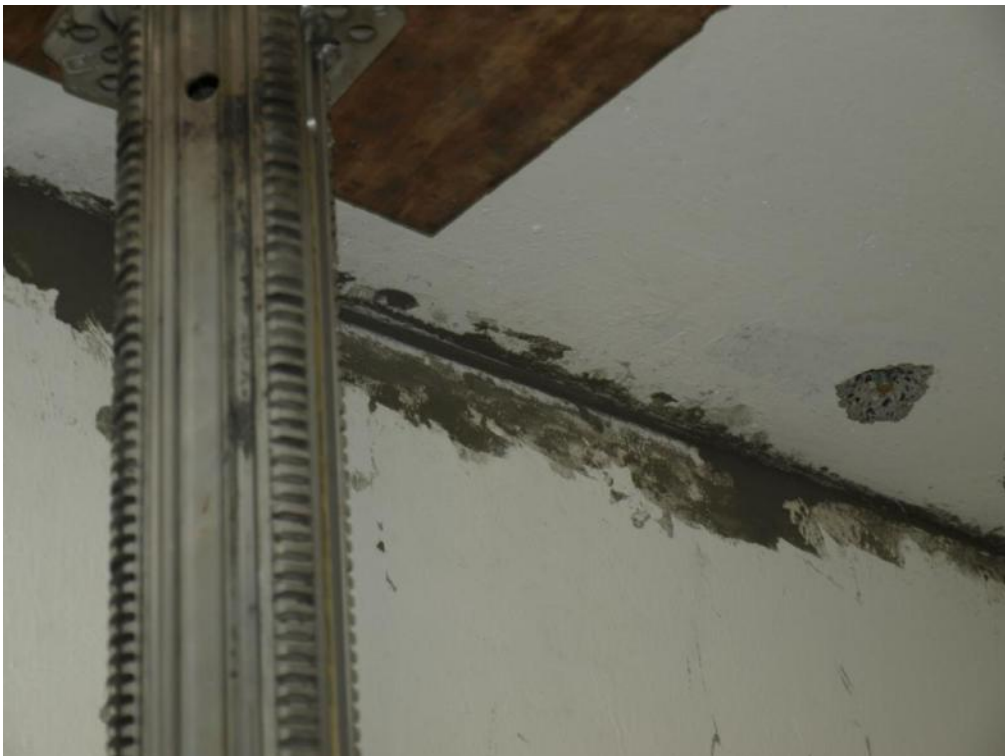
**Figure 165. Mortar filling intervention at the first-floor gap – Detail of the South-sided wall edge.**

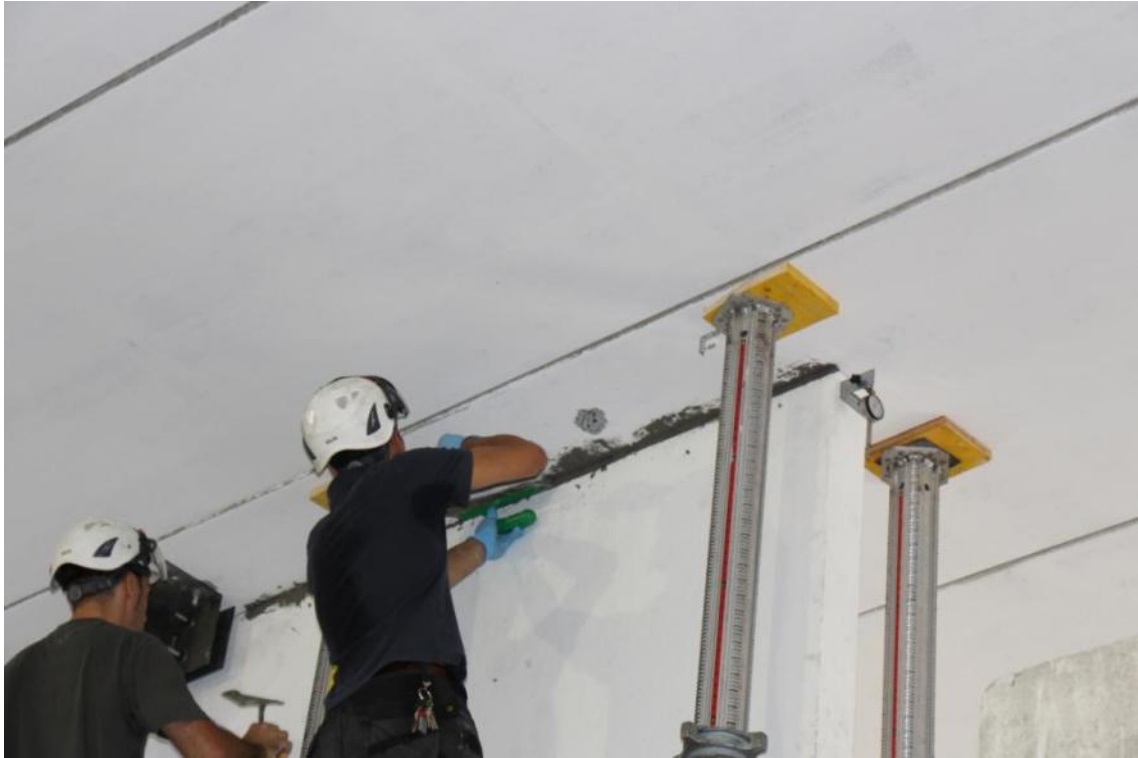
**Figure 166. Mortar filling at the second-floor gap – Temporary steel elements for slab panel uplift.**

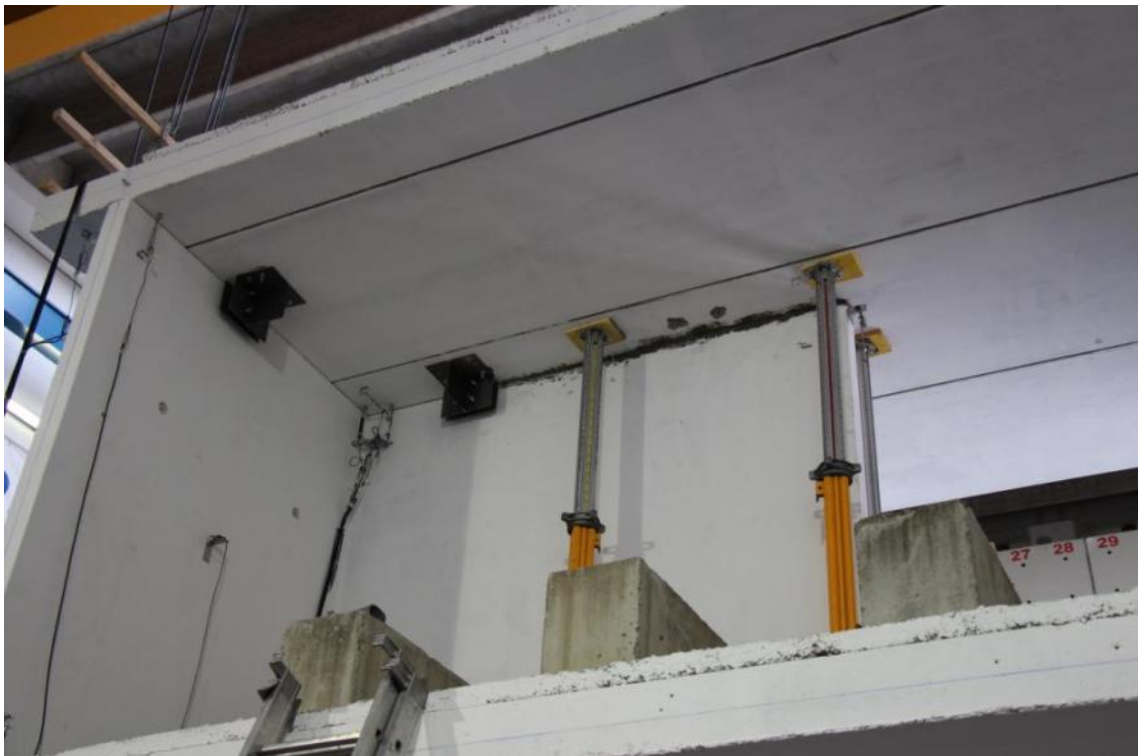
**Figure 167. Mortar filling at the second-floor gap – Overall view of the mortar layer.**

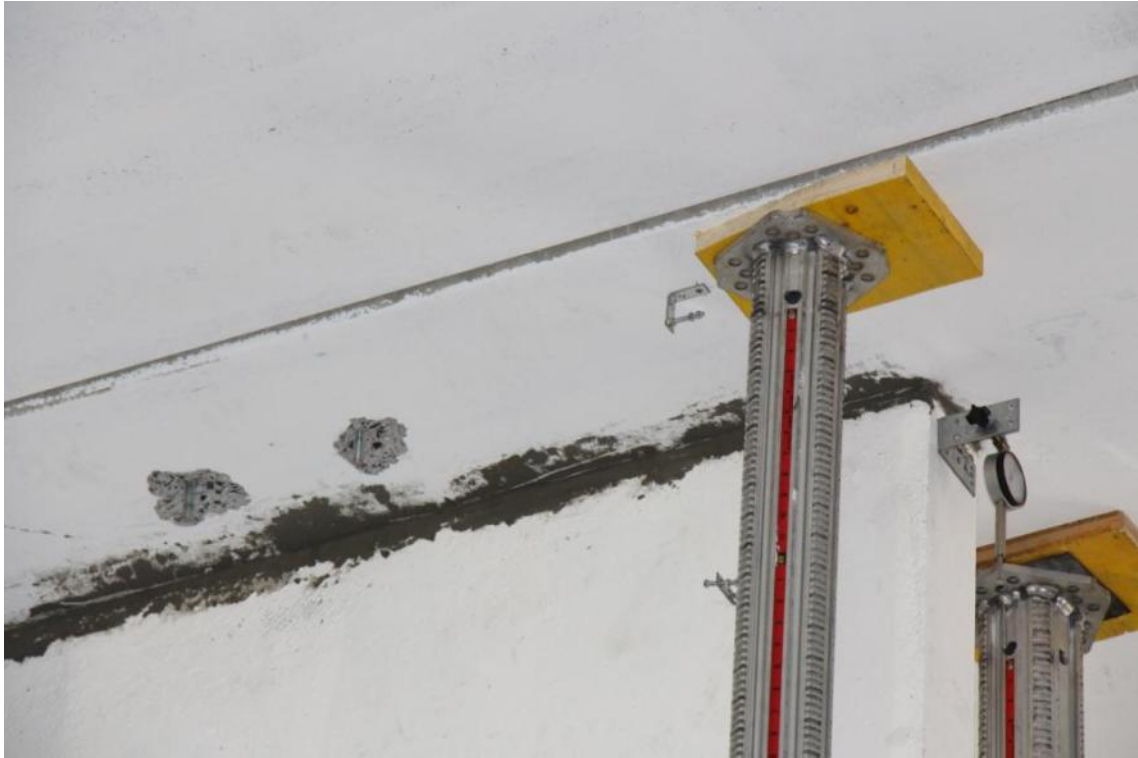
**Figure 168. Mortar filling at the second-floor gap – Detailed view of the mortar layer.**

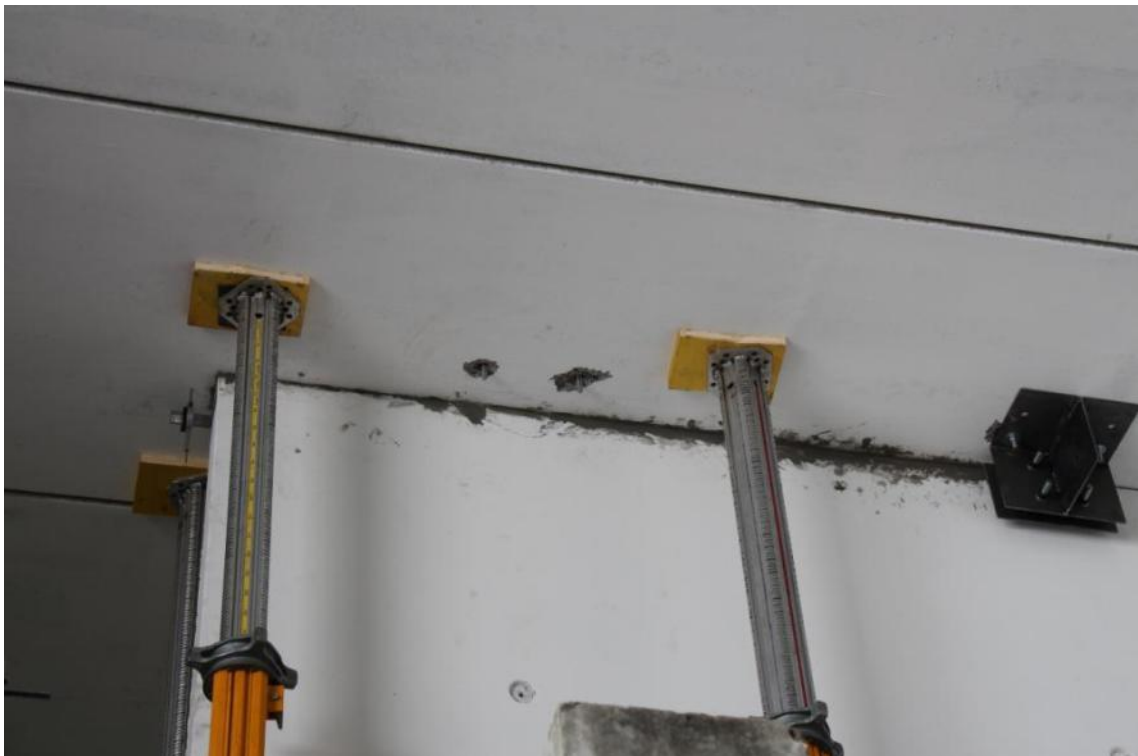
**Figure 169. Mortar filling at the second-floor gap – Overall view of the West-sided wall face.**

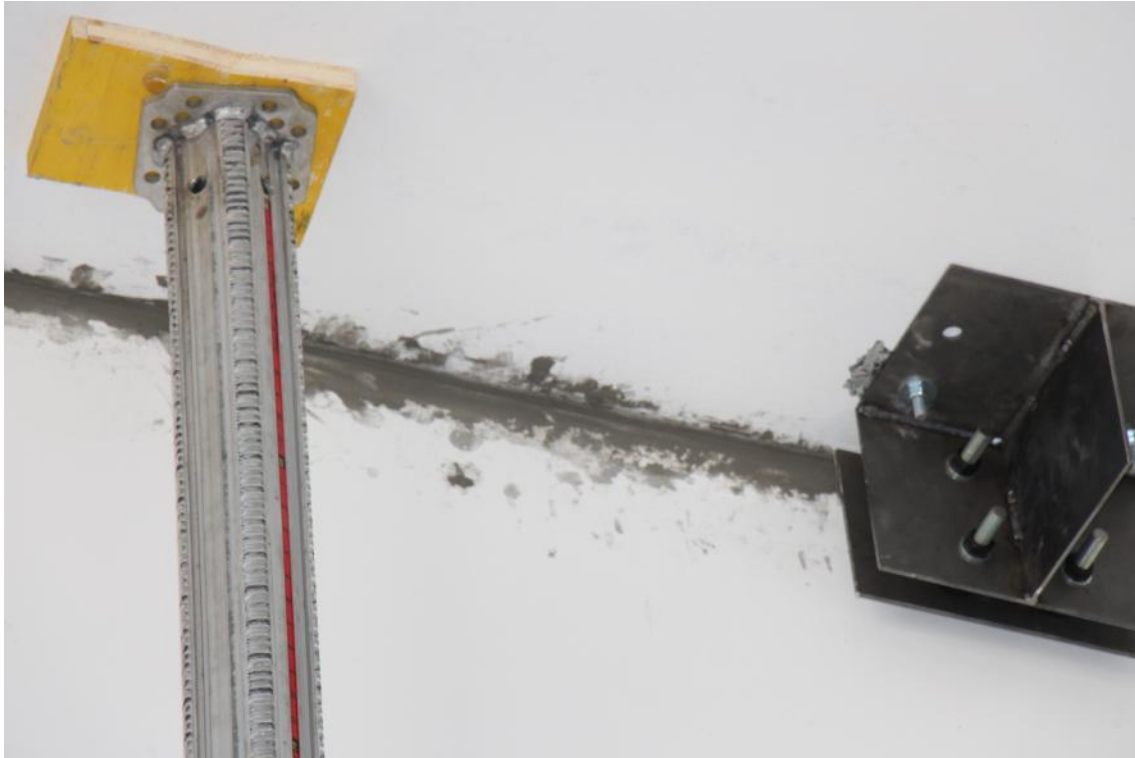
**Figure 170. Mortar filling at the second-floor gap – Detailed view of the West-sided wall face.**

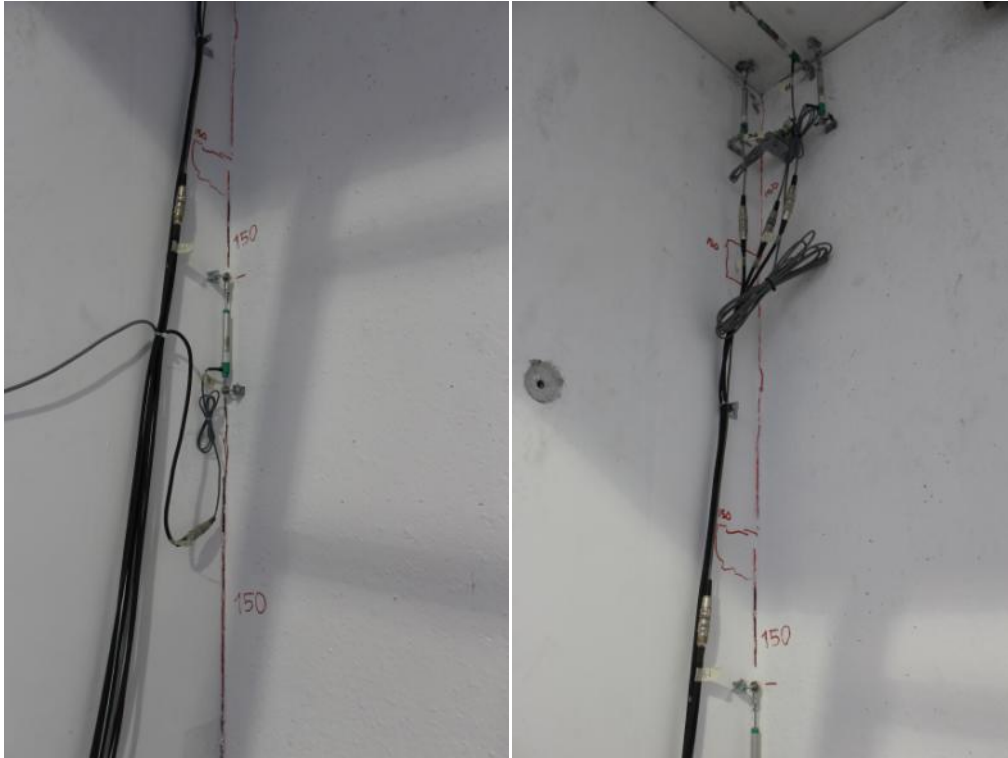
**Figure 282. Crack pattern of three-way joints – East and West faces of the ground-floor stability wall.**

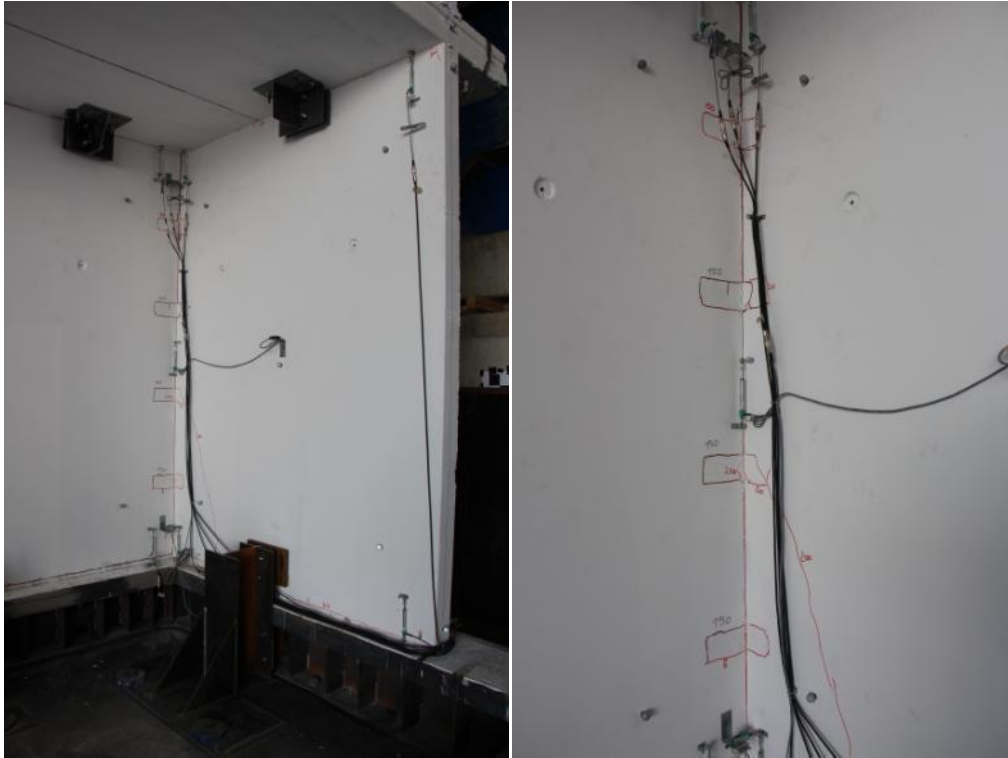
Figure 294 to Figure 316 present a photographic sequence that provides the reader with a clear view of the main damage patterns surveyed at the end of Test run #08. In particular, Figure 294 to Figure 297 show the details of the damage patterns of the ground-floor stability wall at the base and top of it, as well as in correspondence to the four three-way connections between this and the South-sided lateral walls. A full-depth/full-width horizontal crack was seen spreading at the base of the stability wall and also at the base of the transverse walls. One of the two ground-floor ones presents also an inclined crack running from the base of the panel to one of the four connectors socket.

**Figure 294. Crack pattern of the ground-floor stability wall – Enlarged view and detail of three-way joints.**

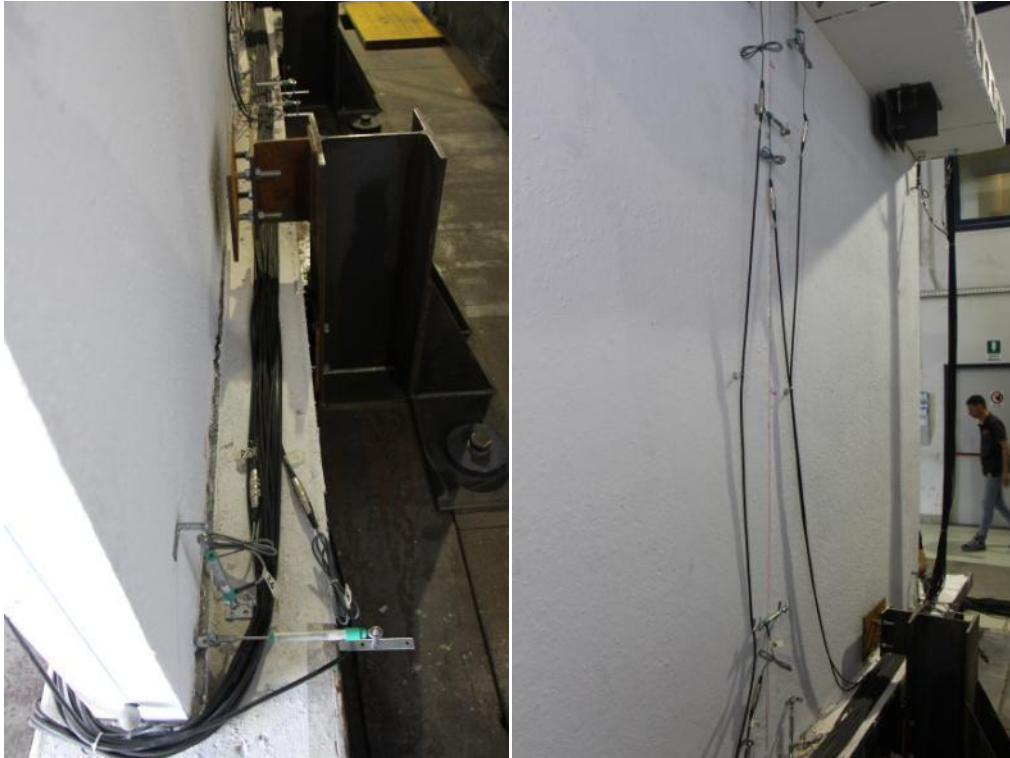
As reaffirmed by Figure 298 to Figure 301, the South-sided ground-floor lateral walls were heavily damaged and presented a full-height vertical crack on their South face, at the wall-to-wall interface. Furthermore, Figure 302 to Figure 305 show different views of the full-depth/full-width crack at the base of the first-storey stability wall, and also point out how the damage patterns of the panel joints propagated on both wall sides.

**Figure 298. Full-depth/full-width horizontal crack at the base of the first-storey lateral wall 1L2.**

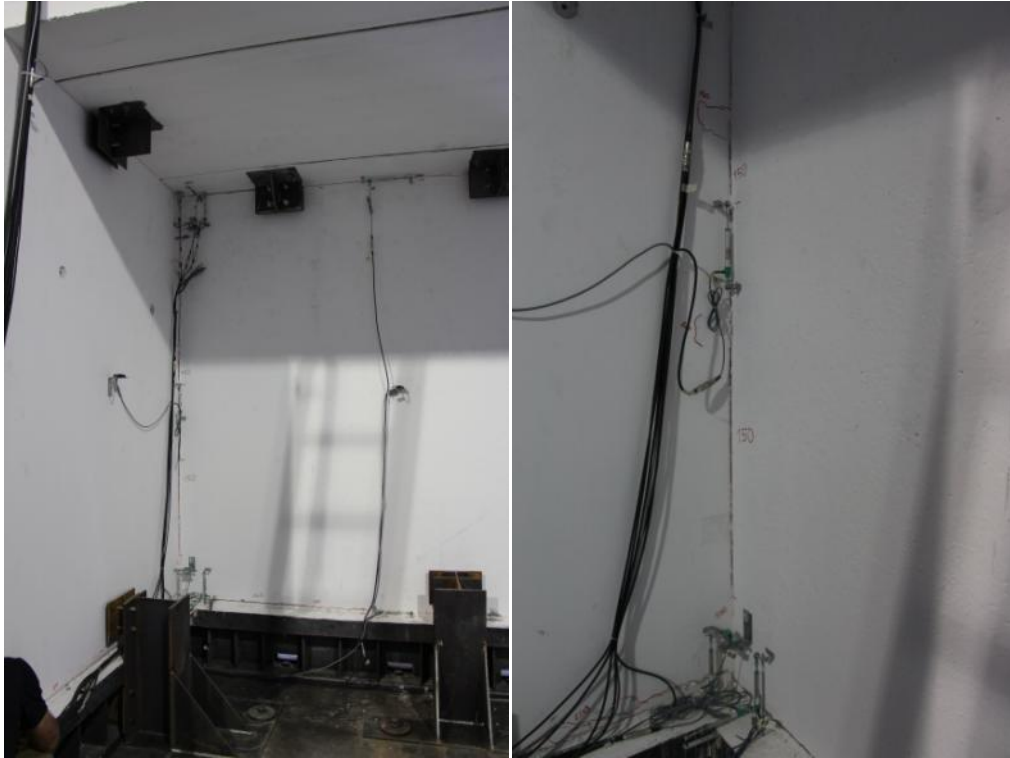
**Figure 302. Extensive damage of the top three-way joint – East face of the first-storey stability wall.**

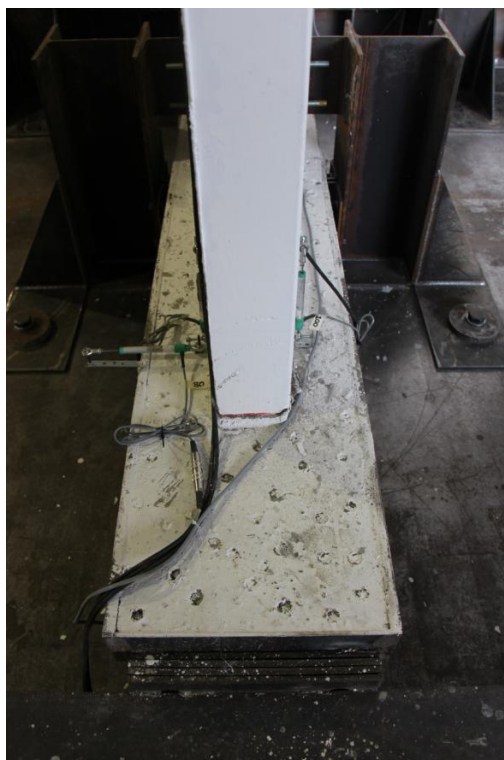
**Figure 304. Crack running through the entire width of the first-storey stability wall – Corner, front view.**
