Nederlandse Aardolie Maatschappij B.V.

# Experimental campaign on RC buildings typical of the Groningen region: dynamic testing of a precast specimen

| LAB AND TESTS RESPONSIBLE | DOCUMENT AUTHOR | REVIEWER |
|---|---|---|
| Issue: 30/10/2017 | Document type:<br><br><b>Technical report</b><br>pages: 364 | File name:<br>EUC_BUILD5-test_campaign_report.pdf |

Brunesi E., Peloso S., Pinho R., Nascimbene R. (2017). *Dynamic testing of a full-scale two-storey RC precast wall-slab-wall structure representative of the Groningen building stock*. Report EUC215/2017U, European Centre for Training and Research in Earthquake Engineering (EUCENTRE), Pavia, Italy.

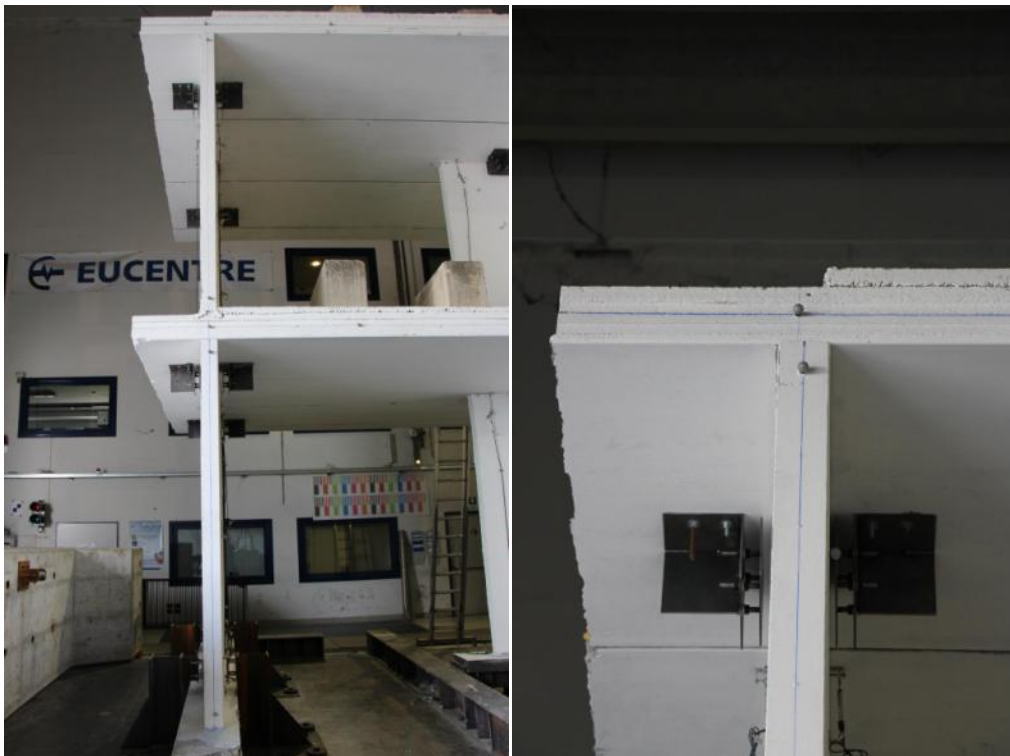
Test run #08 has also highlighted that the accumulation of damage in the wet joints implies sliding of the slabs on the precast walls underneath them (see Figure 306 to Figure 314). As a result of this, non-negligible permanent displacement were reached in key parts of the specimen at both first and second floor levels.

**Figure 307. Sliding and accumulation of displacement residuals – Second-storey floor slab, North side.**

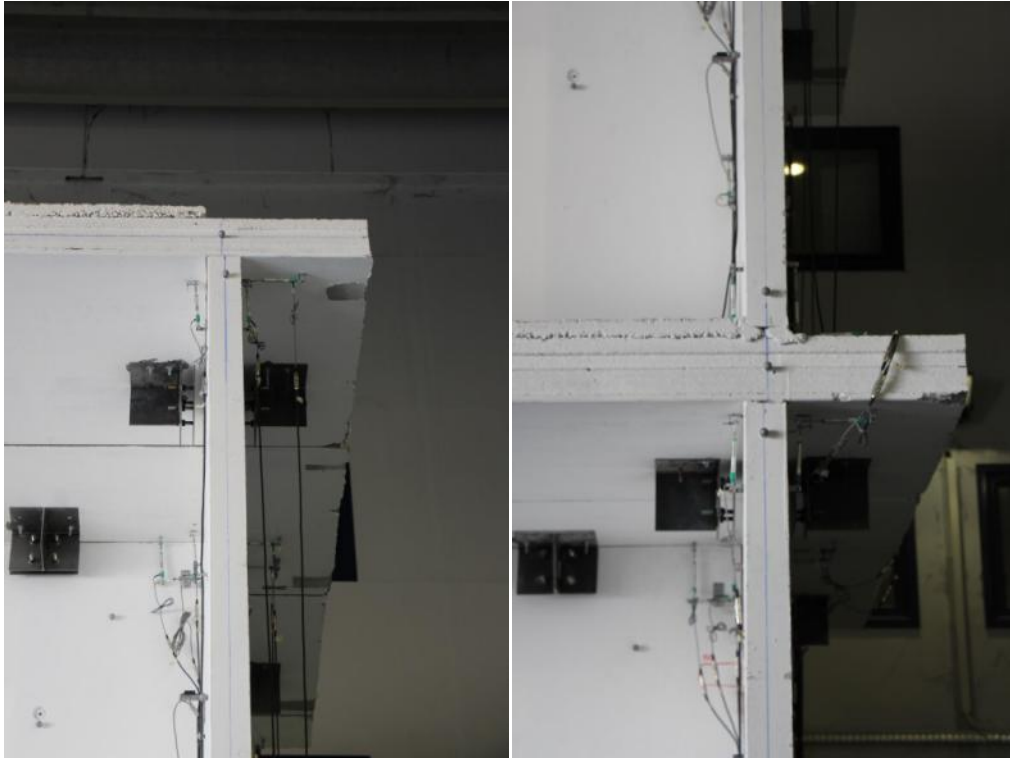
**Figure 308. Sliding and accumulation of displacement residuals – Second-storey floor slab, South side.**

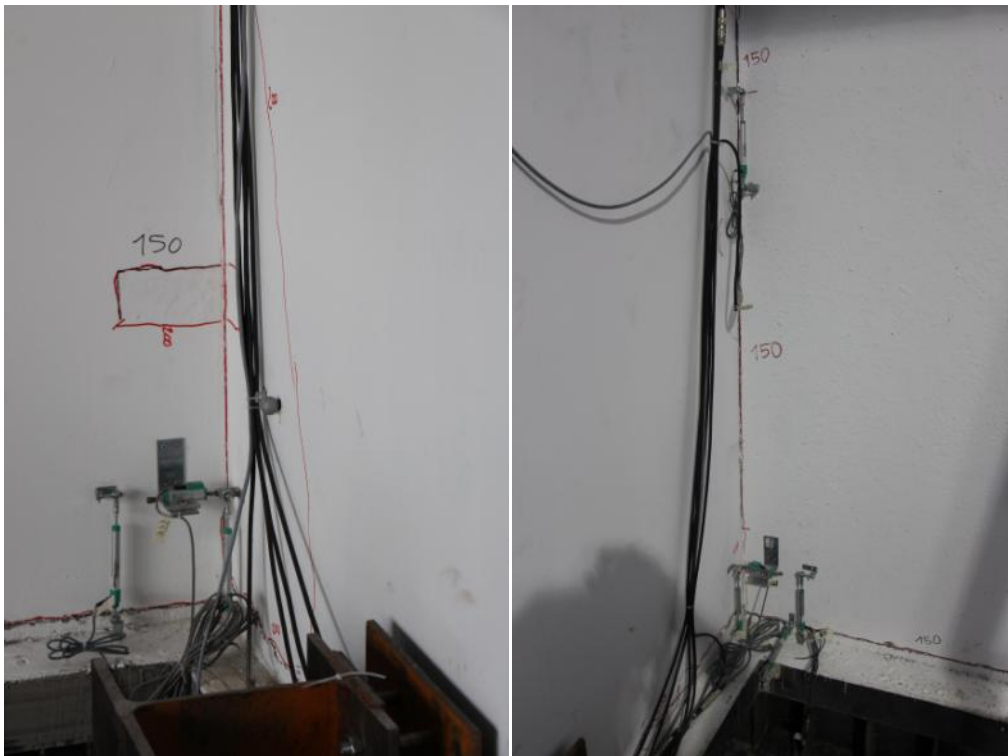
Finally, Figure 315 and Figure 316 provide enlarged and very detailed views of the damage pattern of the top and bottom three-way joints at the end of Test run #08. More in detail, Figure 316 shows the gap opening between the stability and transverse ground-floor walls and may thus provide a very clear picture of the state of EUC-BUILD5 specimen at the end of Test run #08.

**Figure 315. Damage pattern of top and bottom three-way joints at the end of Test run #8.**

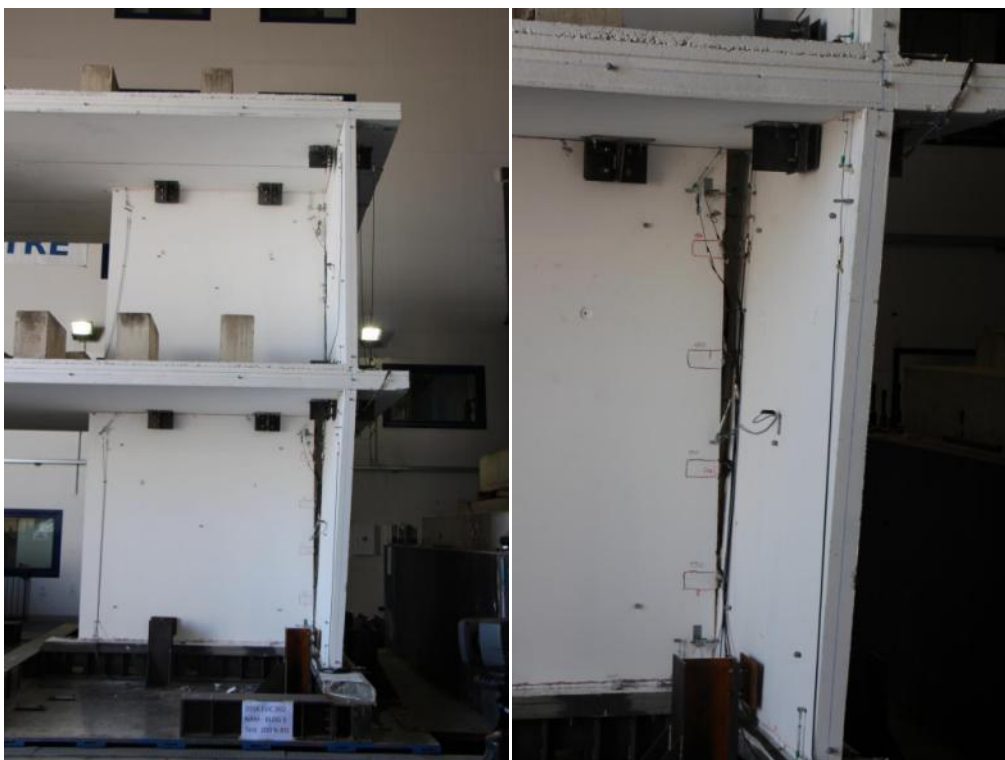
Firstly, Figure 317 shows the deformed shape of the specimen at the end of dynamic testing and gives account of the exaggerated levels of deformation that were reached during the last test run. In Figure 318, an enlarged view of the accumulated permanent displacements is also provided so as to portrait even more clearly how close to collapse the building appeared at the end of the second input motion at 200% intensity.

**Figure 318. Loss of verticality and accumulation of residuals due to failure of bent three-way panel joints.**

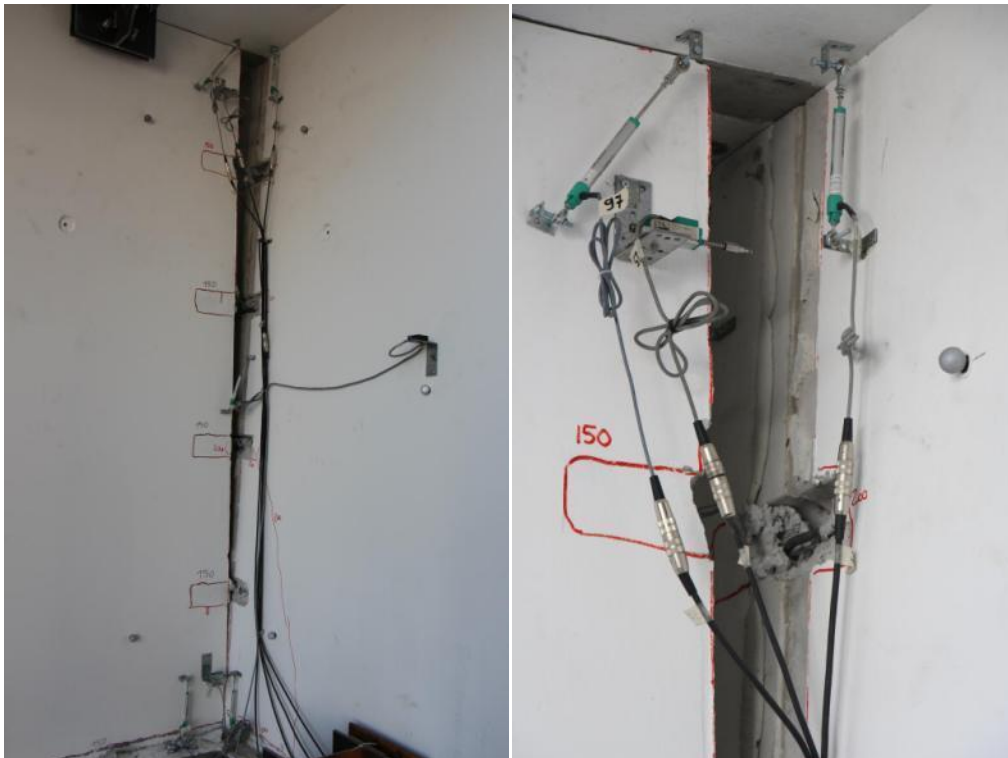
**Figure 324. Failure mechanism of three-way panel connections – Detail of permanently-bent steel connectors.**

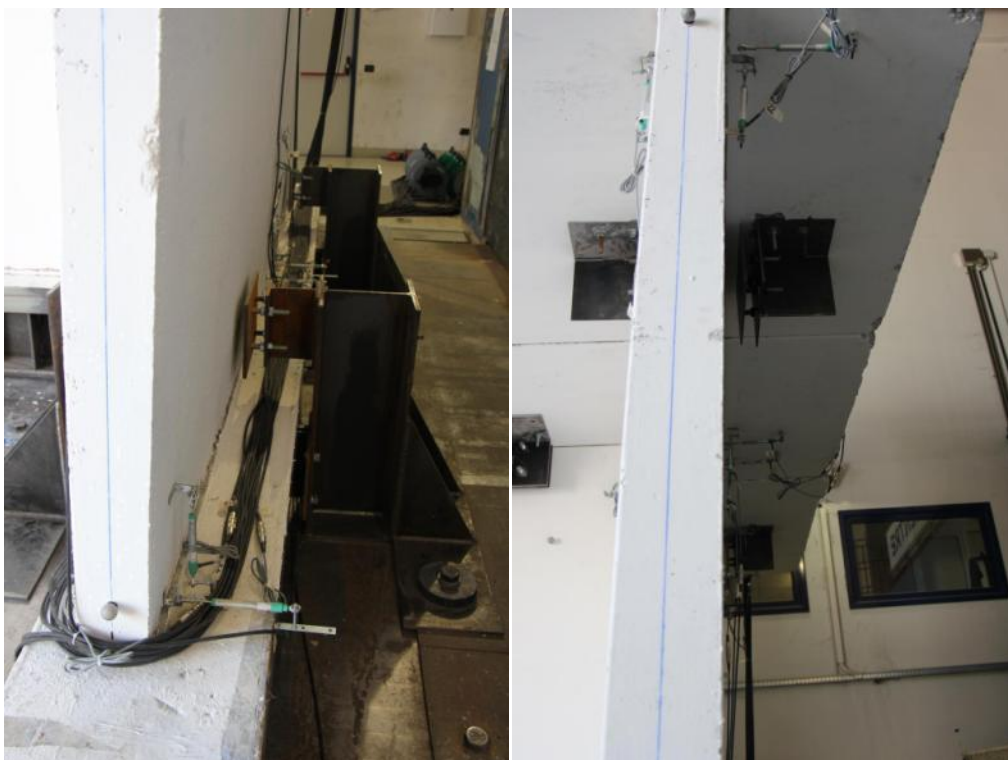
**Figure 325. Damage at the base of lateral walls and rocking with loss of verticality – Detail of wall 1L2.**

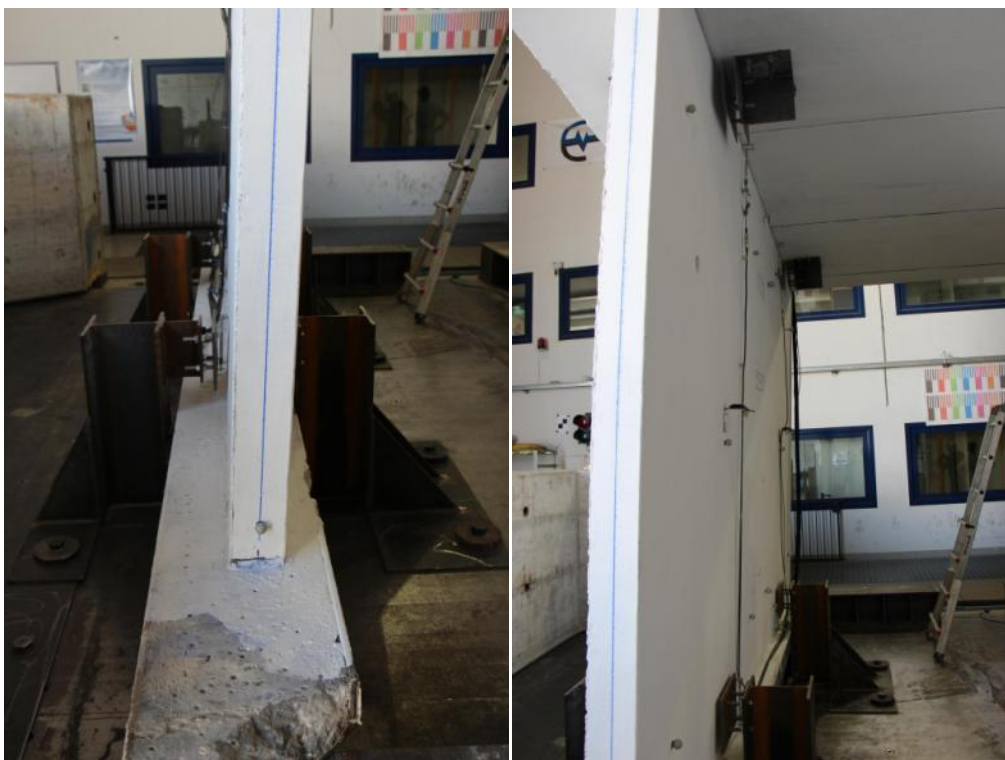
**Figure 326. Damage at the base of lateral walls and rocking with loss of verticality – Detail of wall 1L4.**

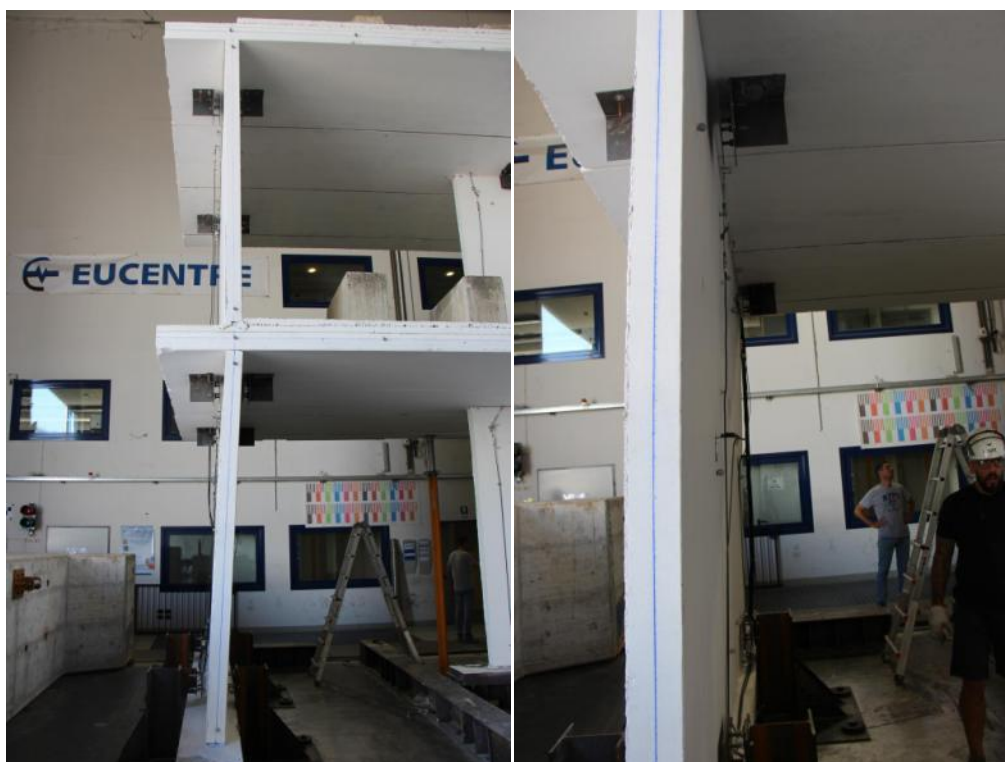
**Figure 327. Overall and detailed views of the North-sided transversal walls at the end of testing.**

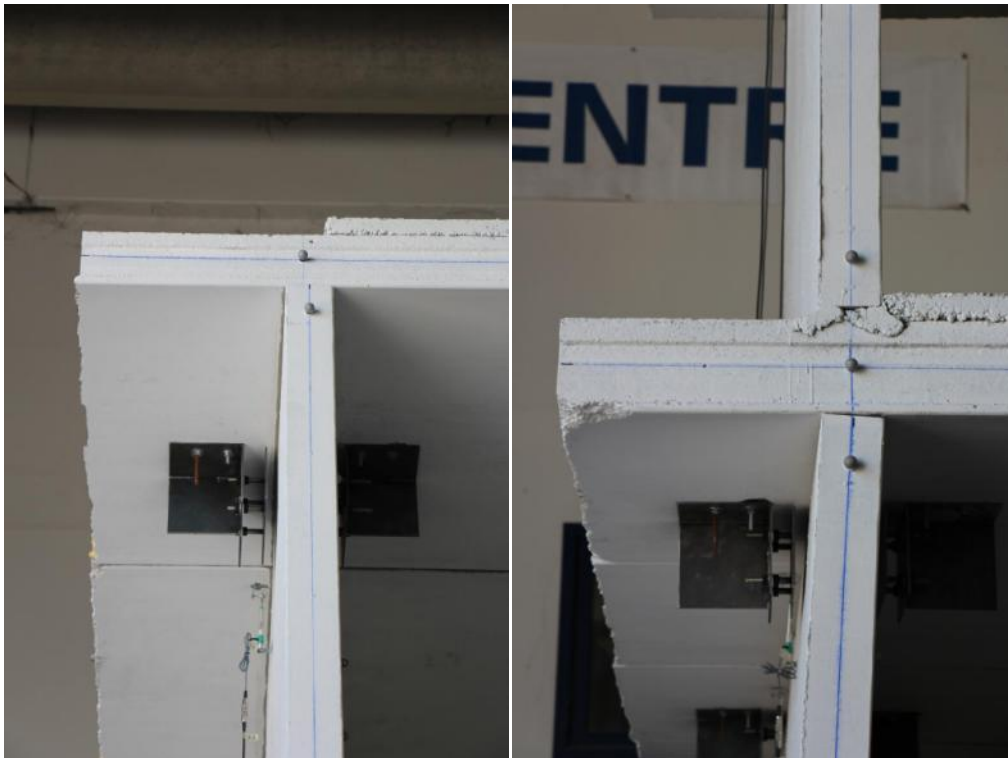
**Figure 328. Detailed views of the first-storey and second-storey slabs and North-sided lateral walls.**

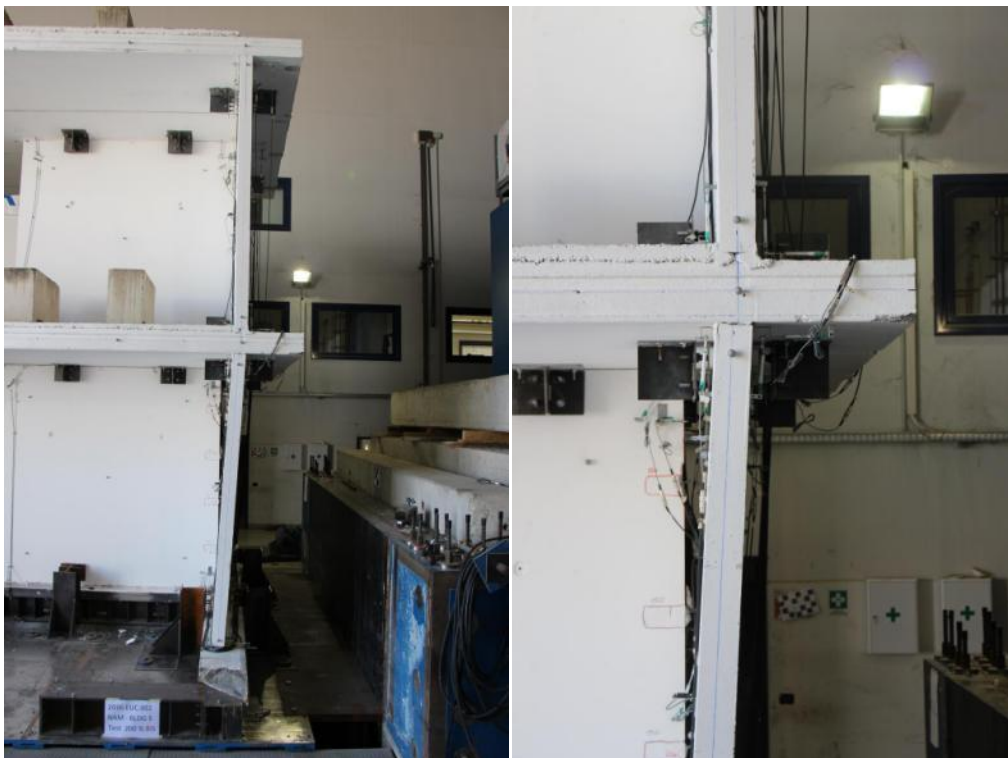
**Figure 329. Overall and detailed views of the South-sided transversal walls at the end of testing.**

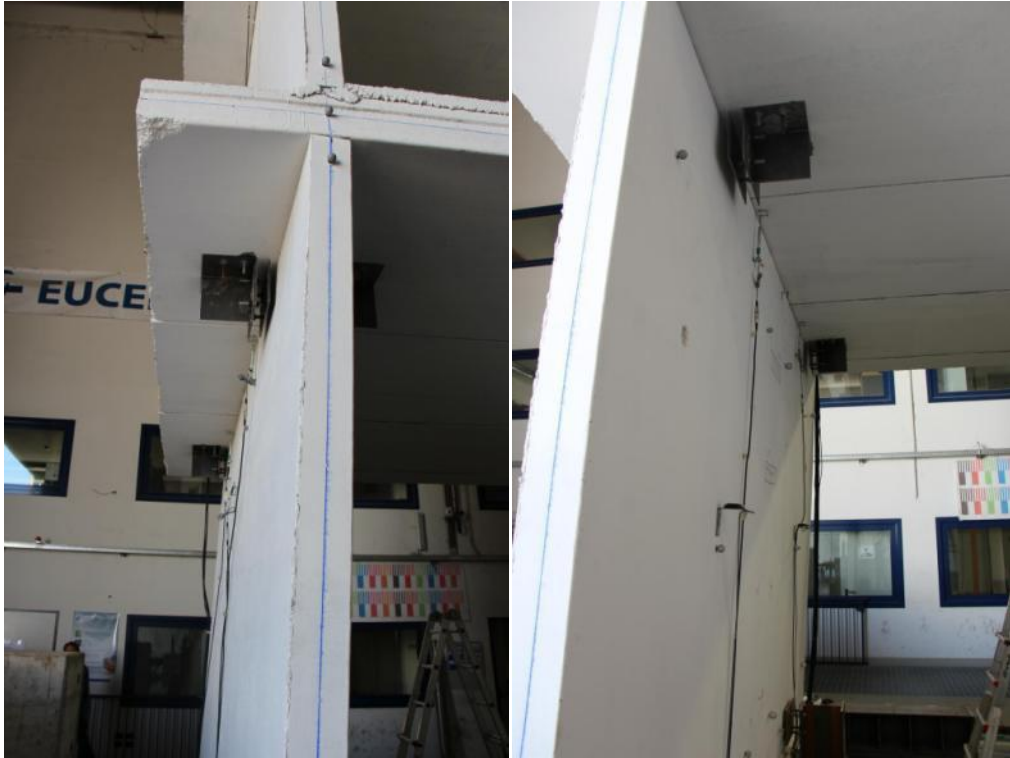
**Figure 330. North-sided ground-floor lateral walls at the end of testing – North and South wall faces.**

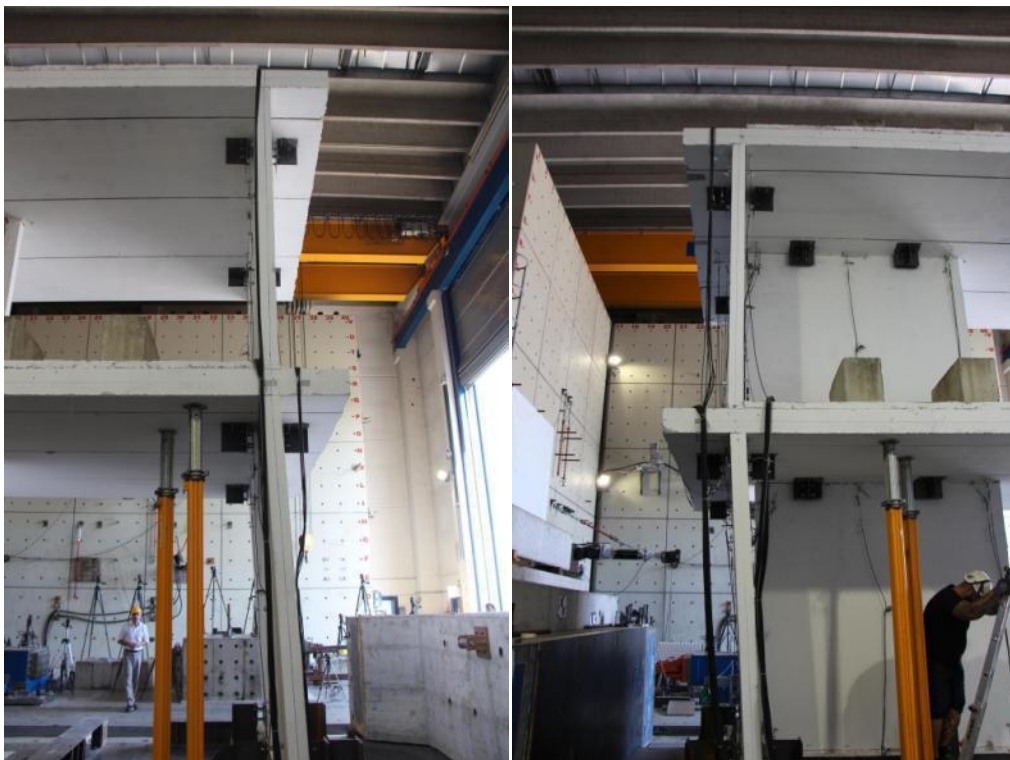
**Figure 331. Propping-up at the end of the last test run – North and South sides.**

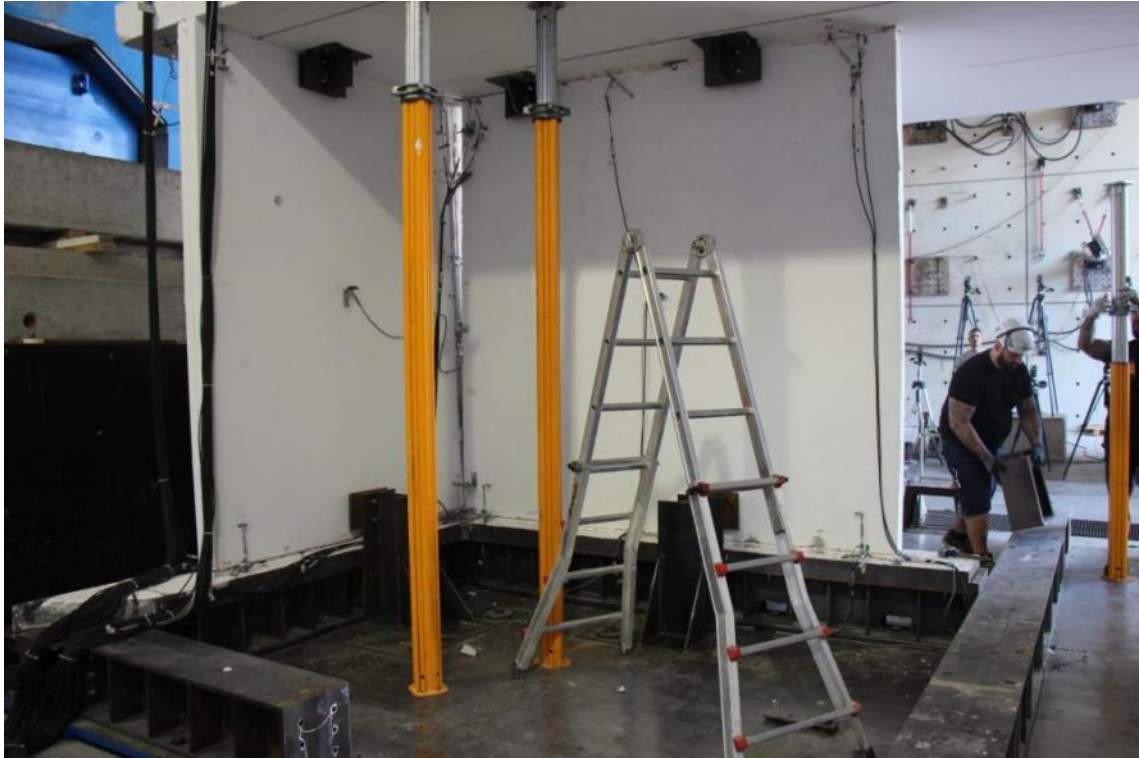
Photos of the building were taken in the first minutes after the test, in parallel with its equally immediate propping-up, deemed urgent in face of what appeared to be a very precarious stability of the structure. The outcome of the visual inspections is illustrated through Figure 317 to Figure 339, which depict well the (battered) state of the specimen after the test.

**Figure 334. Installation of props in face of the very precarious stability of the structure after the test.**

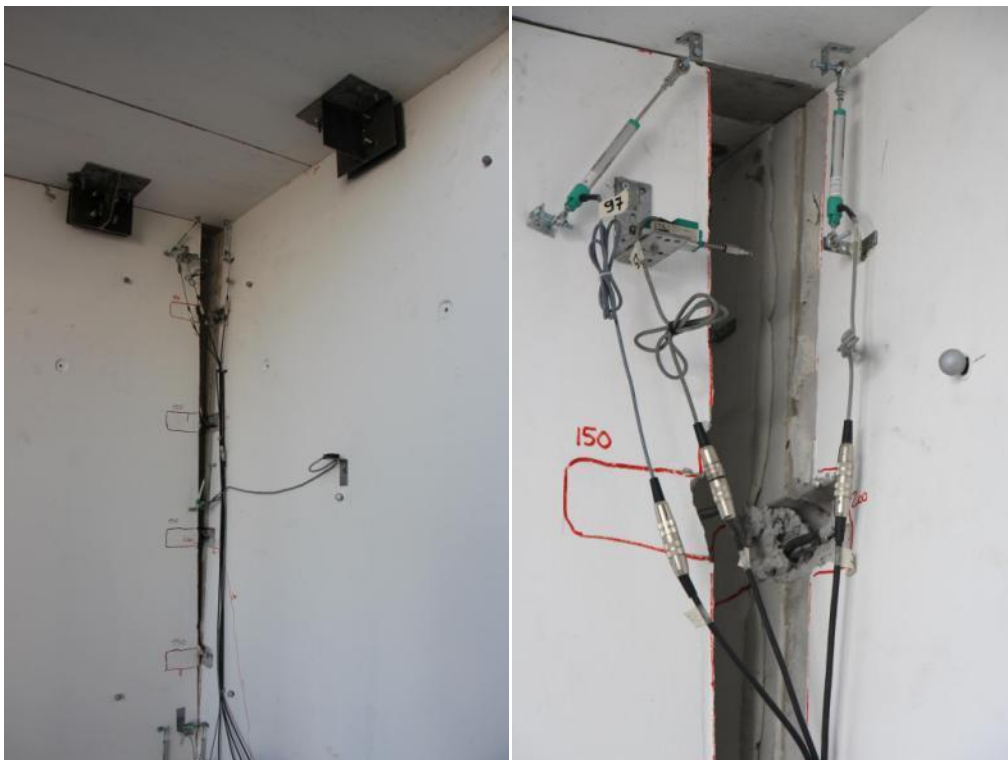
As can be observed e.g. in Figure 337 to Figure 339, the three-way panel joints failed abruptly because of a severe and sudden permanent bending of the steel connectors embedded in the niches of both stability and transversal walls. The gap that had already developed during Test run #08 was shown to widen conspicuously, which implies that the lateral walls lost uprightness rapidly and that displacement residuals accumulated accordingly.

**Figure 337. Permanently-bent steel connectors in the top three-way panel joint.**

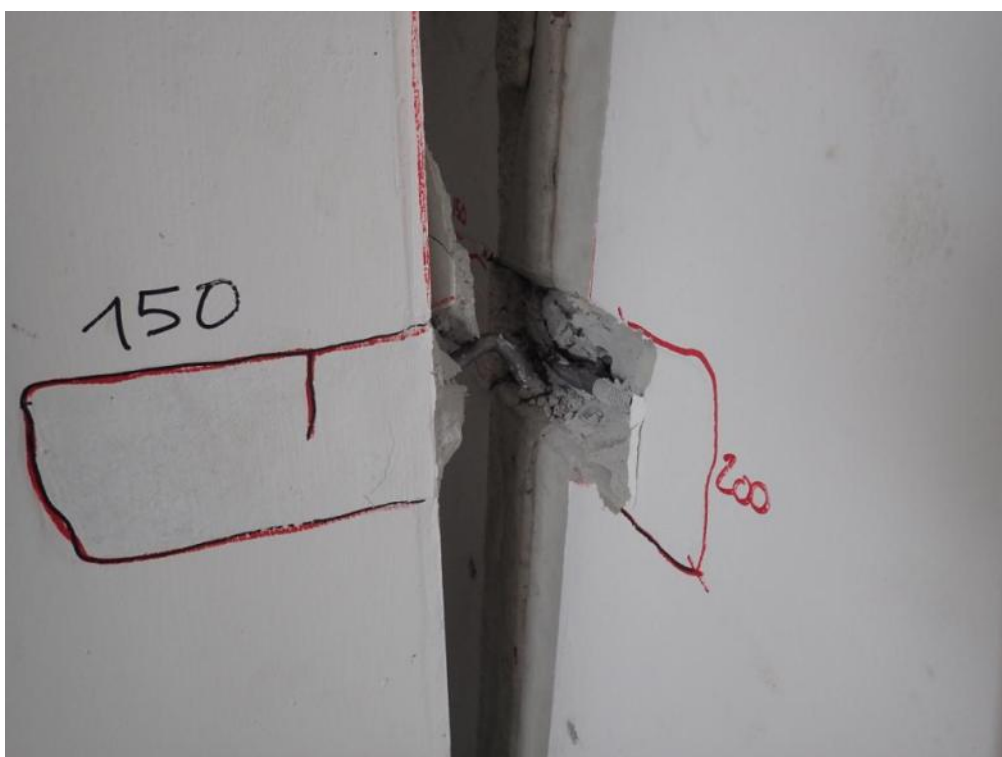
To confirm such a consideration, interested readers may inspect the photographic sequence reported below. Details of the top three-way connection (i.e. the fourth one starting from the base) are shown in Figure 544 and Figure 545, whereas those pertaining to the third joint can be observed in Figure 546 to Figure 548. Furthermore, Figure 549 to Figure 551 present few photos of the steel connectors of the second three-way connection, and Figure 552 to Figure 554 report on the main observations for the bottom three-way joint. Finally, Figure 555 provides a further and even more enlarged view of the top three-way joint, the latter being the one that featured the widest gap between the first-storey stability and lateral walls.

**Figure 546. Permanently-bent steel hooks in lateral and stability walls – Third panel joint from the base.**

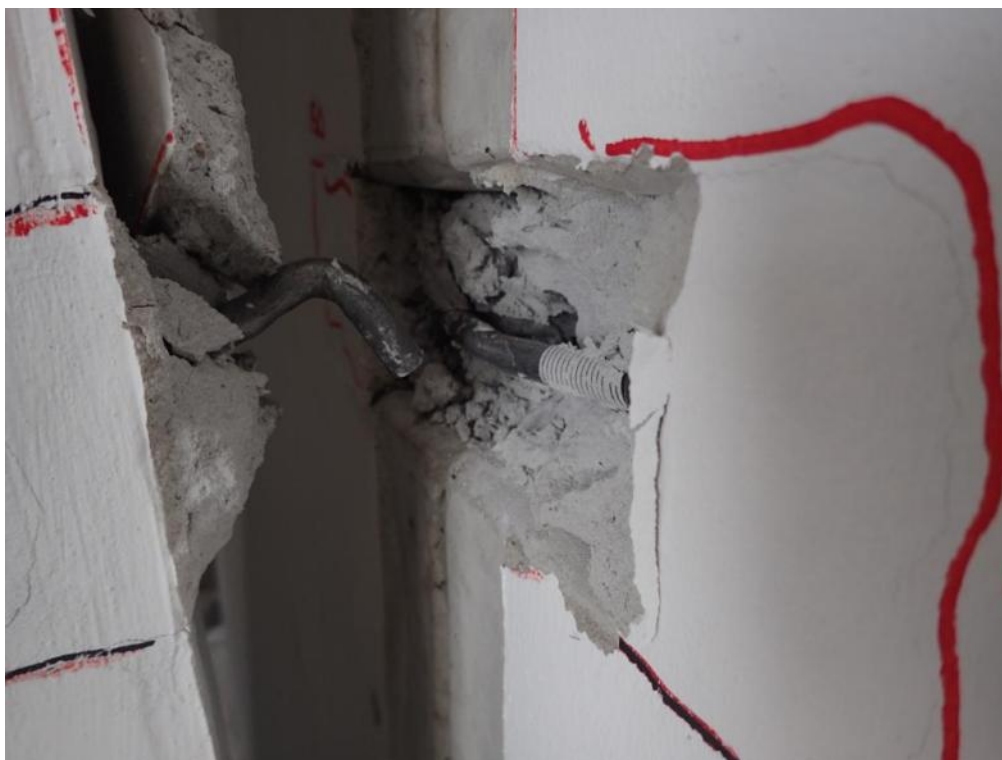
**Figure 547. Enlarged view of steel hooks in lateral and stability walls – Third panel joint from the base.**

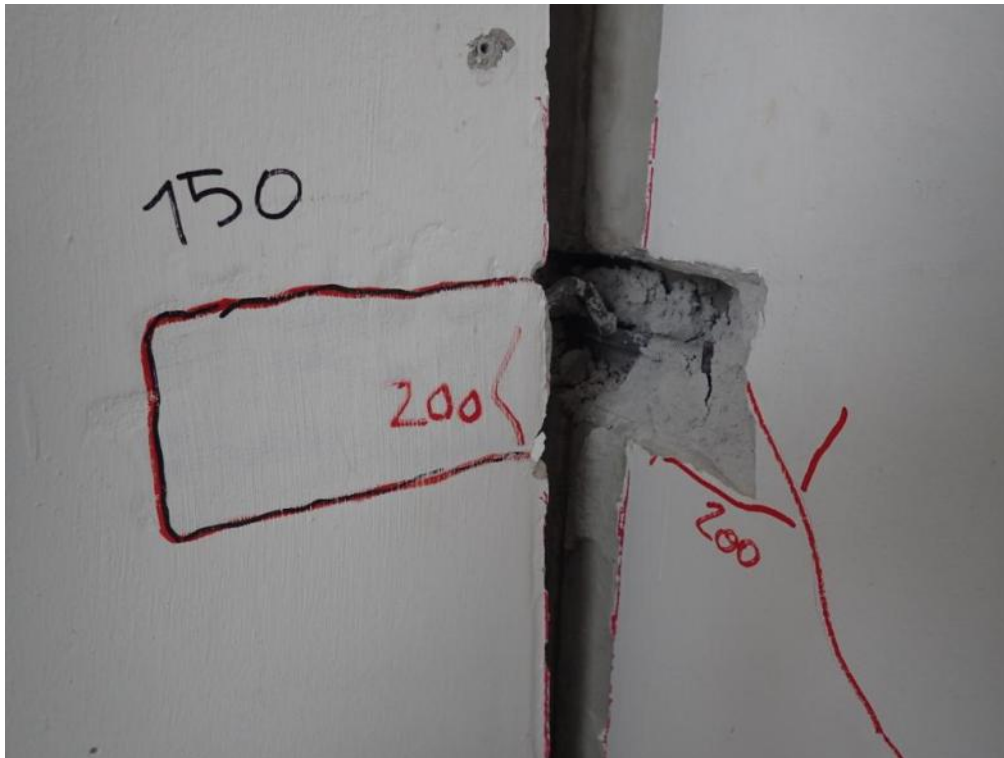
**Figure 549. Damage of steel connectors between stability and lateral walls – Second joint from the base.**

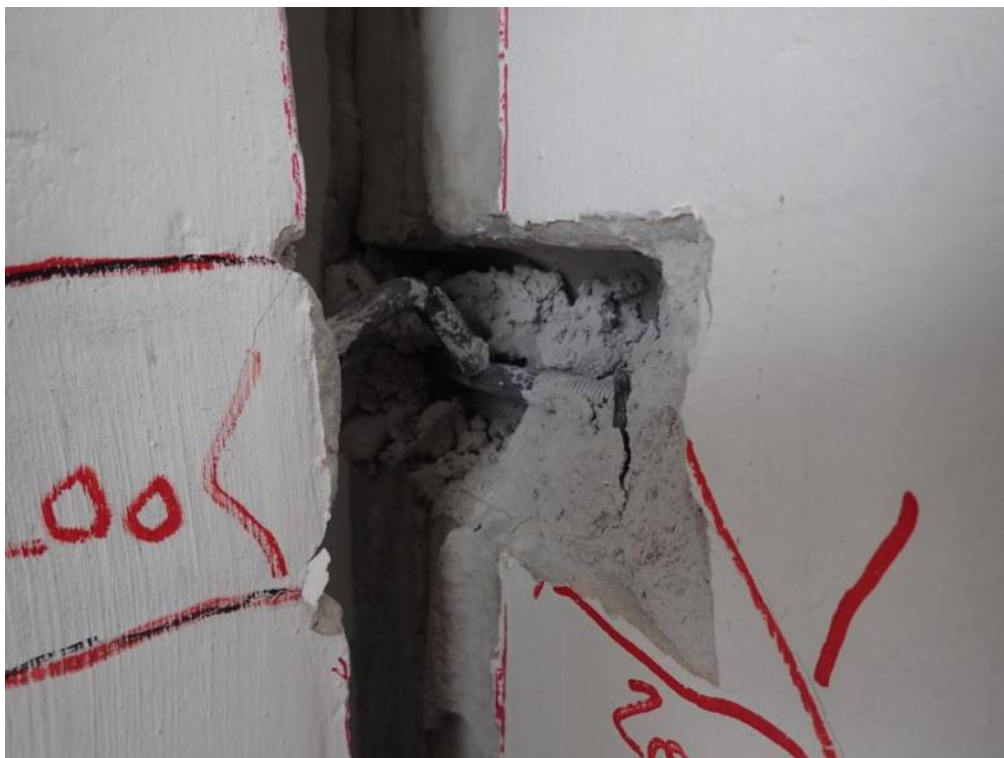
**Figure 550. Enlarged view of failed steel connectors in the second panel joint from the base.**

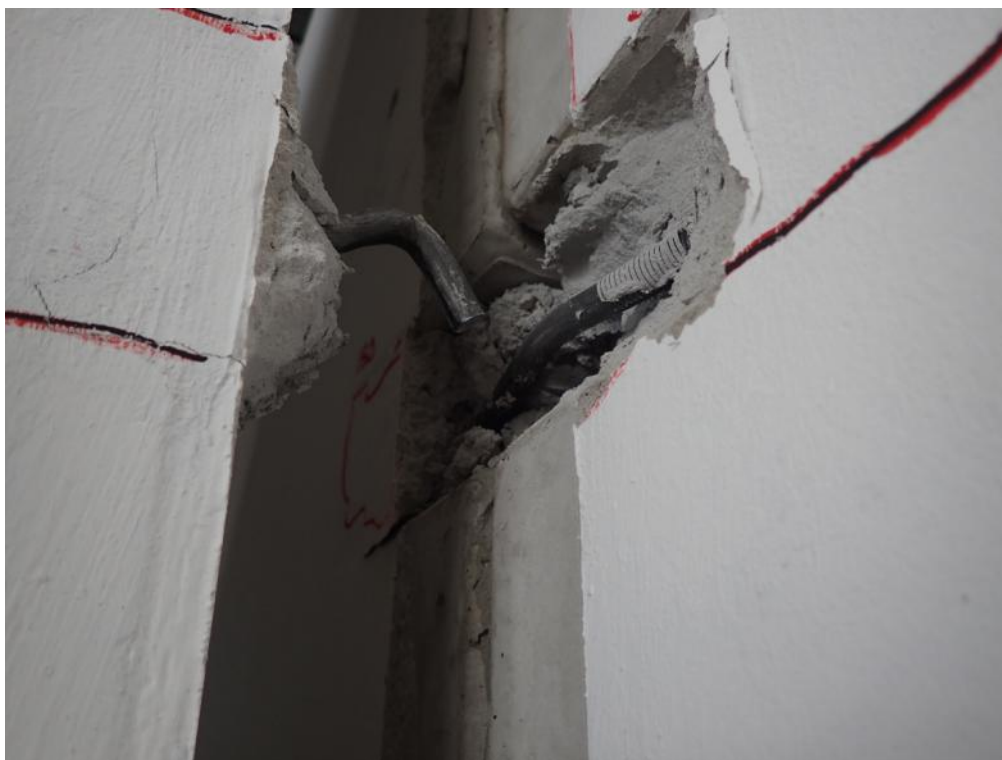
**Figure 551. Outwardly-bent and upwardly-bent steel hooks of the second panel joint (from the base).**

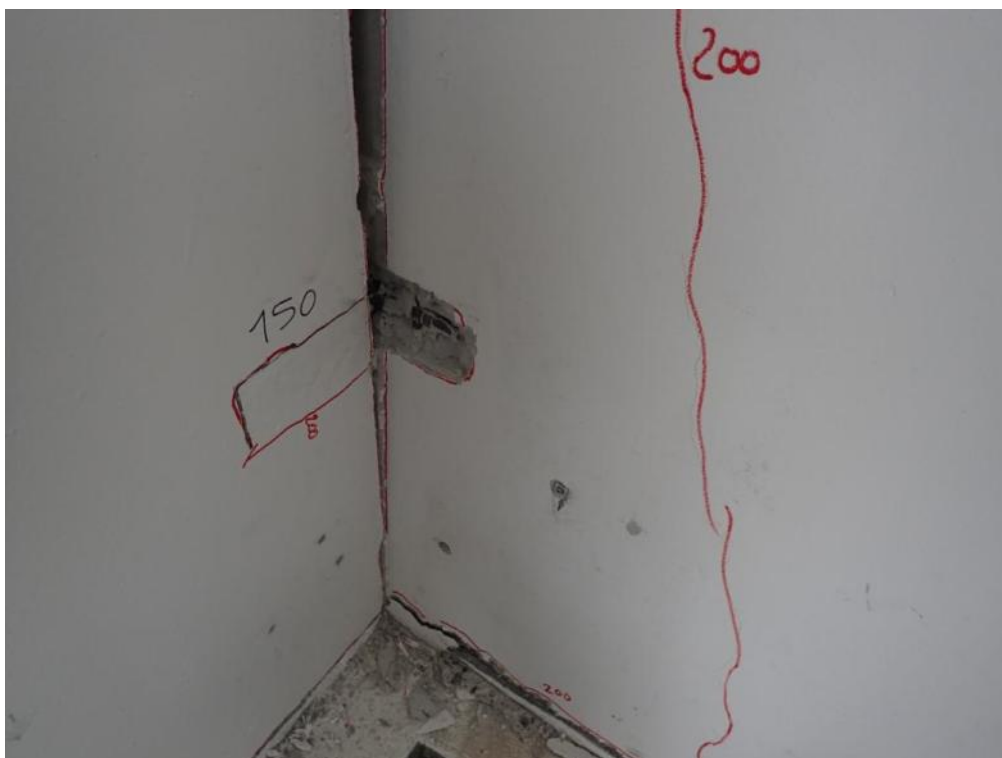
**Figure 552. Damage pattern of the bottom three-way connection between stability and lateral walls.**

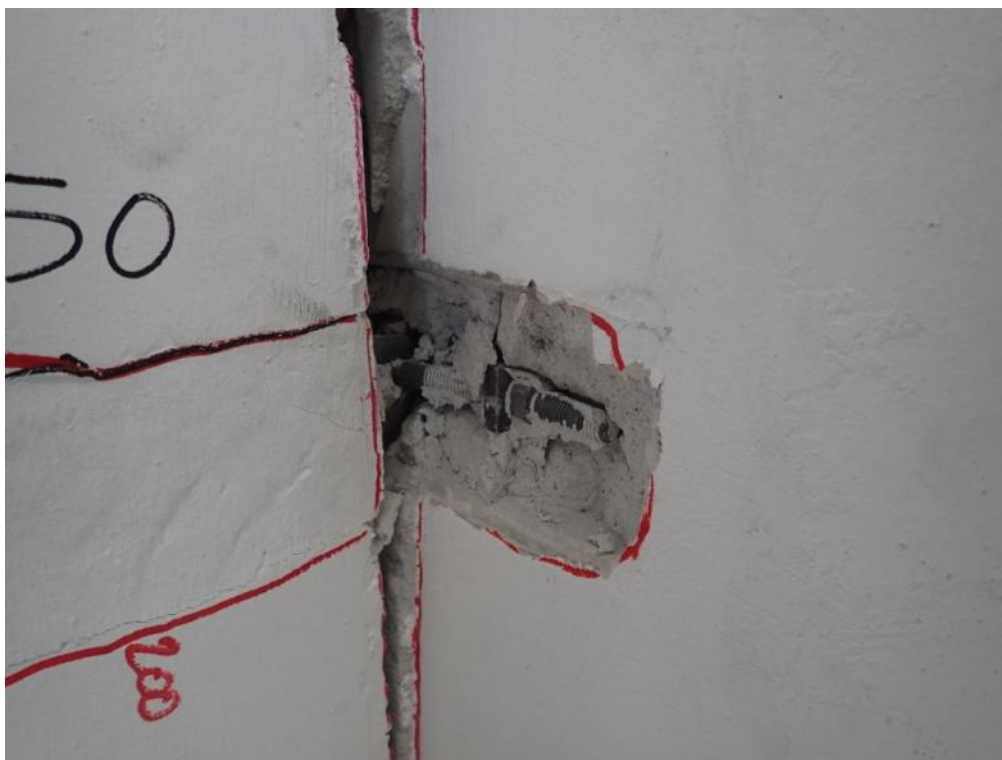
**Figure 553. Detailed view of the bottom three-way connection between the stability and lateral walls.**

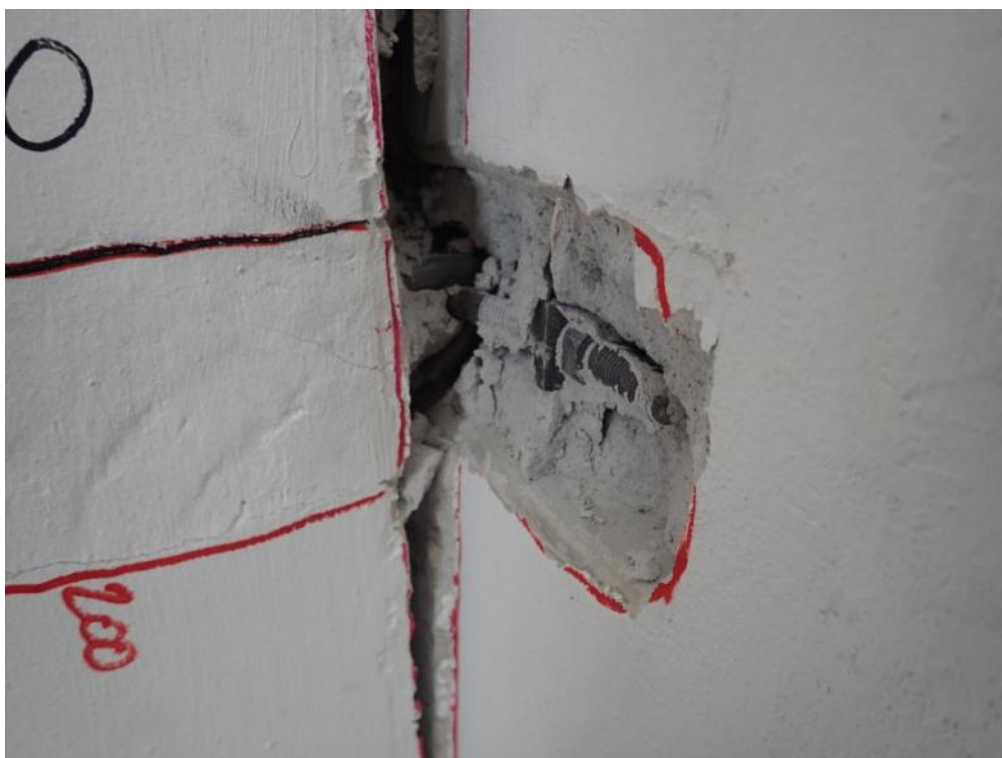
**Figure 554. Side view of the bottom three-way connection between stability and lateral walls.**

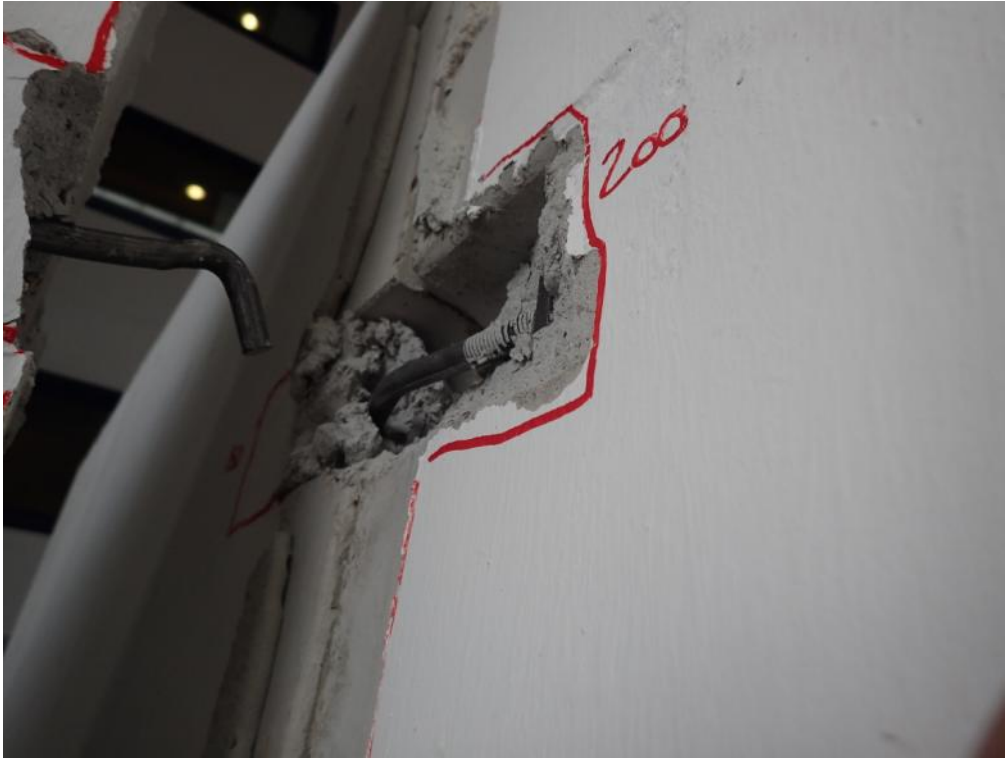
**Figure 555. Bottom view of bent steel connectors between lateral and stability walls – Top connection.**

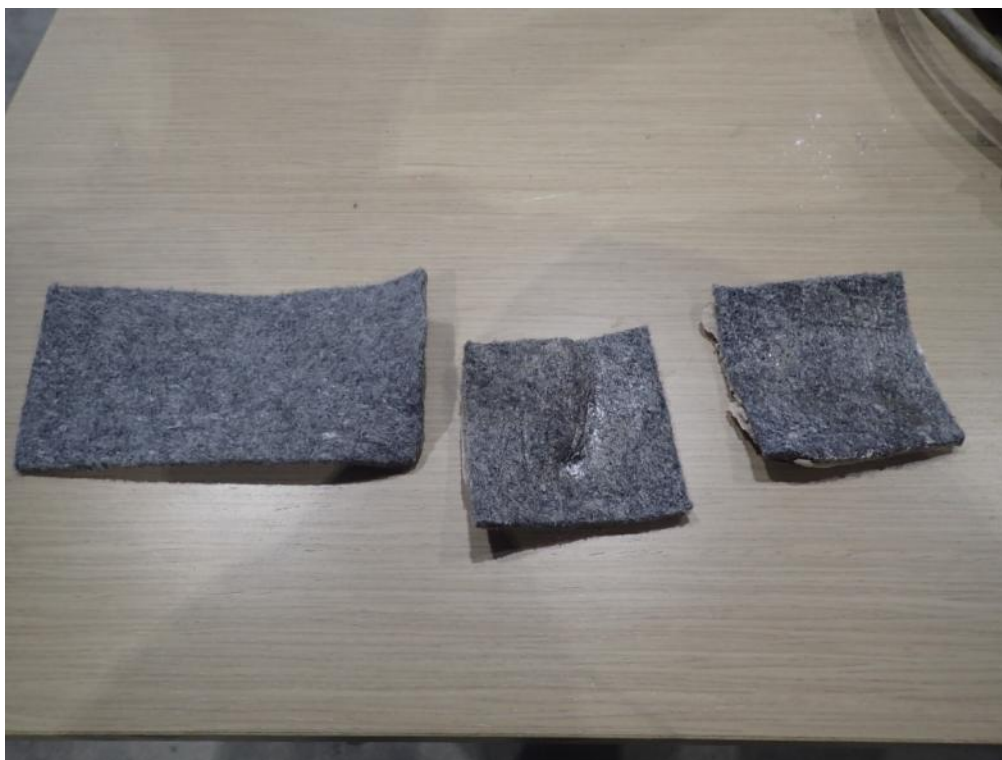
Details of the three pieces of felt material after the cyclic testing can be observed in Figure C2. It is worth specifying that these first test runs were carried out by imposing a maximum displacement of 100 mm in pulling and pushing direction. It is believed that the pressure distribution imposed by the additional vertical loads was far from being uniform (and uniformly distributed on the three pieces of felt) and also that concrete-on-concrete contact occurred during testing for such displacements. It was thus decided (i) to reduce the maximum displacement to 30 mm, and (ii) to change number and position of the points of contact (from three to four symmetrically arranged contact points). Figure C3 shows one of the four pieces of felt during one of the new testing attempts, which were carried out by using layers of felt material taken out from the samples that have been already tested. In this case, four layers of felt per each pile were used, resulting in an excessive deformation in the vertical and horizontal directions. Figure C4 presents an example of disintegrated felt stack after the testing.

**Figure C2. First cyclic friction testing attempts – Felt layers after testing.**

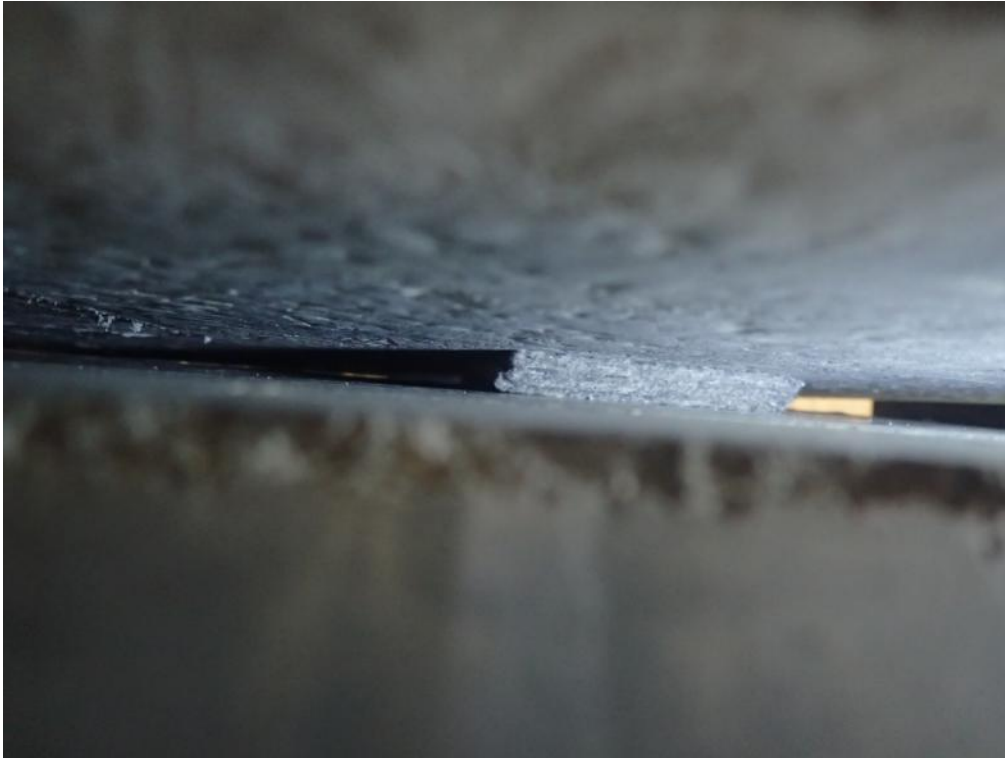
**Figure C3. First cyclic friction testing attempts – Symmetric configuration, four layers of exhausted felt.**

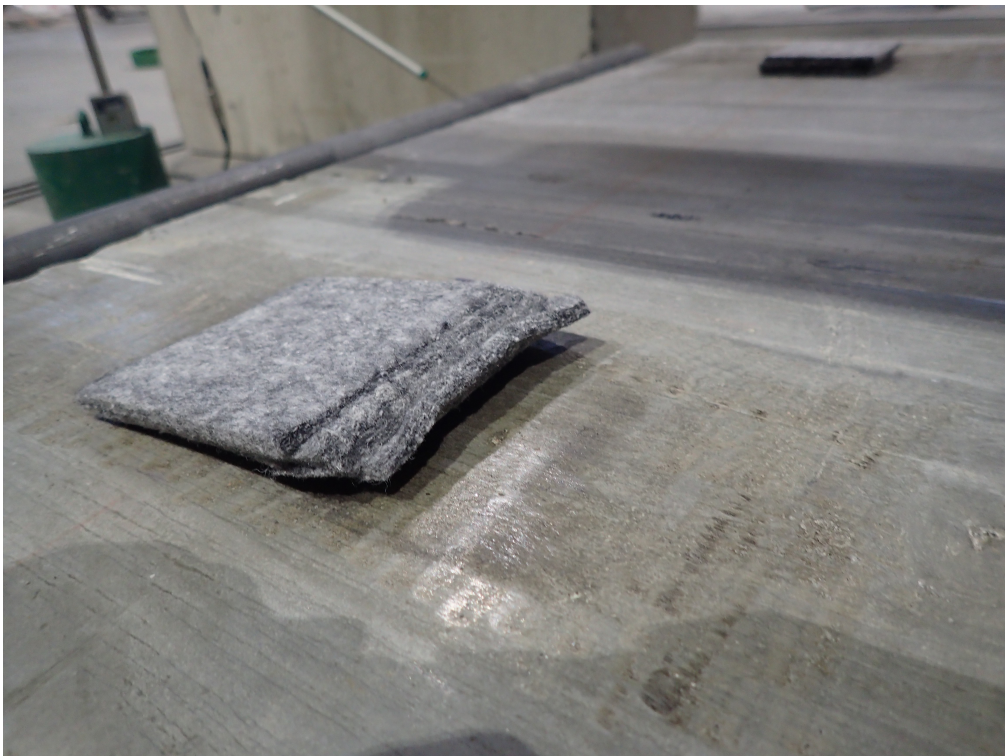
**Figure C4. First cyclic friction testing attempts – Disintegrated felt stack after testing.**
